Safety appraisal and rehabilitation of a quay wall

C. Valore & M. Ziccarelli

Department of Structural and Geotechnical Engineering, University of Palermo, Italy
calogerovalore@tiscali.it

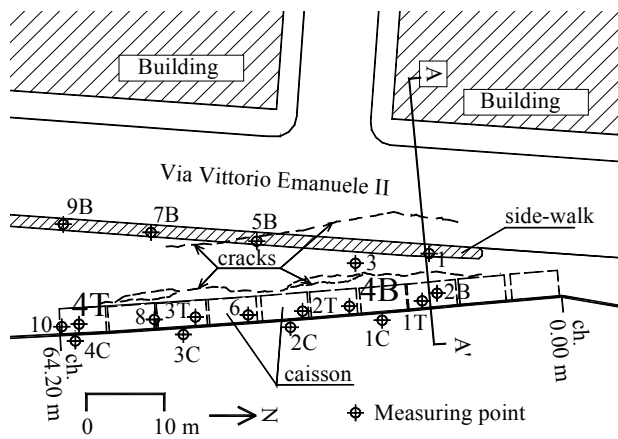
Fig. 2. Schematic plan of Colapesce Quay and location of measuring points for monitoring movements of caissons.

Some well developed tension cracks, almost parallel to the wall edge, were detected on the surface of the backfill behind the quay wall (Fig. 2).

The cracks showed vertical offset of a few centimeters and were approximately located within the active wedge; depressions up to 150 mm deep were also noted on the surface of backfill.

When it was realized that the quay wall tilted towards the sea and that the cracks on the surface of the backfill might have been indicative of the formation of a failure mechanism, the quay was put under control by monitoring its movements, and particularly the horizontal displacements, (Fig. 2), movements of the backfill surface as well as of buildings were also monitored. Operation of the quay was interdicted. A careful subaqueous inspection pointed out the existence of several cavities at the base of caissons. Moreover, it was readily apparent that the sea floor in the vicinity of the caissons was deeper than expected as a consequence of scour and of dredging operations, which however have not been recorded. The trend of horizontal outward displacements (Fig. 4 and Table 1) pointed out that collapse by overturning might have been impending, even in the absence of seismic actions.

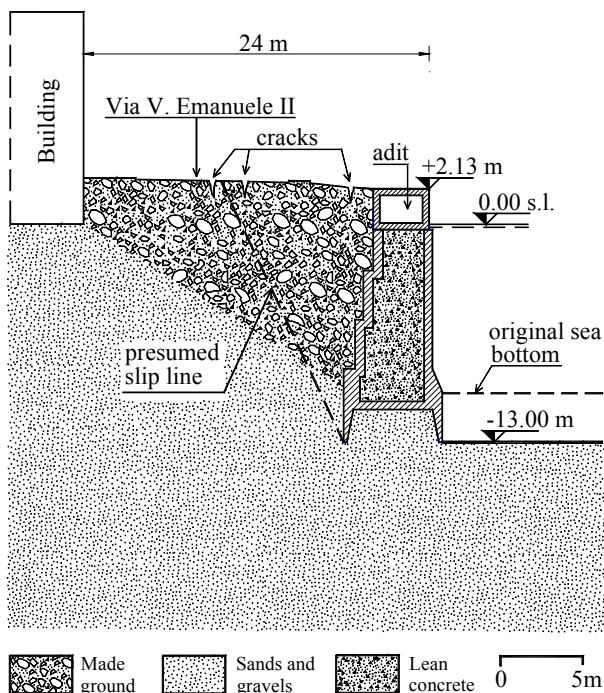
Fig. 3. Schematic cross section A-A' of the quay wall, foundation soils and backfill material and backfill surface.

The crest elevation of the wall is 2.13 m above mean sea level. The depth of the sea floor in front of the wall was originally 10m below m. s. l., while it was found at 13m below m. s. l. in 2000, when investigations were carried out.

The backfill is heterogeneous but prevalingly formed by masonry rubble and debris and occasional silty lenses; the unit weight of backfill ranges from 17 to 21 kN/m^3 with a mean value of 19 kN/m^3 ; cohesion intercept can be considered nil; the operative value of the angle of shearing strength is 38° and has been derived from a backanalysis of the quay wall under the hypothesis that the backfill attained the active state, congruently with the tilt undergone by the wall, which is leaning toward East.

The maximum horizontal projection of the upper edge of the caisson out of the perpendicular was 200 mm, corresponding to an outward rotation of $\text{arctg}(200/1500) = 0.76^\circ$, which results in fairly good agreement with the criteria for the attainment of active state (Terzaghi, 1934 and 1936; Clough and Duncan, 1991).

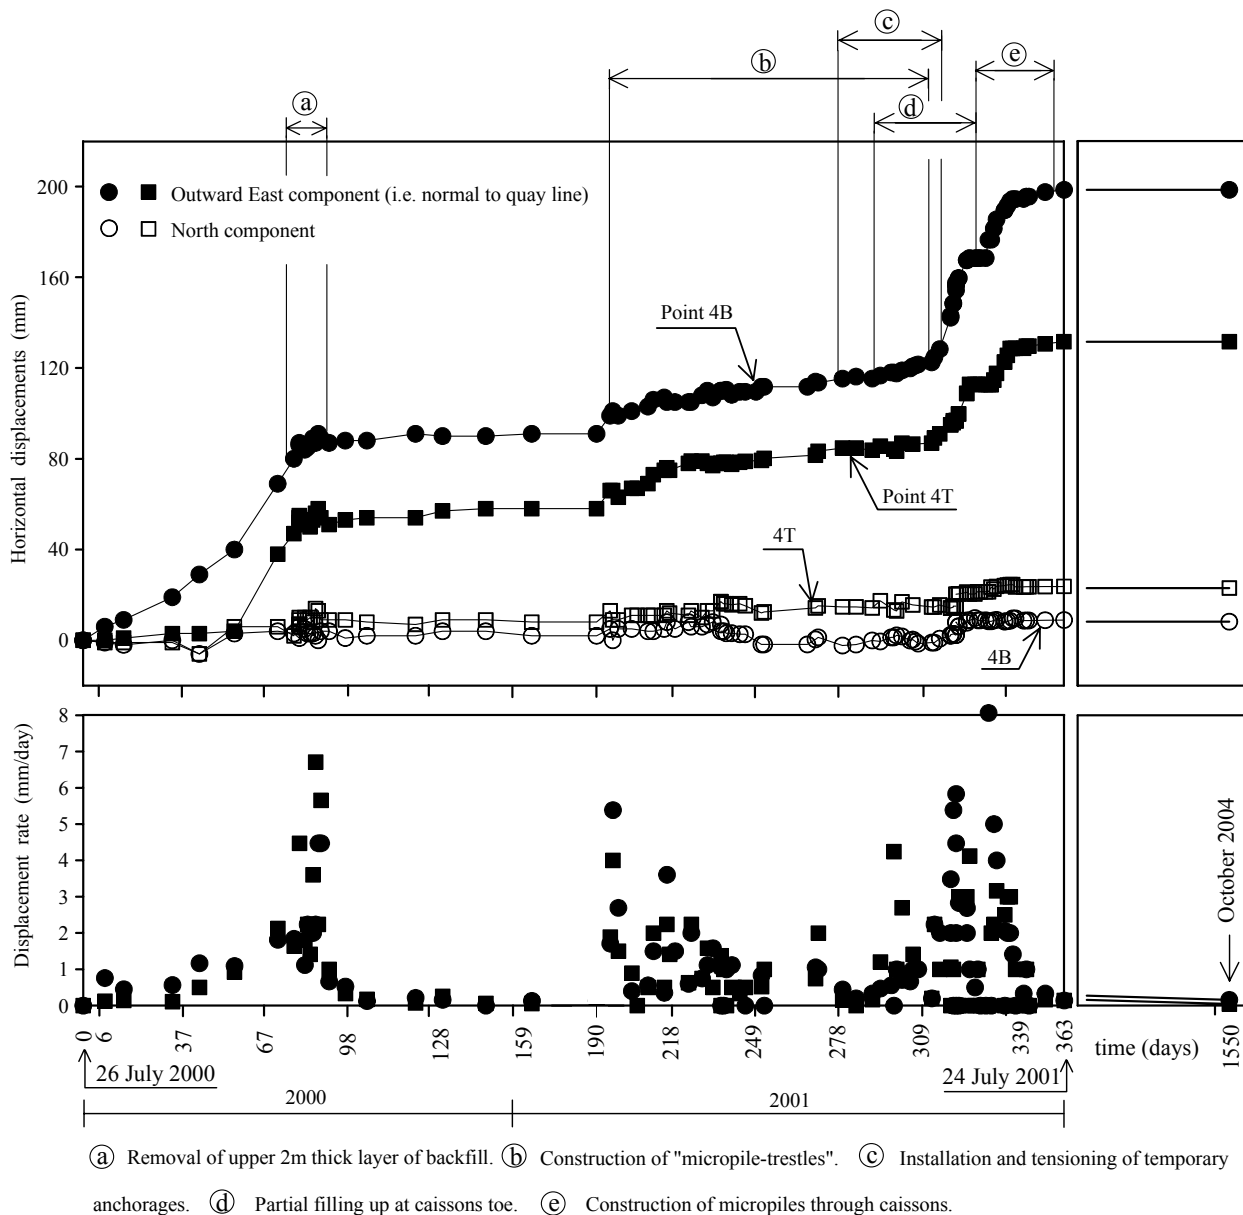
Fig. 4. Typical results of the survey of horizontal displacement of measuring points located on the crest of caissons in relation to stabilisation actions carried out.

Data plotted in Fig. 4 show that moving equipment near to the quay wall during installation of temporary anchors and the placement (from the crest of the wall) of filling material at the toe of the caissons caused resumption of horizontal movement, which, however, became almost imperceptible when the causative operation ceased. Movement was resumed again during the very initial phase of the installation of micropiles

through caissons. One of the anchor was instrumented with a load cell; the tensile force evolved from 19.6 kN (2 t) up to 176.5 kN (18 t) during the execution of works. Movements of the wall slowed down and stopped after the completion of corrective works.

The stabilisation actions were fully successful, although not exempt from risks during their implementation as clearly pointed out by data in Table 1, from which the "reactiveness" of the quay wall to modest mechanical actions - usually taken as negligible - is evident.

The choice of stabilisation actions in the case under discussion was considerably restricted due to serious concern for possible adverse effects on stability of moving the construction equipment necessary for carrying out the corrective measures themselves. A preliminary "first-aid" intervention was eventually deemed indispensable, and this consisted in the removal of the upper 2m thick layer of the backfill. This measure proved effective in slowing down the rate of horizontal displacement, as can be inferred from Fig. 4.
