Re-use of existing piles, Belgrave House, London

Mohsen Vaziri

Geotechnical Department, Whitbybird Engineers, London, UK

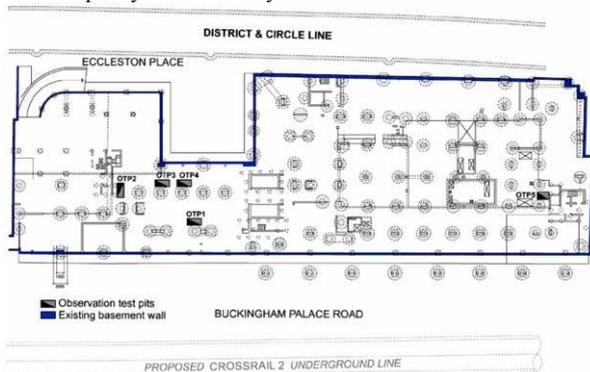
Figure 5: Observation Test Pits – Existing Basement Plan
Depending on the findings from the testing programme it was considered that there may be a need to selectively increase the number of piles tested.

The pile inspection comprised excavating observation pits next to selected columns to expose the range of pile types identified on the drawings; the excavation was then extended to expose the piles to depth. One of the reasons that the pits were excavated was to verify the size and location of the piles with the information shown on the original design drawings. Figure 5 shows the location of the observation pits.

A total of five observation pits were excavated at basement level to a maximum depth of 3.9m below structural slab level. The piles exposed in the trial pits were visually inspected. No obvious defects in the piles were noted. Table 3 below details the piles revealed in the trial pits using the original pile design reference numbers.

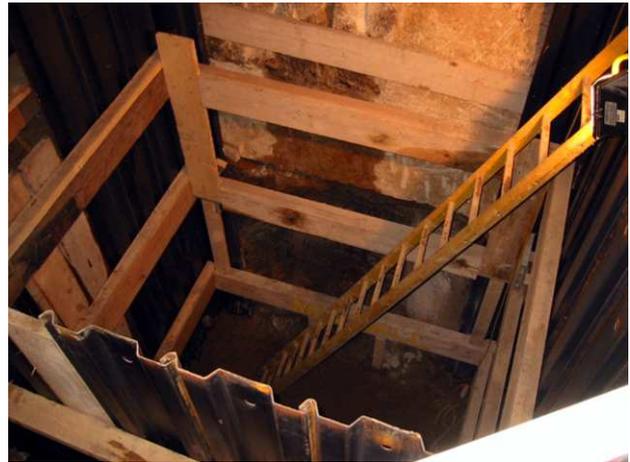
Figure 6: Basement of Existing Building

The observation pits were excavated manually due to the limitations of space and access from working in the basement of the existing building (Figure 6). The pits were also dug during the soft strip demolition of the building and this resulted in additional health and safety considerations.

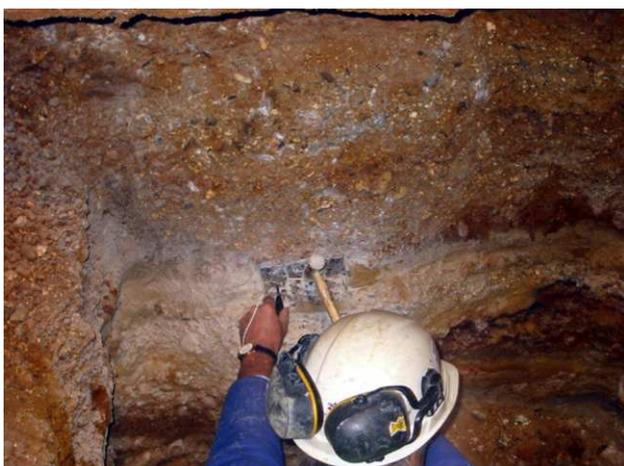
Figure 7: Integrity Testing carried out on Exposed Piles

Integrity tests were carried out in the trial pit on all the piles inspected. This required the preparation of the side of the pile by forming a small notch (Figure 7).

Integrity testing was performed on all seven piles revealed in the observation pits. The tests concluded that there was no evidence of major detrimental impedance changes for the piles and therefore, within the known capabilities of the test, the piles appear to be of a satisfactory integrity with no obvious indication of pile defects.
