Behaviour of foundations over surface fault rupture: Analysis of case histories from the Izmit (1999) earthquake

Ioannis Anastasopoulos
Candidate, National Technical University, Athens

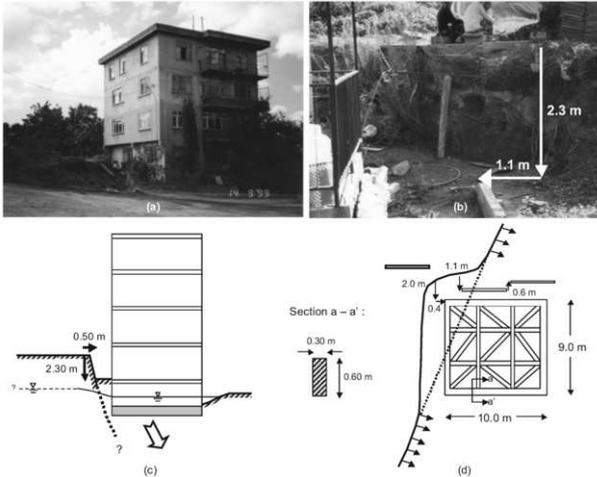
As depicted in Figure 1 the surface rupture diverted and just avoided the 4-story reinforced-concrete structure, leaving it totally un-harmed. The downward settlement reached 2.3 m, accompanied by a strike component of 1.1 m. The only apparent damage was the flooding of the basement, due to the local modification of the water table. The owners were inside the house during the earthquake and felt no vertical falling. Evidently, the vertical displacement was of a quasi-static nature. The foundation of the 9 x 10 m building consists of strip footings ~0.6 m x ~0.3 m (height x width) transversely connected through tie beams of similar dimensions.

Figure 1. Building 1, four stories plus basement : Minor Damage

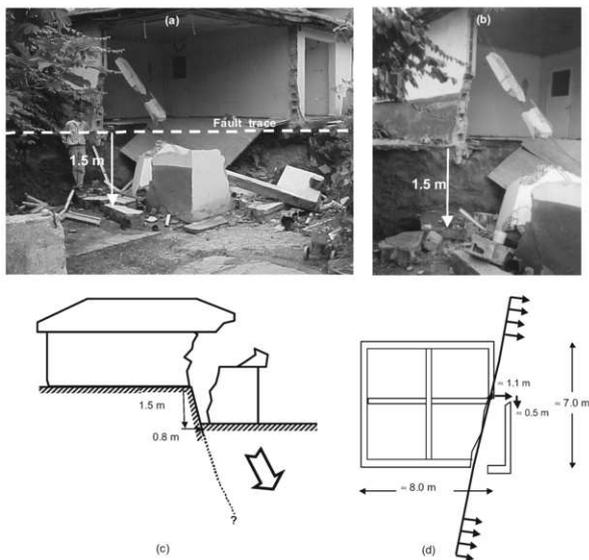
Building 2 was a simple 1-story structure. Its wooden tile-roof was supported on cinder block walls. The walls were practically founded directly on the soil, without any foundation. This poor building could not have been expected to perform well subjected to a differential displacement of 1.5 m, and indeed it was torn apart by the rupture (Fig.2). However, it did not collapse completely, not causing fatalities. The rupture crossed its north-east corner tearing it apart from the rest.

Figure 2. Building 2, one story cinder-block structure : Collapse

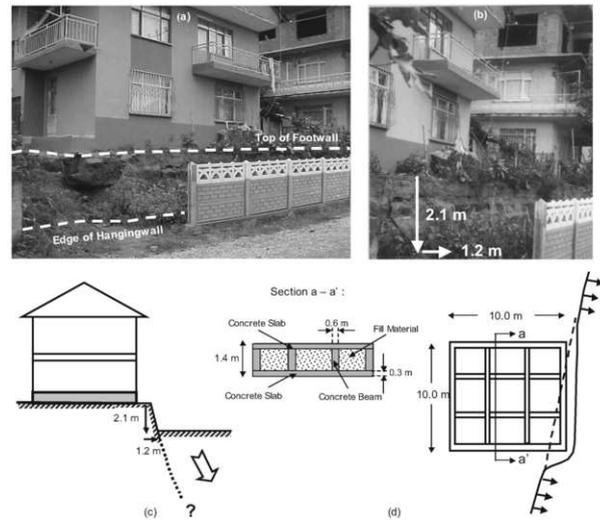
Building 3 managed to survive without any visible damage. Most importantly, the rupture was diverted, as in the case of Bldg. 1, but since Bldg. 3 is founded on the footwall, the rupture was diverted to the North, towards the hanging-wall (Fig.3). The vertical displacement was 2.1 m. The 2-story (+attic) reinforced concrete building is founded on a rigid box-type foundation, comprising stiff concrete beams, ~0.5 m x ~0.8 m (width x height) sandwiched between a mat and a top slab, both ~0.3 m thick. The thickness of the whole box reaches 1.4 m, and the voids are filled with soil. It appears that this box foundation is quite common in the provincial regions of Turkey with poor soils. In Adapazari, where most of the failures were of the bearing capacity type, although many buildings toppled, foundation and superstructure remained un-harmed, confirming the ability of such foundations to safeguard vulnerable superstructures.

Figure 3. Building 3, two stories plus attic : No Damage

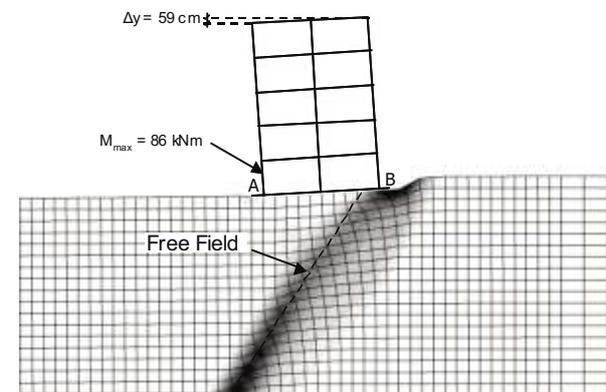
Figure 5. FE analysis of Building 1 : Deformed mesh and plastic strain

As clearly seen in Fig. 5 the rupture path is diverted away from the building (towards the footwall), as it approaches the ground surface (topmost 10 m of the propagation path). As it deviates to the right of the building, the plastic strain does not remain as concentrated as along the free-field rupture path, but is diffused over a wider area. The building tilts towards the hanging wall and the differential settlement reaches 59 cm. Despite this significant differential settlement the maximum bending moment M_{max} in the superstructure does not exceed 86 kNm. The rigid foundation not only managed to divert the rupture, but also allowed the building to rotate essentially as a rigid body, without stressing its superstructure. Although the differential settlement is significant (6 % is much higher than the usually accepted maximum of 1/300), the analysis does not indicate significant distress of the building's superstructure. This agrees fairly well with the observed performance: the building sustained no structural damage. However, in reality, the tilting of the building was not as large as the predicted. We identify two possible explanations: (i) post-seismic consolidation near-the-edge of the building due to the increased contact stresses under that part, (ii) the rupture did not cross the structure perpendicularly as assumed in our analysis: it intersected only at the corner of the building, which is more favorable than our plane strain assumption.

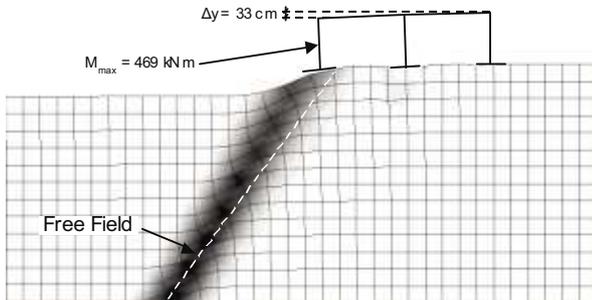
hanging wall to avoid the far-left “footing” of the building (Fig. 6). The dislocation follows the same propagation path as in the free field, with the exception of the top 4 m. The building tilts towards the hanging wall, with the differential settlement reaching 33 cm. Part of the edge footing loses its support from the ground. Despite the smaller differential settlement, M_{max} reaches 469 kNm. Evidently, such a distress could not be accommodated by the cinder walls of this structure. Again, FR-SFSI does not affect either the path of dislocation, or the deformations along the surface. We can safely argue that the analysis agrees quite well with the observed performance, despite the crude modeling of the superstructure.

Figure 6. FE analysis of Building 2 : Deformed mesh and plastic strain

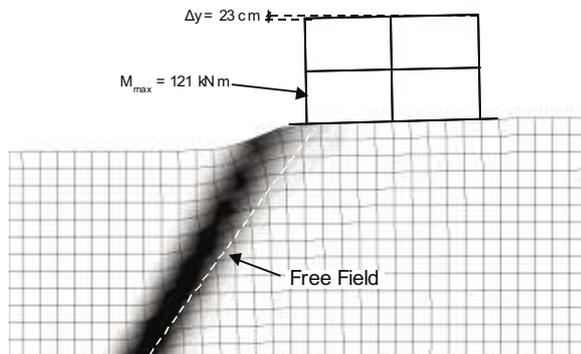
Figure 7. FE analysis of Building 3 : Deformed mesh and plastic strain

Until the rupture reaches a depth of about 12 m it follows the same propagation path as in the free field (Fig. 7). Then it is diverted to the left of the building, towards the hanging wall. The plastic strain seems to be quite localized and a distinct fault scarp is predicted numerically. The building tilts slightly towards the hanging wall and the differential settlement does not exceed 23 cm. Despite the considerable differential settlement the maximum M_{max} only reaches 121 kNm. Again, as in the case of Bldg. 1, the rigid box-type foundation not only succeeds in diverting the dislocation, but it also “converts” the differential displacement to a rigid body rotation. Although the differential settlement is an appreciable 2 %, no sign of distress is predicted for the building. One must realize that despite the commonly accepted 1/300 rule of desired maximum tilting, a 2% tilting is not easily observable and as seen in the article of Charles & Skinner (2004) would not cause any structural distress in buildings on stiff rafts. Of interest are some additional examples from the Kocaeli (Turkey) earthquake. For instance, there were many buildings in Adapazari with post-seismic tilting of about 3° (tilting \approx 5%), or more, that exhibited absolutely no structural damage. This is always the case when the foundation is rigid enough to keep the differential settlement only in the form of rigid-body rotation. As a conclusion, our FR-SFSI analysis
