Analyses of historical buildings condition with respect to soil-structure interaction

V.M. Ulitsky

A.G. Shashkin & M.B. Lisyuk

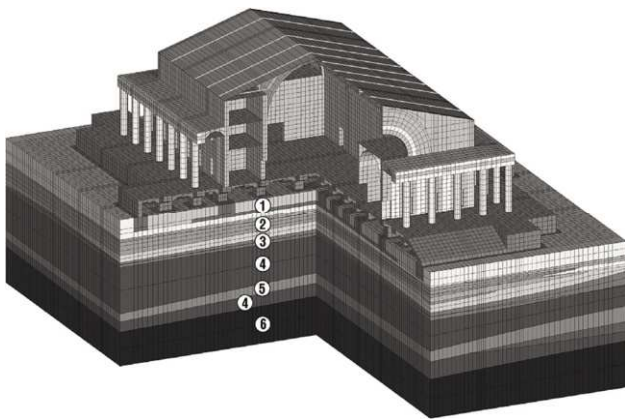
The principal feature of the ground conditions was identified as considerable heterogeneity of the soil strata (Fig. 2). The made-up ground is underlain by intermittent sand and soft clayey sand strata with some presence of loam, including a stratum of peaty clay sand whose thickness increases from 0.0 m to 2.0 m directed from north to south elevations.

Figure 2. Stock Exchange building and its subsoil. Computer generated outlook. Soil layers: 1 – silty sand, 2 – clayey sand with inclusion of peat, 3 – soft sandy clay, 4 – semi hard clayey sand, 5 – sand with gravel, 6 – dislocated clay

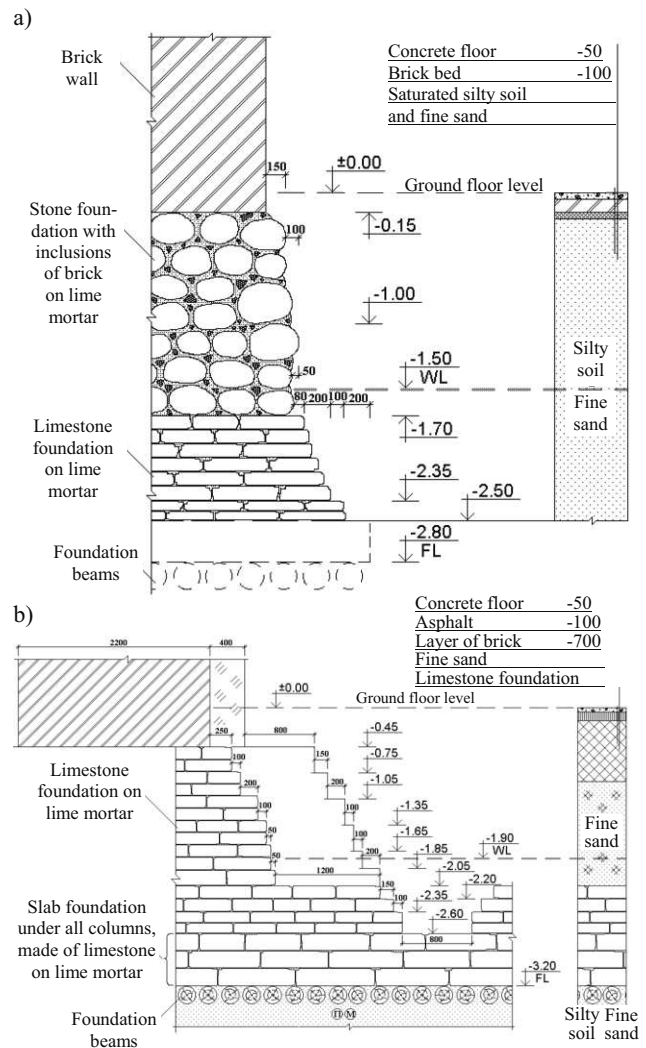
The survey displayed the layout where the strip foundations of the exterior stylobate walls (compounded of granite and limestone elements) served as a strengthening embankment for the excavation pit, inside which (over a layer of timber beams) a solid limestone foundation wall was constructed supporting pillar-type rubblework foundations (Fig. 3).

The hypothesis as to discontinuity of the foundation layout was disproved. No rotting of timber beams was observed; fine sand underneath was found to be of mostly firm composition. Therefore it was possible to establish that development of the deformations in the given case was unrelated to either of the

Figure 3. a) Exterior wall foundation of Stock Exchange stylobate; b) Foundations of Stock Exchange pillars

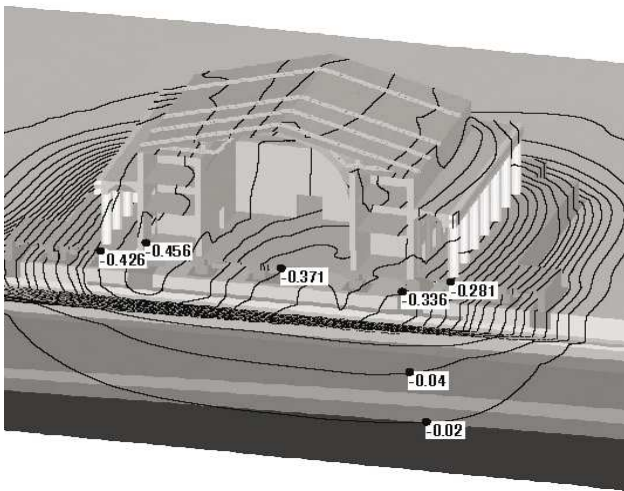
Calculations were carried out in two steps (Fig. 4). The first step featured modelling of the natural stressed subsoil conditions, the second – construction of the building. As was shown by the calculations, the overall settlement of the building throughout the entire period of its life should have been in the order of 26-44 cm. Thereat settlement differential between the corners of the building reached 9-14 cm increasing towards the south wall, which was validated by monitoring. The bulk of compressible strata taken into account was 13-15 m. The most substantial contribution to settlement differential was rendered by the stratum of peaty loam. Considering that the absolute levels of the underside of that stratum vary from -0.8 m to -5.3 m, the foundations of the building fail to reach any reliable support and are embraced by the peaty loam area in the south-east part of the buildings.

Figure 4. Contours of subsoil settlements (m)

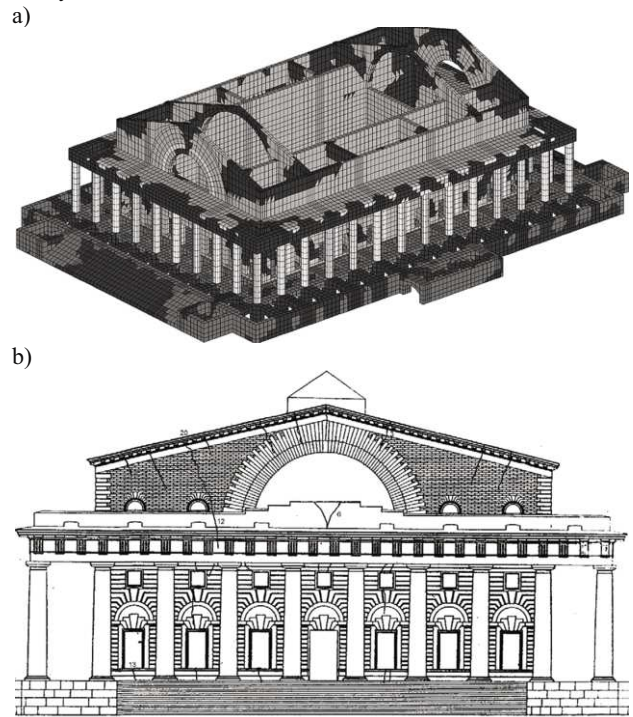
As per the calculation results the reason for opening of the cracks lies in development of tensile stress in the upper part of the walls owing to settlement differentials (Fig. 5a). The calculation results fully agree with the actual conditions of cracking (Fig. 5b).

The calculation identified the most adverse settlement on the foundations located under the double contour of the building walls. A somewhat smaller settlement of the other sections of the foundation is responsible for development of tensile areas in brickwork vaults of the central and edge zones of the stylobate, also validated by the actually observed situation. The conclusion therefore suggested itself as to the discontinuity of the subsoil strata being responsible for the detrimental settlement differential (Fig. 5).

Figure 5. a) Possible locations of cracks development. Shaded areas denote major tensile stresses development; b) Cracks layout according to condition survey results

Thus, there are no grounds to expect any progressive character of deformations and no strengthening or underpinning of the building is required, provided, of course, that the present situation remains unchanged.

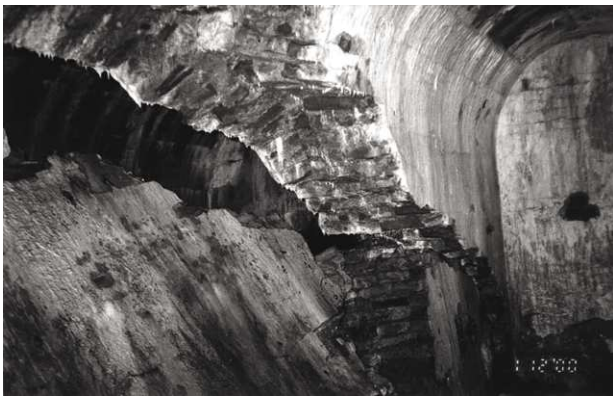
The entire brickwork structures were soaked in water conducive to dilapidation thereof through repeated frost penetration. Rotten timber pile crowns supported the transverse walls. Dilapidated terrace gutters had brought about weakening of some retaining wall sections adjacent to niches of the loggias and the grottoes. Dilapidated drainage incorporating precipitation sewer was formed by three straight courses underneath the retaining structures designed to divert precipitation and ground water from the palace. Most structural damage (fallouts) was associated with the destroyed drainage sections underlying the retaining structures (Fig. 7).

Figure 7. Dilapidated transverse cellar wall behind east section loggias (photographed in 2000)

The most considerable dilapidation was observed in locations with the initially thinnest sections of the wall (in the cross-section weakened by the vertical gutter of precipitation drainage and by local crumbling of brickwork around that gutter) in the area overcrossing the dewatering mains of the palace.

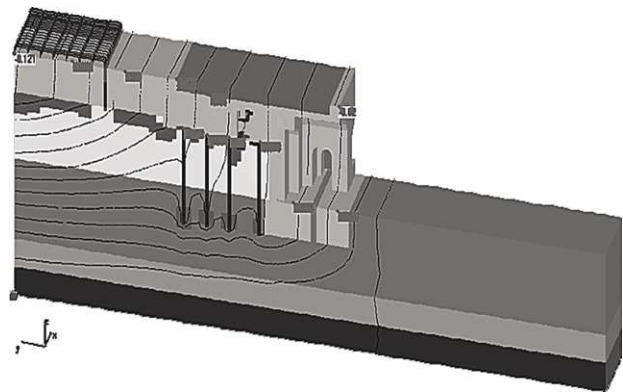
Figure 8. Calculation profile of cellars and loggias with account of timber piles

1. Provided that the piled foundation is kept intact underneath cellar walls (Fig. 8) the loggia structures remain in stable condition, with settlement of exterior loggia structures not exceeding 3.4 cm, and settlement of cellar walls not exceeding 5.8 cm.
2. In case of piles exception the cellar walls settlement reaches 7.7 cm which will serve as cause for transverse walls dilapidation.
3. In case of ground wash-out and foundation brickwork loosening settlement reaches 8.3 cm and deformation acquires appearance as shown in Fig. 8 (deformations are enlarged 500 times for the sake of impression). In that case brickwork material is dilapidated.
