## Special session on the 2004 Niigata-ken Chuetsu earthquake Séance spéciale sur le tremblement de terre de Chuetsu, Niigata, en 2004

F. Tatsuoka  
*Tokyo University of Science, Japan*  
 K. Konagai  
*Institute of Industrial Science, University of Tokyo, Japan*  
 T. Kokusho  
*Chuo University, Japan*  
 J. Koseki  
*Institute of Industrial Science, University of Tokyo, Japan*  
 M. Miyajima  
*Kanazawa University, Japan*

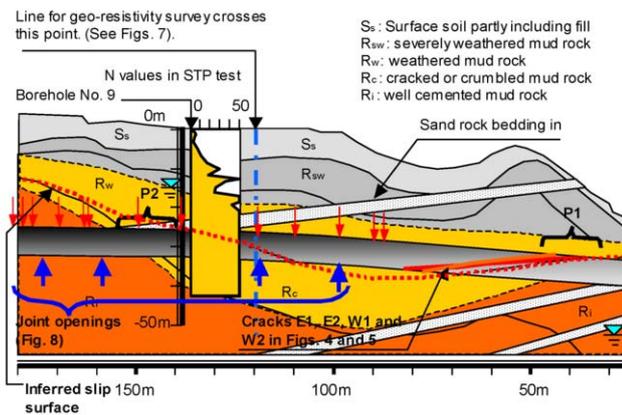
Fig. 4. Soil/rock profile along Kizawa tunnel: Downward thin arrows on the tunnel crown show locations of cracks cutting the tunnel axis up-right and diagonally crosswise, while upward thick arrows show locations of joint openings (Konagai et al. 2005).

Fig. 4 shows the soil/rock profile along the tunnel. Though the rock layers forming this mountain exhibit a normally stratified geological structure sloping about 18 degrees towards SW

(Yanagisawa et al. 1986), a different image of structure appears when the rocks are described in terms of their strengths. At two locations, P1 and P2, the northern part of the tunnel crosses a severely cracked and/or weakened mud rock layer overlying a depressed surface of an almost intact mud rock.

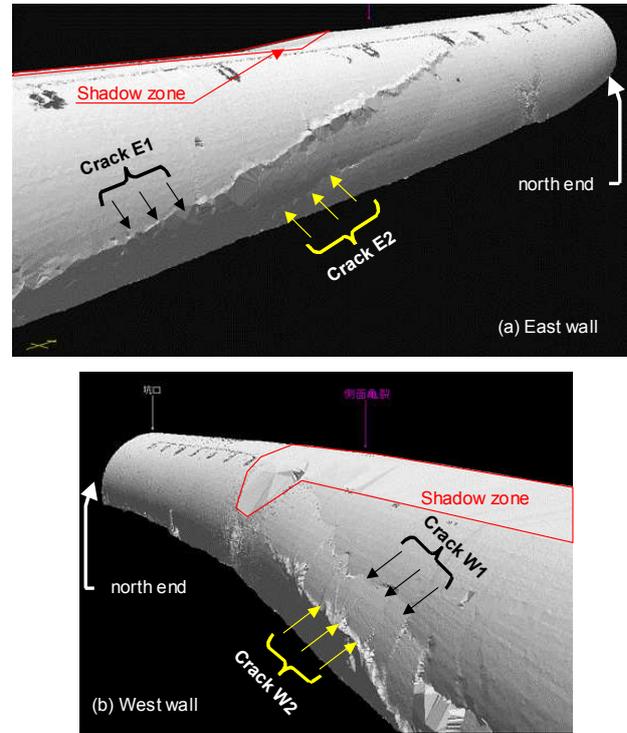
Northern 120 m segment of the Kizawa tunnel was laser-profiled. The image laser-profiled (Fig. 5) shows that two pairs of major cracks, E1, E2, and W1, W2, go diagonally up through the tunnel. The cracks, E1 and E2 on the east wall, extend over the 45 to 83m distance from the north tunnel end, while the cracks W1 and W2 extend over 38m to 88m distance on the west wall.

Fig. 5. Laser-profiled north segment of Kizawa tunnel (Konagai et al. 2005).

been caused by the movement of the soil/rock surrounding the tunnel, which was not clear in appearance from outside. As mentioned above, the northern part of the tunnel crosses at two locations, P1 and P2, a severely cracked and/or weakened mud rock layer (Fig. 5). The cracks E1, E2, W1 and W2 shown in Fig. 5 seem to be developed in this weakened mud rock zone P1 near the north tunnel end.

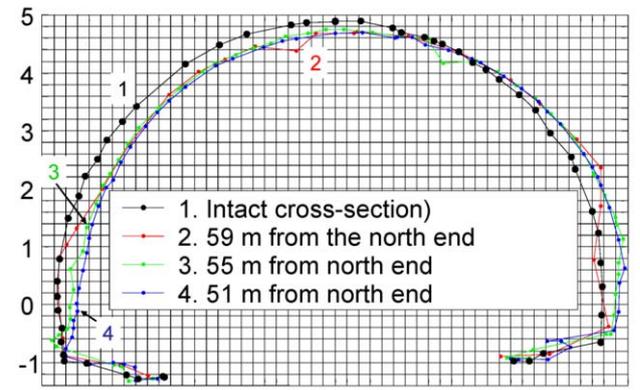
Fig. 6. Cross-sections of the cracked segment of Kizawa tunnel (Konagai et al. 2005).

Fig. 6 shows three tunnel cross-sections at 51, 55 and 59 m distances from the north end together with an intact cross section measured at the 100m distance. It is clear from this figure that the pairs of cracks on the wall became hinges for the upper half of the tunnel cross-section that was pushed 40 to 50 cm eastwards and about 10 cm down.

This part of the tunnel passes through a mountainside that slopes steeply down east, and the damage is considered to have

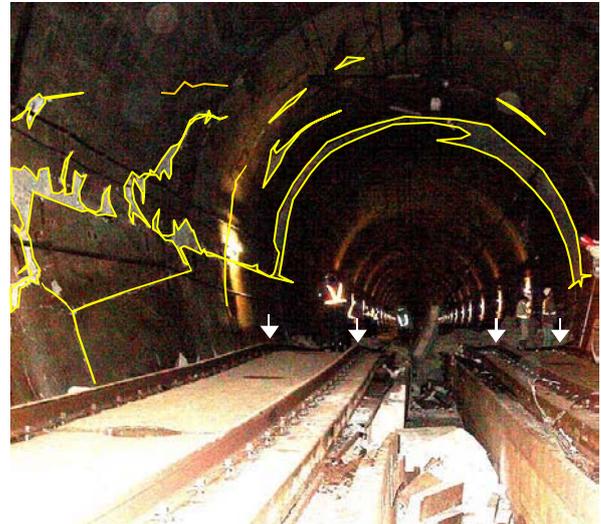
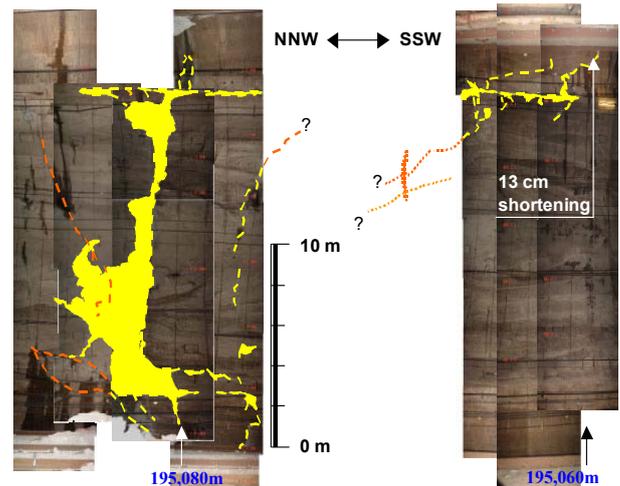
The tunnel was constructed through a squeezing rock zone, which spreads 120 m north ahead of the segment damaged in this earthquake. At the damaged location, the tunnel is about 60-100 meter deep. Cracks and their development of the damaged tunnel segment (Fig. 8a) over 195,060 to 195,080 m distance from Tokyo station are given in Figs. 8b and 8c. Several cracks cut the tunnel diagonally from the south to the center of the damaged area. These diagonal cracks merge at their southern ends to form a thrust dislocation showing about 13 cm shortening of the lining at this point. At the center of the damaged segment, the concrete crown broke up into large pieces, and fell in onto the rails and their slabs. The spalled part of the tunnel crown in Fig. 8c exposes steel supports. In Fig. 8c, the south part of the damaged area is to the right and the central part to the left. The northern part of the damaged segment (195,113m -) has lighter damage and the rail foundation was not deformed as much as in the south part (see Fig. 8a). However the center ditch along the rails shows a clear right-lateral shift of about 10-15 cm when it crosses this damaged part. NW-SE trending diagonal cracks were prevalent there.

Fig. 8. Cracks in the southern part of the damaged segment of Uonuma tunnel (195,060 - 195,080 m, Konagai et al. 2005b).

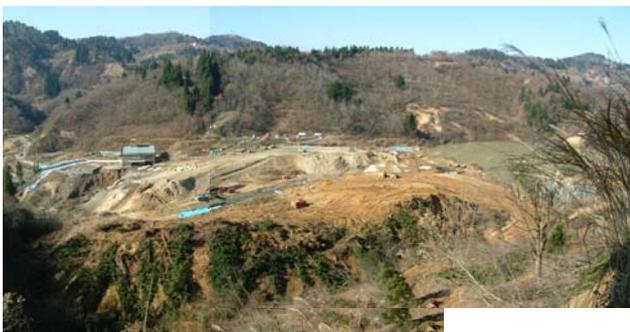
Fig. 2. Landslide mass in Higashi-takezawa seen from the scarp.

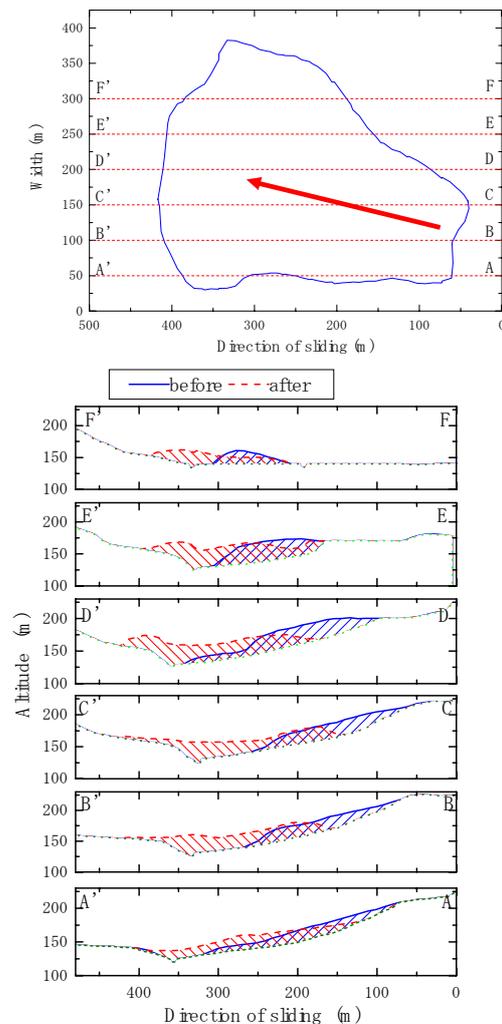
Fig. 3. Plan view (top) and cross-sectional views (bottom) of the slope failure shown in Fig. 2.

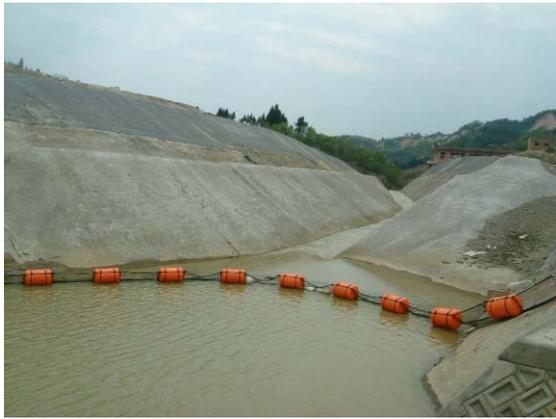
Fig. 4 Spillway constructed on the natural dam in Higashi Takezawa.

On the natural dams, emergency dewatering and spillway-constructions were implemented to prepare for flooding in next spring as shown in Fig. 4.

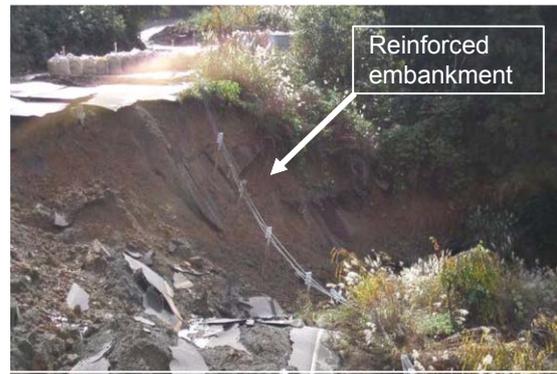
Fig. 1 shows an extensive slide of a road embankment constructed by filling a valley in a mountainous area along National Highway Route 290 (at Kuriyama-zawa, Tochio city). It should be noted that, as shown in the figure, a geogrid-reinforced embankment that had been constructed next to the collapsed unreinforced embankment was also damaged in the earthquake. This reinforced embankment had been constructed as a part of rehabilitation works for previous damage caused by rainfall.

Fig. 1. Collapsed road embankment along National Highway Route 290 at Kuriyama-zawa, Tochio city.

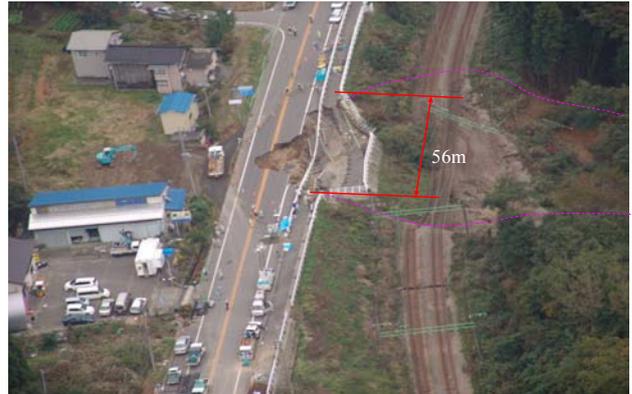
Fig. 2 shows failure of a gravity type soil retaining wall along National Highway Route 17 at Tenno, Ojiya city. This wall had been constructed in parallel with a railway embankment, which also suffered from sliding failure as shown in the figure. These embankments had been filled on uncemented debris or weathered terrace deposits and were reconstructed by using geogrid-reinforced soil (GRS) retaining walls (Fig. 3). At the adjacent site, a railway embankment was reconstructed by using a combination of GRS retaining wall and ground anchoring.

Fig. 2. Damage to embankments along National Highway Route 17 and JR Joetsu Line at Tenno, Ojiya city (by the courtesy of Ministry of Land, Infrastructure & Transport).

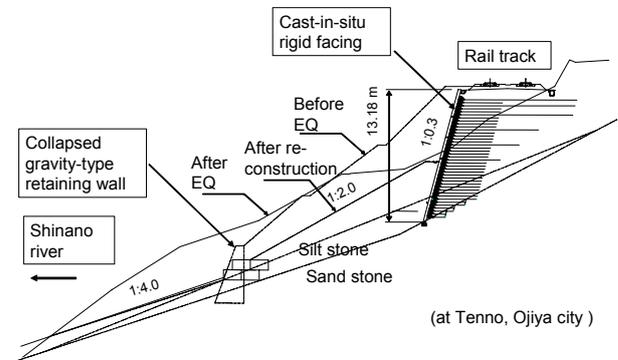
Fig. 3. Typical reconstruction of damaged railway embankment using geogrid-reinforced soil retaining wall (by the courtesy of JR-East).

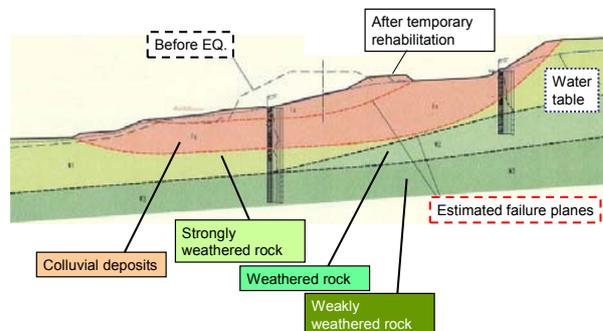
Fig. 4. Estimated soil profile of collapsed embankment along National Highway Route 290 at Kajigane, Yamakoshi Village (by the courtesy of MLIT).

Fig. 4 shows a cross-section of a collapsed embankment along National Highway Route 290 at Kajigane, Yamakoshi Village. This embankment was involved in earthquake-induced large scale landslide. In the reconstruction works for such a case, a careful judgment was required whether the landslide movement would restart again or not by possible heavy rainfalls in the future. It should be noted that, at the adjacent site, flow-type failure of embankment took place during the large aftershock, due possibly to water leakage from adjacent carp pond damaged by the mainshock.

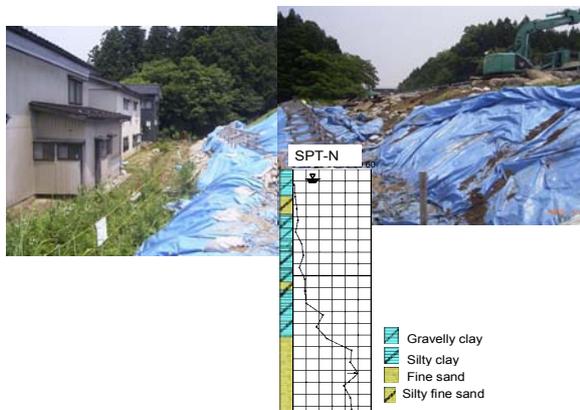
Fig. 5 shows failure of an embankment along National Highway Route 8 at Miyamoto, Nagaoka city. It also shows a typical profile of SPT-N values. Road settlement and embankment deformation accumulated during several large aftershocks. During temporary rehabilitation works, it was confirmed that the ground water table was very high. Since there did not exist a liquefiable loose sandy soil layer in the subsoil, concentration of longitudinal or transverse ground water flow into soft clayey subsoil layers that was magnified by the preceding heavy rainfall was considered to be the major cause for the failure. During the reconstruction works, the subsoil layers were improved by installing gravel compaction piles.

Fig. 5 Failure of road embankment along National Highway Route 8 at Miyamoto, Nagaoka city and typical profile of SPT-N values (by the courtesy of MLIT).

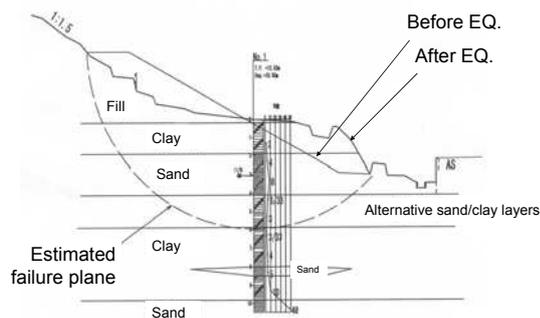
Fig. 6. Estimated soil profile of failed abutment embankment at Mitsuke-Ohashi bridge, National Highway Route 8 (by the courtesy of MLIT).

Fig. 6 shows a cross section of a failed abutment embankment at Mitsuke-Ohashi bridge, National Highway Route 8. In this case, a loose sandy layer existed below the ground water table, which is estimated to have liquefied during the earthquake. During the reconstruction works, the subsoil layers were improved by installing in-situ cement-mixed piles by jet grouting method.

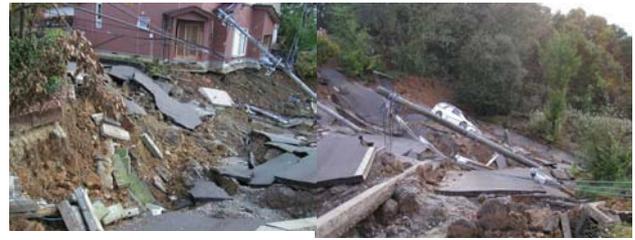
Fig. 7. Collapsed embankment for regional road around a newly-developed building estate at Taka-machi, Nagaoka city.

Figure 7 shows collapse of an embankment for regional road around a newly-developed building estate at Taka-machi, Nagaoka city. The estates were constructed by cutting hills and filling valleys. The filled portions along their outer rim were severely damaged due possibly to insufficient compaction and drainage capacity of the fill materials, causing uneven settlement of the adjacent building foundations. They were reconstructed by using GRS retaining walls.

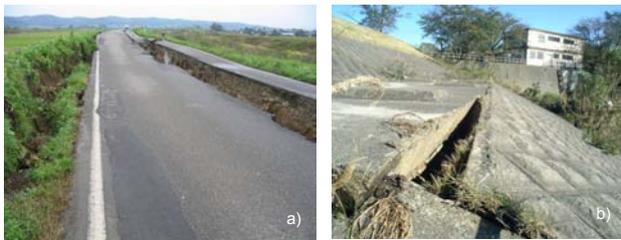
Damage to river levees were caused mainly by liquefaction of subsoil layers. Most of the damage was accompanied by sand boils in the subsoil layers at the foot of the levees.

Fig. 9. Damage to levees along Shinano river; a) crest settlement at Namiki-shinden, Nakanoshima-machi (by courtesy of Mr. Ishihara, M., PWRI); and b) failure of concrete revetment at Chiya, Ojiya city (by the courtesy of MLIT).

Large scale damage such as the one shown in Fig. 9a occurred in moderately-shaken regions where liquefiable layers existed in the subsoil. In severely-shaken regions, on the other hand, the extent of the damage was rather limited as typically shown in Fig. 9b, since these regions were located on the upstream side of the river, where liquefiable layers in the subsoil existed only locally.

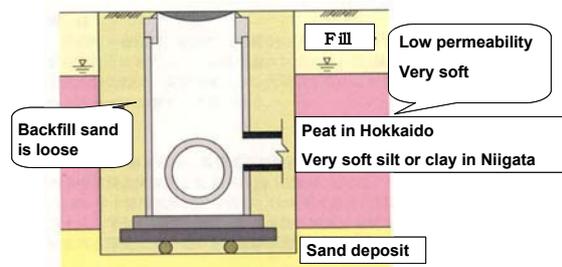
Fig. 2 is a schematic diagram of a section of sewerage manhole that is damaged by the liquefaction in the backfill (Yasuda et al. 2004). The surrounding soil of sewerage line was peat in Hokkaido and very soft silt or clay in Niigata. These materials have a low permeability and are very soft. Moreover the backfill sand of sewerage line was relatively loose and the underground water level was high during the earthquake. The backfill sand

was, therefore, very liquefiable because the backfill sand easily deformed under undrained conditions during the earthquake.

Fig. 2. Schematic diagram of a section of sewerage manhole (Yasuda et al., 2004).

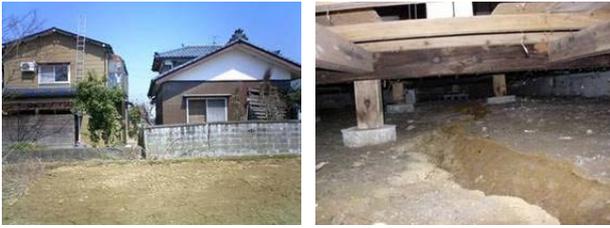
Photo. 4 shows a typical case of the subsidence of a wooden house that occurred at Mitsuke City. Cracks of the ground of the foundation appeared and subsidence of surface ground and foundation of house was caused by soil liquefaction.

Photo 4. Subsidence of a wooden house induced by soil liquefaction, Mitauke City.

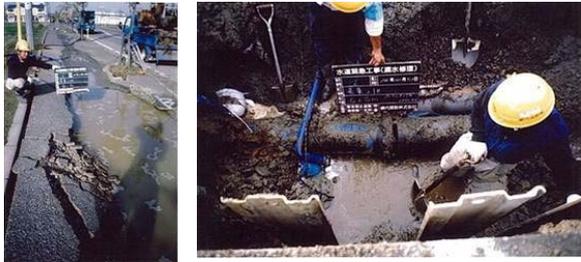
Photo. 5 indicates damage to a water supply pipeline in Ojiya City. Pull-out at joint of ductile iron pipe occurred at soil liquefaction sites. Since sand ejection happened from the backfill sand, the liquefaction of the backfill seems to be one of the causes of damage. The total number of failures for service and distribution pipelines was 102 in Ojiya City. The damage ratio, defined as the amount of failure per length of pipeline, was 0.31/km in Ojiya City. In Nagaoka City, 287 failures for service and distribution pipelines occurred and the damage ratio was 0.26/km. Liquefaction-induced damage to water supply pipeline was, however, relatively light.

Photo 5. Pull-out at joint of water supply pipelines, Ojiya City.

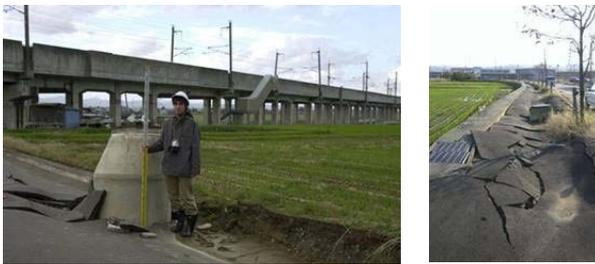
Photo. 6 shows an uplift of a sewerage manhole in Nagaoka City. This is typical of over a thousand occurrences of distributed manholes that were observed throughout the region. Buried sewerage lines were also disrupted due to permanent ground deformation. The total length of damaged pipelines was 152.1 km and the total number of damaged manholes was 2,719. Similar phenomena appeared during the earthquake occurred in Hokkaido, for example, the 1993 Kushiro-oki Earthquake, the 1994 Hokkaido Toho-oki Earthquake, 2003 Tokachi-oki Earthquake and so on, as shown in Photo. 7.

Photo 6. Uplift of sewerage manhole, Nagaoka City.

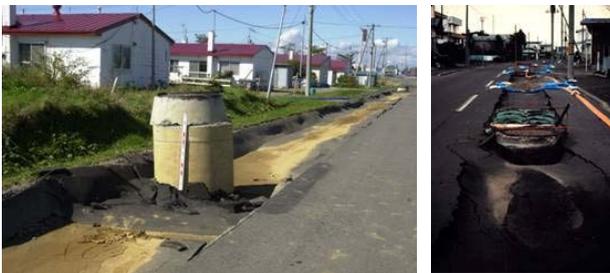
Photo 7. Uplift of sewerage manholes at Toyokoro Town (2003) and Shibetsu Town (1994), Hokkaido.
