# Strengthening the foundations of the main building of Tartu University, Estonia

K. Avellan & et al.

KAREG Consulting Engineers, Helsinki, Finland

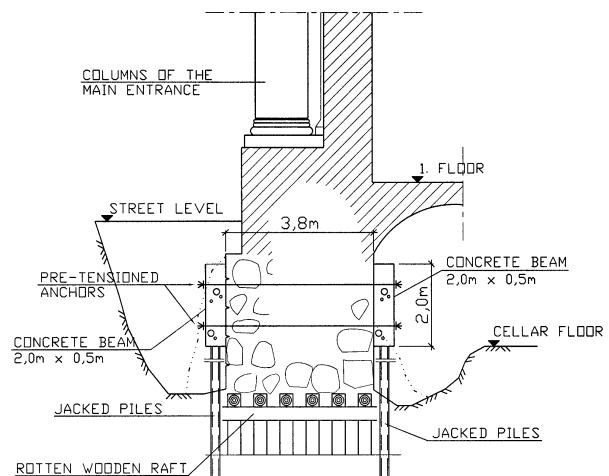
Thick external wall under the main entrance was not possible to dig underneath. The wall was supported both

Figure 1. The principal of the work under the main entrance wall of the building.

sides with reinforced concrete beam  $h \times b = 2.0 \times 0.5 \text{ m}^2$  (figure 1). The old stone and brick masonry of the wall was injected and the beams were post-tensioned against the old wall. Each post-tensioned anchorage consists of seven plastic-sheathed greased strands (monostrand) SUP 1630/1860,  $A_s=140\text{mm}^2$ . Each anchorage was tensioned to 1350kN and confirmed to 1050kN nine months later.

Jacked piles  $\varnothing 218 \times 10$  were made under reinforced concrete beams. The permissible load for each pile was  $P_w=500\text{kN}$  and the load test/end wedged action was  $P_t=750\text{kN}$ .
