Cement silo – Correction of tilt

S. Geffen & I. Birnbaum – *S. Geffen Soils Eng. Ltd., Kfar Saba, Israel*

ABSTRACT: A silo with a capacity of 100,000 kN cement, was constructed in 1991, at the Nesher plant near Haifa, Israel. The soil investigation indicated saturated plastic clays to 22 m followed by 3-5 m of sand. The silo is based on a shallow doughnut shaped raft foundation. Shortly after the filling, large settlements and tilt occurred. After 3.4 years, the differential settlement reached 285 mm (1:73) and a remedial measure was taken. Slanted borings were drilled on the less tilted side and left void. For 1.8 years, the tilt decreased by 33 mm. During the following 2.5 years, the leaning increased again to 270 mm. Then, additional vertical borings were drilled. The differential settlement decreased sharply by 84 mm. Presently, the silo is straightening at the rate of almost 1 mm/month.

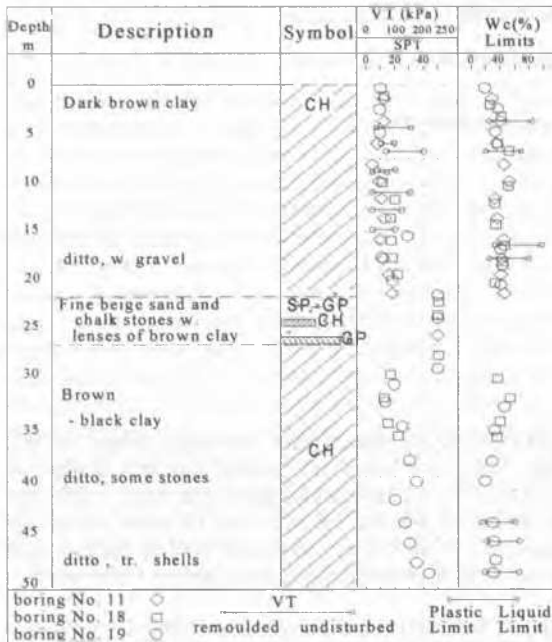
Figure 1. Soil profile: borings nos. 11, 18, 19, and from adjacent site.

water level observations. The laboratory-testing program included Atterberg limits, oedometer tests and triaxial tests. At an adjacent site some pressuremeter tests were performed up to a depth of 70 m. The soil strata are shown in Figure 1 up to a depth of 50 m and are described below.

The upper 22 m is a layer of clay (CH) of high plasticity, followed by a few meters of granular soil layer, partly cemented with lime. The liquid limit of the clay ranged between 72% and 96% and the plastic index from 32% to 58%. The groundwater table at the time was 3.5-3.7 m below ground surface. Oedometer tests showed some preconsolidation in the upper portion of the clay with overconsolidation ratios (OCR) of about 1.5 - 3.0.

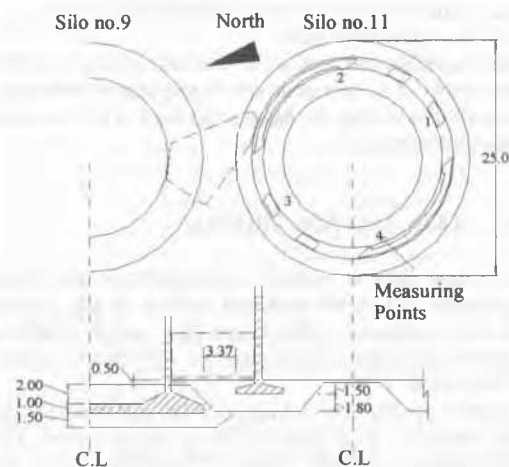
Figure 2. Layout and section of foundations.

The described silo no. 11 was built during the early months of 1991 and filling started later that year. Its centerline is located 25 m south from cement silo no. 9, which was built several years earlier and its capacity was increased in 1995. Silo no. 11 is based on a shallow doughnut shaped raft foundation, whereas silo no. 9 is based on a full circular raft foundation. The distance from the outer perimeter raft of silo no. 11 to the adjacent foundation of silo no. 9 is 3.7 m. The layout and the section of foundations of silos no. 11 and no. 9 are presented in Figure 2. It may

be seen that the bottom of the foundation of silo no. 11 was 1.5 m below final grade and about 2 m above the bottom of the raft foundation of the second silo, no. 9. The soil to depth of 1.8 m below the foundation of silo no. 11 was replaced by granular compacted fill. The doughnut foundation measures an outside diameter of 25 m and a width of 5 m.

The proximity to silo no. 9 is believed to be detrimental due to two causes: a) the random loading and unloading of silo no. 9 caused a remarkable increase in the preconsolidation ratio of the upper clays which was already effective at the time silo no. 11 was built; b) the raft foundation of silo no. 11 was constructed on 1.8 m of granular fill material while some of the layers were stabilized with 5% cement. Base layers were compacted on top of medium hard clays with the exception of the site adjacent to silo no. 9 where already there existed the granular base layer on which the foundation of silo no. 9 was constructed.

It was found that close to silo no. 9 there was a specially large concentration of cement within the granular base material which became a hardened layer of concrete of 0.2 to 0.5 m width.

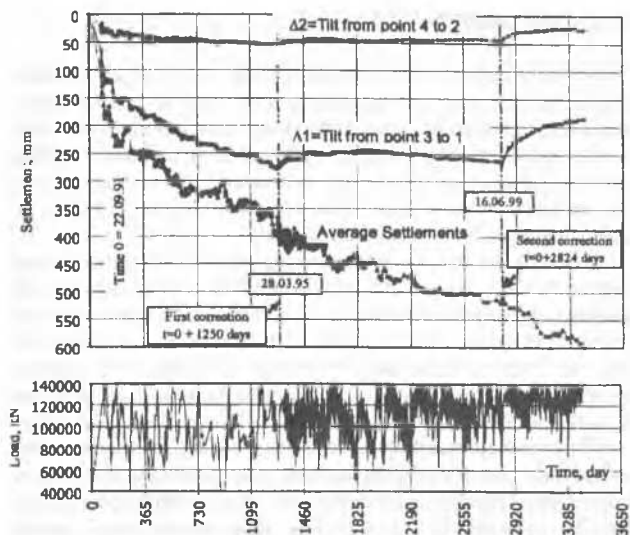
Figure 3. Settlement and tilt.

3.4 years after settlement observations started, the average settlement reached 370 mm and the differential settlement increased at a fast pace, reaching 285 mm, which amounts to a tilt of 1:73. This excessive leaning had to be stopped or at least decreased since there was the potential danger of the silo overturning, which would probably damage also silo no. 9.

Results of the full monitoring of settlement and tilt are plotted together with the loading history in Figure 3.

A theoretical solution for analyzing settlements, based on sinusoidal loading, was suggested by Rahal & Vuez (1998). In the lower chart of Figure 3, the loading history of silo no. 11 is indicated. For this random loading and unloading, a sinusoidal assumption is not valid. Using the logarithmic relation between plastic strain and number of cycles, as suggested by Ansal & Tunçan (1989), assuming that after long time the silo operation activity repeats itself, the predicted differential settlement for 10 years (equivalent to 3650 cycles), turned out to be 320 mm. It is not clear whether the loading of silo no. 11 could be viewed as cyclic.

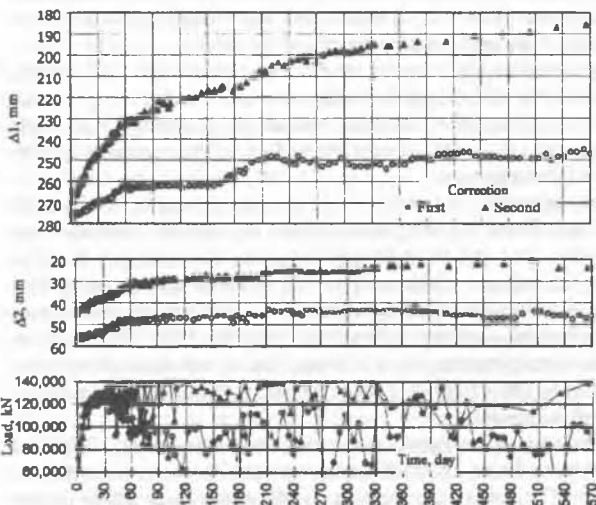
Figure 5. Performance of two corrective measures.

The correction of the tilt worked in the right direction, however it dwindled to a stop after about 650 days and then the tilt resumed. The differential settlement increased at about 1 mm/50 days, until it reached again 270 mm, when a second correction measure had to be performed. The first correction succeeded in returning the foundation from a maximum differential settlement of 285 mm to 251 mm, which is about 12% of the maximum out of level. During all this time the average settlement continued as before, without showing any increase in pace which was at the time about 6 mm/year.

The second corrective measure was intended to cause a partial shear of the upper clay layer by inducing relatively large lateral movement of the soil towards the excavated boreholes. This condition necessitated careful reloading of the silo and daily monitoring of the settlements. As expected, the tilt decreased at a faster rate than after the first corrective measure, Figures 3 and 5. The average settlements continued to increase at a slightly faster pace.

19 months (570 days) after performing the second corrective measure, the differential settlement of the footing was 186 mm, compared with 270 mm measured before this correction took place. The settlement measurements of the silo, during the following months, indicated that the straightening was still taking place, but at the reduced rate of about 1 mm per 35 to 40 days.
