Improved ground performance during the 1999 Turkey earthquakes

C.G.Olgun, J.R.Martin II & J.K.Mitchell – Virginia Tech, Blacksburg, VA, USA
H.T.Durgunoğlu – Boğaziçi University, Istanbul, Turkey

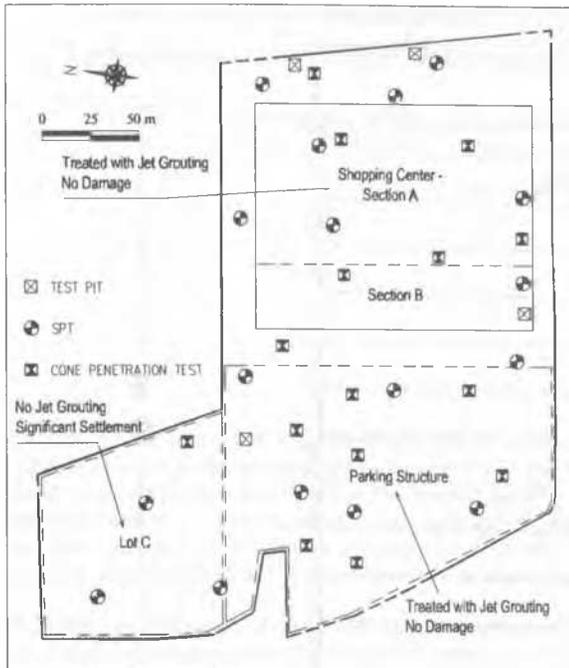
Figure 2. Carrefour site plan

As shown in Figure 2, the site covers an area of about 55,000 m² and will house two main facilities. A large supermarket is being built at the eastern end of the site, and a parking garage will be constructed at the opposite end. Both structures will be supported on shallow foundations on improved ground.

Lot C and parts of Parking Structure area were the only areas at the complex that had not been improved with jet-grouted columns. All other areas had been improved with both primary and secondary grids of grouted columns to reduce liquefaction susceptibility. Based on the differences in performance between the unimproved areas and the adjacent improved areas, the jet-grouted columns appear to have been effective in reducing liquefaction potential and liquefaction-related settlements of the sand layer.

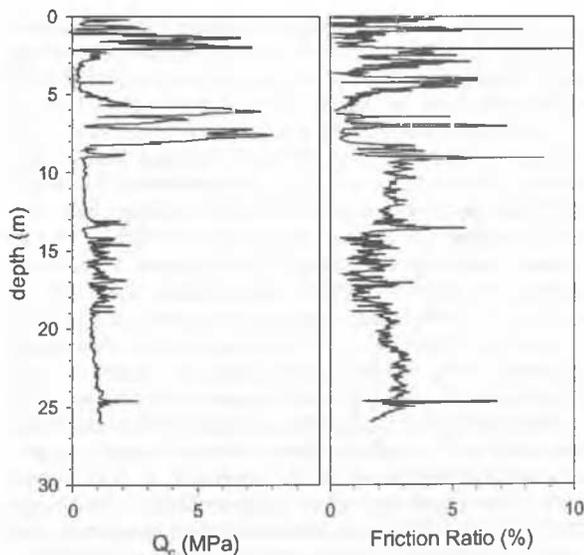
Figure 3. Typical CPT sounding from Carrefour site

encountered in a loose-to-medium dense condition. The thickness of this sand layer ranges from 2 m to 4 m across the site. Penetration data indicate that this layer is liquefiable under strong ground shaking. Below the sand, a second stratum of medium silty clay is encountered that extends from 10 m to a depth of more than 30 m where the exploration was terminated. The ground water table is found within 2 m of the ground surface throughout the site. A CPT sounding typical of the site is given in Figure 3.

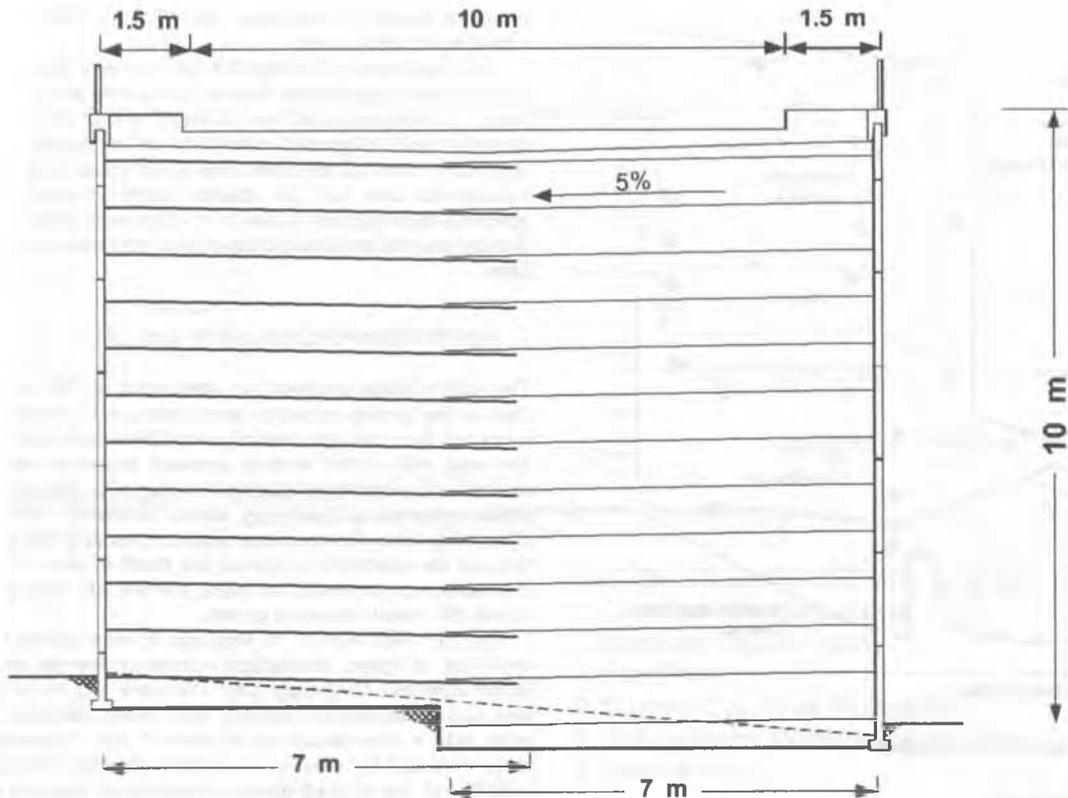
Figure 4. Cross section of the Arifiye Reinforced Earth Walls

The RE walls were 10 m high and of conventional design, consisting of square, interlocking reinforced-concrete panels as facing elements. The panels were 150 cm x 150 cm in frontal area, and the reinforcing elements were ribbed, galvanized steel strips with a cross section of 40 mm x 5 mm. Typically four strips were used per panel at a horizontal spacing of 90 cm. The backfill soil was of good quality, consisting of sand and gravel that was compacted in lifts during wall construction. A cross section of the double wall abutment at its highest is given in Figure 4. A reinforced-concrete culvert of 4.8 m width passed beneath the RE wall. The culvert is located in a creek channel that runs beneath the site. Settlement or possibly internal collapse of this culvert led to significant vertical movements in the wall. Four spans of the bridge collapsed in a "saw-tooth" manner due to lateral displacements of the piers and abutments, along with inadequate beam seat widths. However, the RE walls remained intact and experienced relatively little damage. A nearby unreinforced embankment suffered heavy damage.

Maximum horizontal and vertical ground displacements near the northern wall were estimated at 350 cm and 45 cm, respectively. These movements were inferred from the measured displacement of a buried pipe that was ruptured by the fault about 50 m from the wall. In addition to fault-related lateral movement, up to 25 cm of vertical movement occurred in the section of the wall overlying the culvert. The culvert appears to have settled during the earthquake, probably due to the presence of soft and/or liquefiable creek bed sediments. The resulting differential wall settlement caused the facing panels to become separated and misaligned, which allowed spillage of some backfill material. The maximum out-of-plane panel displacement was 5 cm. The differential wall movement may have also been related to the fact that the culvert created a discontinuity in foundation conditions beneath the wall.

The most notable overall observation was the relative lack of significant damage to the RE walls despite being subjected to strong ground shaking and large displacements. In stark contrast to this behavior, a conventionally-constructed approach embankment located about 250 m from the RE walls suffered heavy damage during the earthquake, experiencing settlements of more than 1 m. The good performance of the RE walls is thought to be particularly meaningful in demonstrating the seismic stability of conventionally-constructed walls of this type.
