Excessive settlements and failure of two embankments caused by degradation of soft rockfill

Orhan Erol & Asli Ozkeskin – Middle East Technical University, Ankara, Turkey

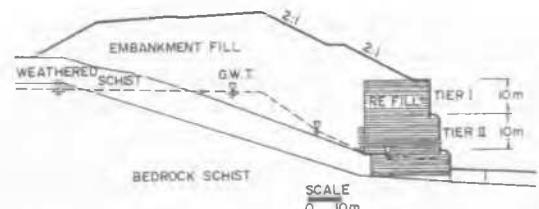
Figure 1. The typical cross section of the Embankment D6

takes place in the embankment. Presence of water accelerates this degradation process. The ground water levels shown in Figure 1 in Embankment D6 were detected during recent investigations in 1997. It is noted that the ground water levels are close to the base rock surface and rose into the embankment at the center line of the embankment. Presence of water level in the embankment as well as the capillary rise of ground water through the highly weathered upper layers of the bedrock aggravated the degradation of the fill material at lower elevations where high overburden pressures act.

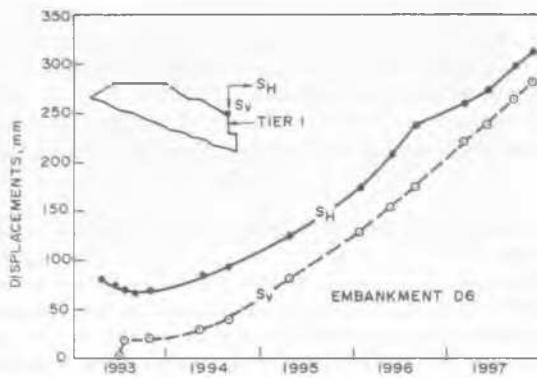
Figure 2. Vertical and lateral deformations measured at the crest of Tier I of Embankment D6

Vertical and lateral deformations measured at the crest of Tier I of Embankment D6 are shown in Figure 2. Another 44cm of settlement and lateral deformations would be added to S_V and S_H in Figure 2. These deformations occurred from 1992 to 1993 during which topographic measurements are not available. It is noted that both the settlements and the translational deformations continue to increase without any trend of reduction in the post construction rate of deformations for a period of 5 years. The magnitude of the deformations in both directions is in the same order of magnitude; and the rate of deformations in vertical and lateral directions is almost the same (i.e. 75mm/year).

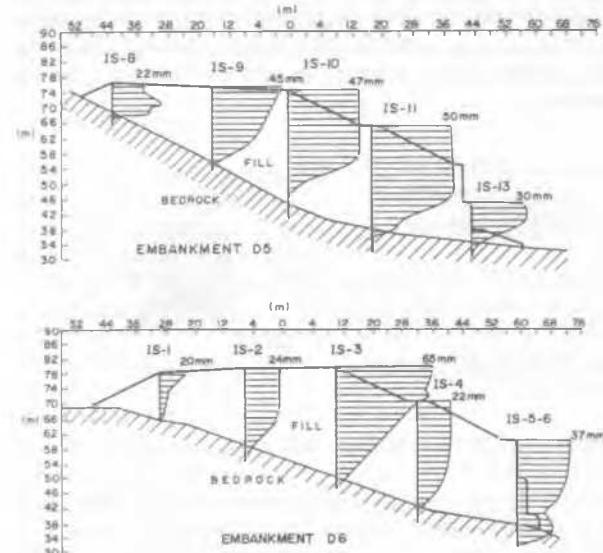
Figure 3. The inclinometric measurements taken between August 1997 and April 1998

The magnitude of the lateral deformations varied over a range from 20mm to 65mm being proportional to the height of the embankment. The movements are creep type in the upstream side of the embankment; and more or less slide type in the downstream part where the reinforced earth walls are situated. This mode of deformations may suggest that slide and translational type movements occur around the reinforced earth walls possibly due to

to lack of adequate internal and external stability; and rest of the embankment follows this movement as creep deformations. The inclinometric deformations show that movements start at the embankment fill-base rock boundary indicating a plane of weakness at the base of the embankment. This is possibly due to the presence of ground water close to the bedrock surface and its capillary affects as will be discussed later.

The inclinometric data shown in Figure 3 indicates that the embankments suffer from overall stability problems. The probable failure surfaces starts somewhere on the right lane, extends down to base rock and reach to the reinforced earth region. The presence of the groundwater either in the embankment or close to the bedrock surface gives raises to wetting of the embankment fill material. Wetting occurs when the fill is in direct contact with groundwater; or through capillary rise of the groundwater that is situated at shallow depths in the bedrock. The overburden pressures are the highest at the bottom of the fill where wetting process is also in action. These factors aggravate the particle crushing and degradation mechanism, resulting in deterioration in the frictional properties of the fill material.

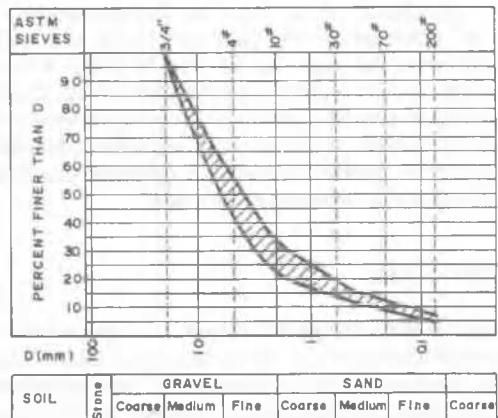
Figure 4. Typical grain size distribution of fill material

Highly weathered clayey schists excavated from the nearby cuts were used in the construction of both the embankments and the reinforced earth fills. Typical grain sized distribution of the fill material is shown in Figure 4. According to the specifications of the project, minimum of 90% modified proctor maximum dry density is required; and this compaction level was achieved in every stage of the construction with only few exceptions.

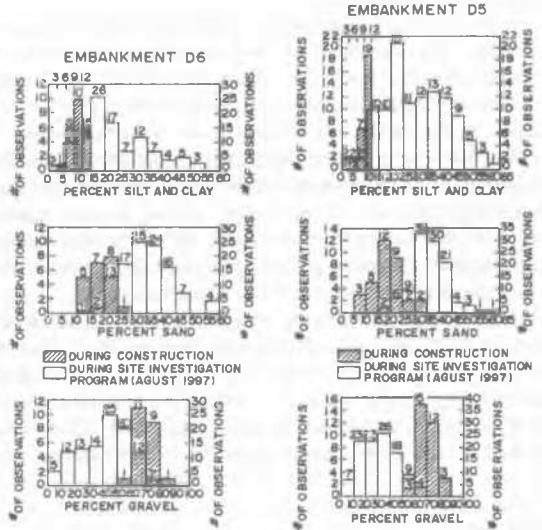
Figure 5. Histograms illustrating the change in the grain size of the fill material

The histograms given in Figure 5 show that a significant particle crushing and degradation have taken place in the fill material resulting in increased percentages of fines (silt and clay); and reduction in the coarse fraction (sand and gravel). This is a well-known phenomenon referred as "evaluation of weak and weathered rock when used as embankment fill" in the literature (Vaughan, 1994; Lade et al 1996). When weak rock is used as fill material in high embankments, the material consists of primarily angular coarse gravel and cobble size grains possessing large pores and porous fabric, during the placement of the fill. Although some particle crushing takes place during compaction, the process is not finalized unless heavy over compaction efforts are utilized during the construction. Subsequently high pressures due to self-weight of the embankment act at the particle contacts giving rise to particle crushing and grinding. Eventually crushed materials fill the voids and significant volume reduction

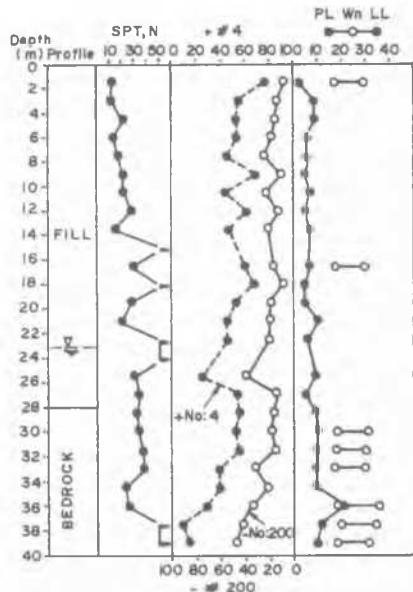
Figure 6. The characteristics of fill material obtained from recent investigations

The characteristics of the fill obtained from recent investigations are shown in Figure 6. Average properties of the fill are as follows: Fine content ($<0.074\text{mm}$) varies over a range from 5% to 55%, however in the majority of the samples fine content is in the range 15% to 35%. In general the material is non-plastic; in some samples liquid limits $LL = 30-35\%$ and plasticity indices $PI = 10-15$ are noted. Gravel size particles (i.e. $>4.76\text{mm}$) comprised 30% to 60% of the fill material. Standard penetration resistances are on the order of $N_{45} = 20-30$ blow counts/ft, indicating that presently the fill is in a medium dense to dense state.
