Failure analysis of an 80m high geogrid reinforced wall in Taiwan

R.D.Holtz & S.L.Kramer – *University of Washington, Seattle, U.S.A*
C.W.Hsieh – *National Pingtung University of Science and Technology, Taiwan, R.O.C.*
A.B.Huang – *National Chiao-Tung University, Hsiuchu, Taiwan, R.O.C.*
W.F.Lee – *Taiwan Construction Research Institute, HsinTien, Taiwan, R.O.C.*

ABSTRACT: During the magnitude 7.3 Chi-Chi earthquake that occurred in Taiwan on September 21st 1999, an 80 m high geogrid reinforced wall failed. The failure site is located about 20 km from the epicenter, and peak ground acceleration at the site is believed to have been in excess of 0.5g during the earthquake. The GRS wall used geogrids as reinforcement and the backfill was an on-site lateritic soil. Because geosynthetic reinforced soil (GRS) structures have generally performed well under seismic conditions, this failure offered a rare opportunity to investigate the ultimate seismic behavior of a full-scale GRS structure. A series of field observations and measurements were made in an attempt to establish the possible failure mechanisms of the wall. Laboratory experiments were conducted on the soils and geosynthetics t

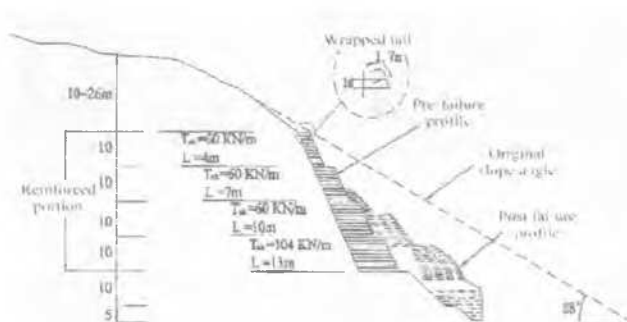
Details of the GRS wall as designed and constructed are shown in Figure 1. The vertical spacing of the geogrids was 1 m. The bottom of the GRS wall was 15 m above the toe of the slope. The height of the GRS wall (from bottom to top) varied from 40 to 50 m and the length of the wall was 250 m, running in north-south direction. Properties of the geogrids are provided in the following sections. The in situ lateritic gravel and clay soil was used as the backfill of the GRS wall. Unfortunately, no record is available as to the compaction specifications or field density tests on the backfill material. To the north of the GRS structure, the slope gradually transformed to its original shape, and a steel net was used for slope stabilization. The steel net reinforced slope did not fail during the earthquake.

Figure 1. Cross sectional view of the original slope and the GRS wall.

Unfortunately, the original design calculations are unavailable, so it is impossible now to know what the original design concept for the wall was. However, from the lengths of the reinforcement shown in Figure 1, it appears that potential sliding of the wall was either overlooked or not considered to be of concern. Another possible explanation for the short reinforcement lengths is that the design followed steep slope rather than wall design procedures, although even a steep slope design would likely have required longer lengths than were actually utilized in the wall.

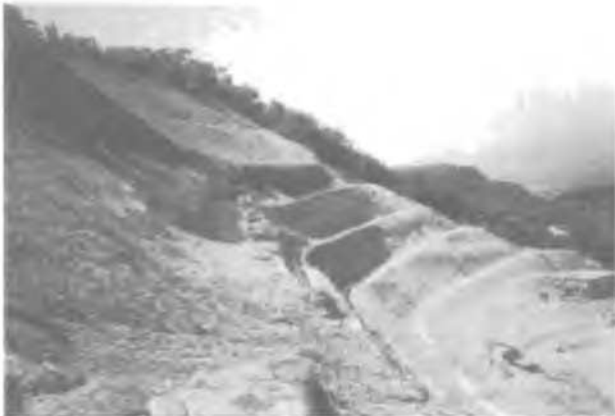
Construction of the GRS wall started in 1994. A massive slope failure as shown in Figure 2 occurred near the top of the slope in 1995 after the original slope was cut to its design grade and just prior to the placement of the GRS wall. The failure zone was backfilled and the GRS wall completed in 1996. A second failure

Figure 2. The 1995 slope failure.

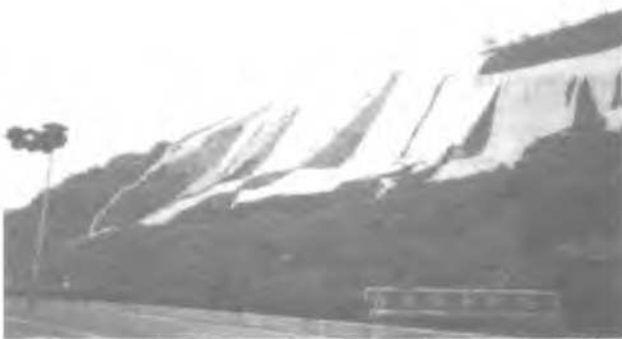
The latest failure was triggered by the magnitude 7.3 Chi-Chi earthquake that occurred on September 21st, 1999. The failure site is located about 20 km from the epicenter, and peak ground acceleration at the site is estimated to have been in excess of 0.5 g during the earthquake. The failure was massive. A majority of the GRS wall slipped downward from its original position by as much as 10 to 13 m. Figure 3 shows a front view of the failed GRS wall and Figure 1 depicts a cross-sectional view of the failed GRS wall. According to our observations, the failure did not appear to have extended into the original earth slope behind the GRS wall. In other words, the slippage happened almost entirely within the GRS structure itself. During site visits following the Chi-Chi earthquake, field sand cone and nuclear soil density tests as well as total station surveys were performed

Figure 3. Front view of the failed GRS wall.

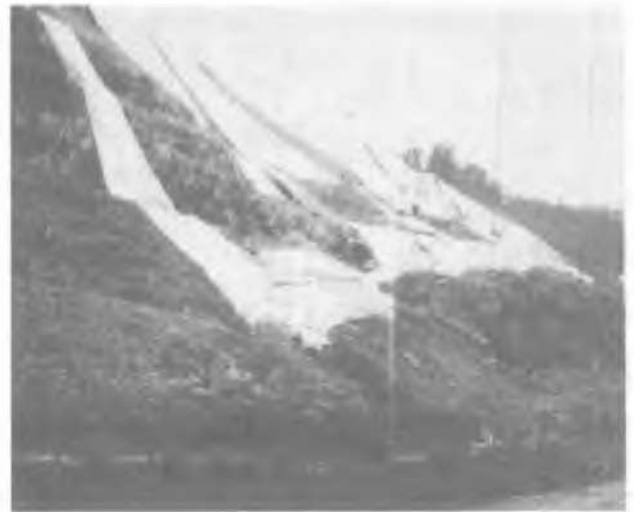
Field observations of the wall indicate that failure occurred along the boundary between the GRS structure and the original slope surface. The failure surface had a fairly steep angle (Figure 6). This observation suggests that, under the strong ground motion that occurred during the Chi-Chi earthquake, the reinforcing design of the failed GRS wall was insufficient, i.e., the reinforcement length was too short and/or the vertical spacing of the reinforcement was probably too large.

Figure 6. Side view of the failed GRS slope.

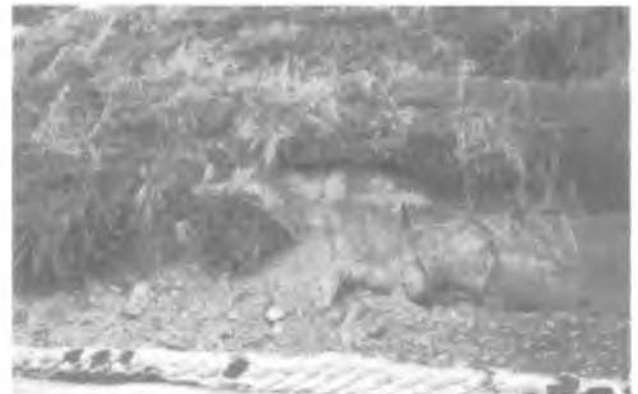
Figure 7 shows an example of the separation between two adjacent geogrid sheets. The slope face opened up during the earthquake and the apparently small overlap of the adjacent geogrid sheets failed to accommodate the large local deformations. The separation of the geogrid sheets in turn probably triggered progressively the other two types of failures. As a result of the reinforcement separation, the backfill soil fell out of the geogrid-sandbag face through the opening (Figure 8). The "tail" of the geogrid reinforcement then overturned and pulled out the portion that still remained in the backfill (Figures 8 and 9). The failure of the geogrid-sandbag face then led to the instability of the entire GRS slope.

Figure 7. Separation between the adjacent geogrid layers.

The wall was under-reinforced; the embedded lengths of the geogrids were too short for a wall of this height. The vertical grid spacing of 1 m also probably contributed to the instability observed at the wall face. In seismically active areas, simple butt joints or small overlap of the sheets of reinforcement perpendicular to the face may not be sufficient to prevent separation and failure of the face. To further increase face stability, it may be necessary to tie or otherwise positively join the sheets together in the lateral direction.

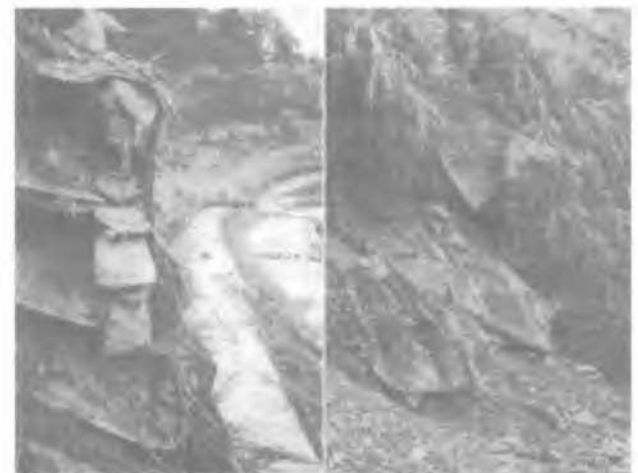
Figure 8. Decomposition and collapses of the wrapped face of the GRS slope.

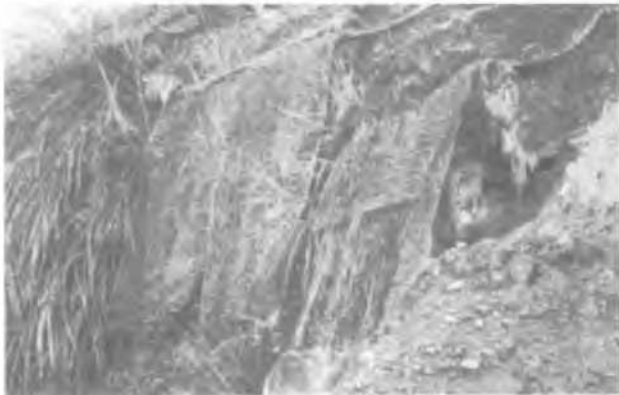
Figure 9. Remaining reinforcement being pulled out from the backfill.

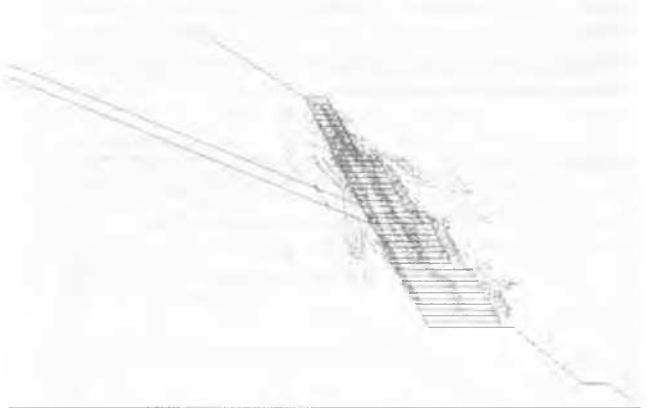
The mechanism of failure was investigated numerically using the finite element program, PLAXIS. A model of the reinforced slope, using tension-only geotextile elements surrounded by interface elements, was constructed and subjected to earthquake loading similar to that estimated to have occurred in the Chi-Chi earthquake. The computed permanent displacements, shown in Figure 11, indicate that the failure occurred primarily within the reinforced zone. This mechanism is consistent with the behavior observed in the field.

Figure 11. Schematic illustration of permanent displacements computed by PLAXIS. Displacements are highest in reinforced zone, indicating a deformation pattern consistent with that observed following the earthquake.
