# The plumbing of 2.2° inclined tall building

C.E.M.Maffei – *Maffei Engenharia, Polytechnic School, University of São Paulo, Brazil*  
H.H.S.Gonçalves & P.M.Pimenta – *Polytechnic School, University of São Paulo, Brazil*  
C.A.Murakami – *Maffei Engenharia, São Paulo, S.P., Brazil*

**ABSTRACT:** This paper addresses the straightening up project of a reinforced concrete building complex in Santos, Brazil, which is composed by two towers. At the ending of the year 1998, before the recovery works Tower A was 2.08 m out of vertical position while Tower B was almost the same. Tower A is 55.0 m high, 10.50 m wide and 24.0 m long, resembling the famous case of the leaning Tower of Pisa, which is 58.0 m high and has a diameter of 12.5 m [Leonhardt, 1997]. First, a safety assessment analysis was undertaken. Application of modern computational considering realistic constitutive models for the concrete and steel as well as non-linear geometrical effects, has shown that the strengthening of the structure was urgent, since the buildings could be in risk of structural collapse after ten years. Sixteen excavated large diameter concrete piles were built as the new foundation. They have reached

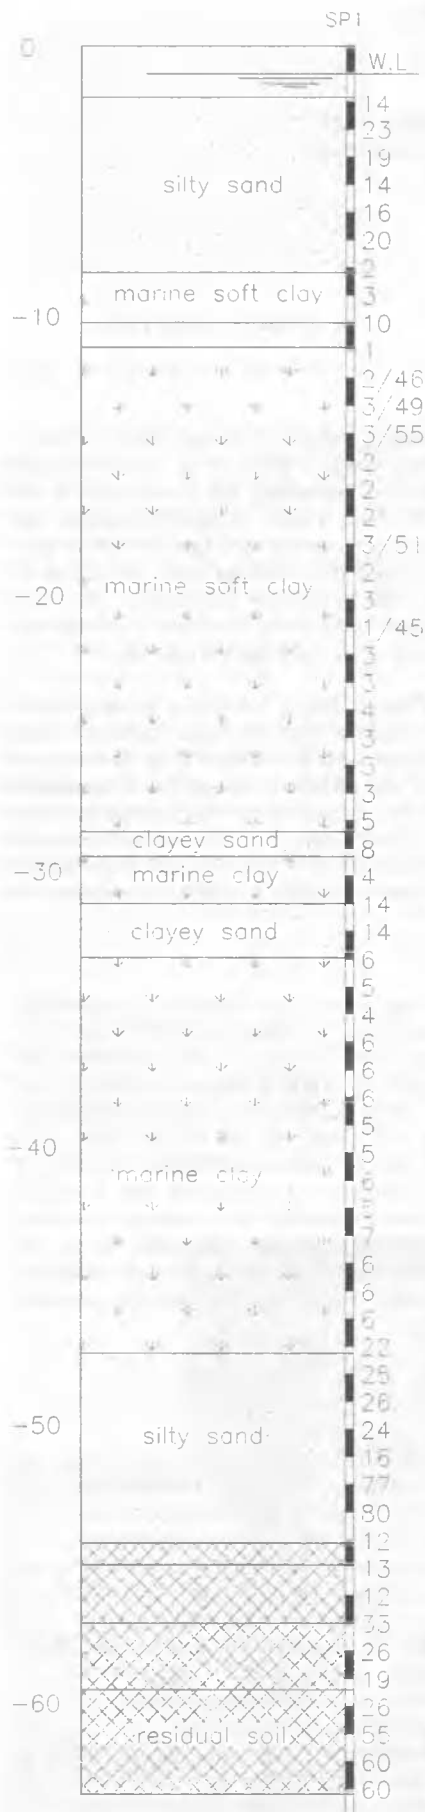
Figure 1. Subsoil profile.

This superficial sand layer of 12m thickness is supported by deep soft clay layers (fluvio-lacustrine sediments) with OCR about 1.3, approximately 18m thick. Under this layer there is another sand layer of 3m to 5m and a clay (transitional clays) layer 13m thick with OCR higher than 2. The residual soil is found at the depth of 45 m. The underground profile is shown in figure 1.

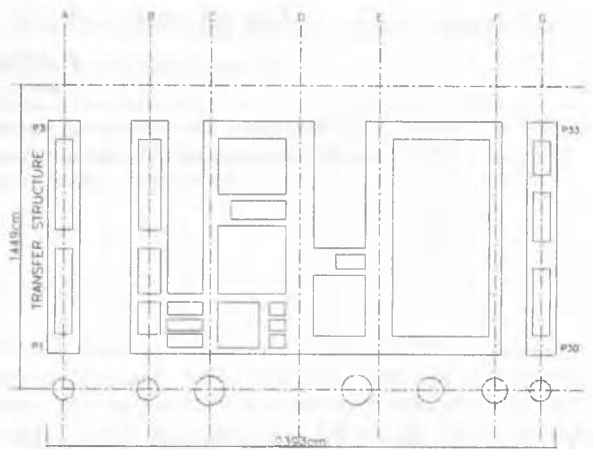
Figure 2. Plant of the transfer structure and piles.

The inclination has been monitored by settlement measures of several columns with respect to a bench mark. The measured settlements of the corner columns A1, A3, A30 and A33 (figure 2) since 1972 are displayed in figure 3. Column A1 has settled 26 cm since the beginning of the measurements while column A33 presents the total value 53 cm. Nevertheless the inclination measurement showed that the real differential settlement

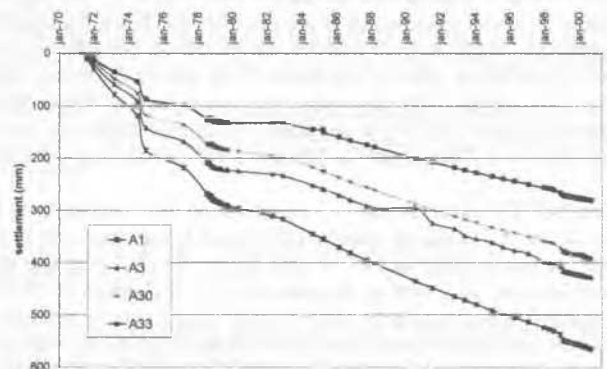
Figure 3. Recorded settlement (mm) vs. time (days)

between A1 and A33 was 65cm This difference is responsible for the inclination of more than 2.2° observed at the frontal view and 0.6° at the lateral view. Despite of this inclination the structure has not presented any cracking because the building has moved as a rigid body. With exception of a tentative foundation strengthening done in 1978 with the aid of root piles, both columns presented an almost constant settlement velocity of 9mm/year in A1 and 13mm in A33 along the last 20 years! Several modern consolidation theories were examined elsewhere [Gonçalves, 1992] with the purpose of better fitting the experimental data. It was necessary to include viscous effects in the soil constitutive model in order to reproduce the long-term consolidation.

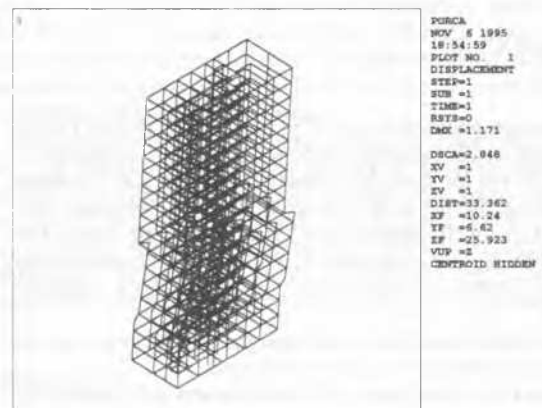
Figure 4. Structure collapse (numerical simulation).

After this analysis, a vast measurement program was conducted on the structure in order to confirm the mathematical model. Through stress relief tests on several reinforcement steel bars it was possible to estimate the current stresses on them. The measured values were compared with the computed ones. The constitutive parameters of concrete were then reformulated in order to keep the stress data fitting within 10% error. After that, a new analysis was performed, applying the settlement displacements with the measured average velocity. Figure 4 above shows the numerical collapse of the structure through a combined rupture of columns and beams. According to our mathematical model, the collapse would occur in 10 years.

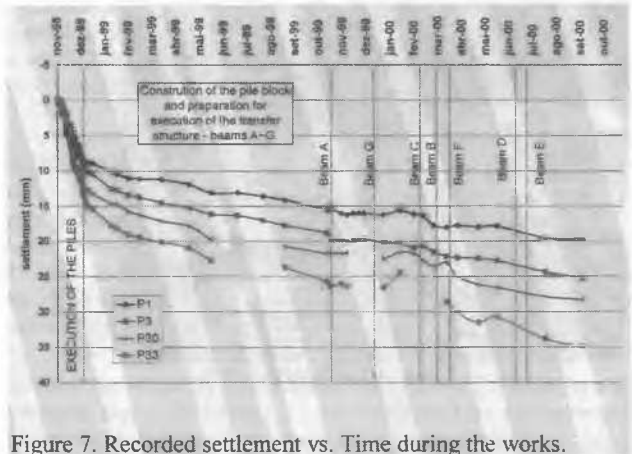
Figure 7. Recorded settlement vs. Time during the works.

All the stages of the build rehabilitation were accompanied by means of level readings in all the columns. The settlements of the columns A1, A3, A30 and A33 during the construction work can be seen in figure 7. During the works the building continued to incline and reached  $2.10\text{ m}$  out of plumb line.

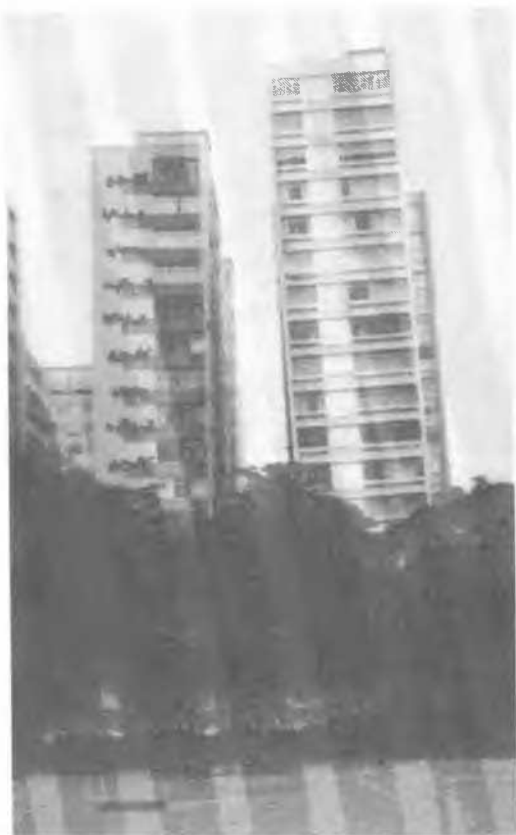
Figure 9. Tower A (at Right) in 1995.

Tower A of the "Condomínio Edifício Núncio Malzoni" was built on 1967 on shallow foundations at 2.0 m depth interlocked by rigid beams with 30cm x 150cm. In the same period of the construction of Tower A, a similar building was erected on its left side. The superposition of the pressure bulbs on the deep soft clay layers caused additional settlements making both buildings to lean, one against the other, as it can be seen on figure 9.
