# Strengthening and underpinning of stone foundations of St. John Church in Gdańsk

M.Topolnicki – *Technical University of Gdansk*

**ABSTRACT:** The St. John church in Gdańsk, almost 600 hundred years old, has been constructed on weak organic soils. Available records describe numerous attempts to improve the foundations and to stop the observed settlements. In the framework of a recent restoration programme it was decided to conduct underpinning and strengthening of the stone foundations at the eastern part of the church, where significant settlements and horizontal displacements occurred. For technical and economical reasons jet grouting technique was applied. Presented are design considerations, execution of the work and control measurements, with special emphasis on heavily loaded pillar foundations.

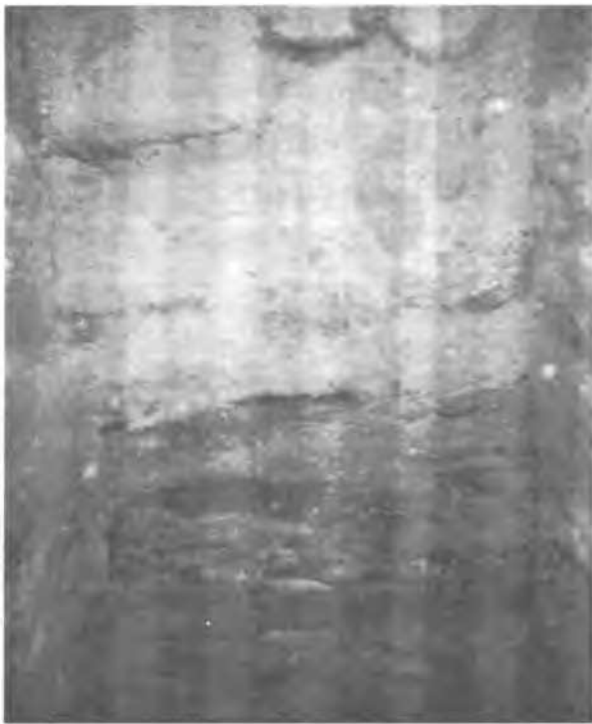
Fig. 3 Side view of excavated foundation wall (1995).

The St. John church has been founded on a very weak subsoil, containing peat and organic silt layers below a thin fill layer at the surface. Initial foundation works started with excavation of the top layer of soil up to the groundwater level, since dewatering techniques were not available at that time. Gravel, stones and weak mortar were subsequently placed inside wooden formwork, which was pushed into the peat layer. On this support stone foundations for church walls and pillars were constructed. A photograph taken from a recent excavation pit at the south site wall of the church shows wooden beams at the depth of about 4.5 m and overlying stones of the foundation wall (Fig. 3).

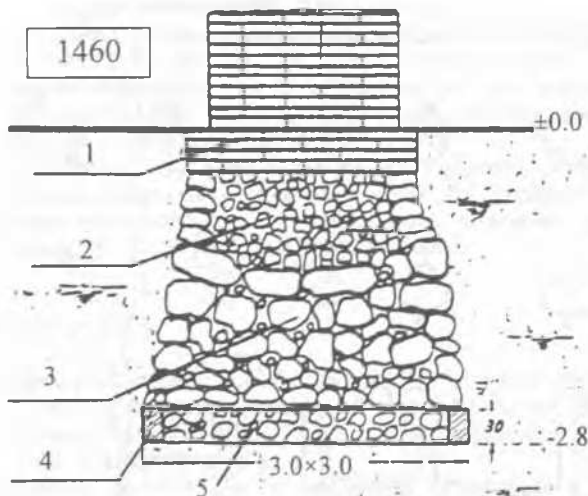
Due to high loads transferred to the subsoil serious stability problems and uneven settlements occurred soon after, particularly with the pillars. Available records describe numerous „engineering” attempts to improve the foundations and to stop the settlements. Some of these attempts were very advanced and included, in the period of 1640 to 1680, even a total replacement of few foundation pillars, as shown in Figs. 4 and 5.

Fig. 4 Initial construction of the foundation under a pillar: 1- bricks and lime mortar, 2- small stones, brick pieces, lime, 3- bigger stones without lime, fill, 4 - wooden box, 5- field stones with clay (Bukowski, 1948).

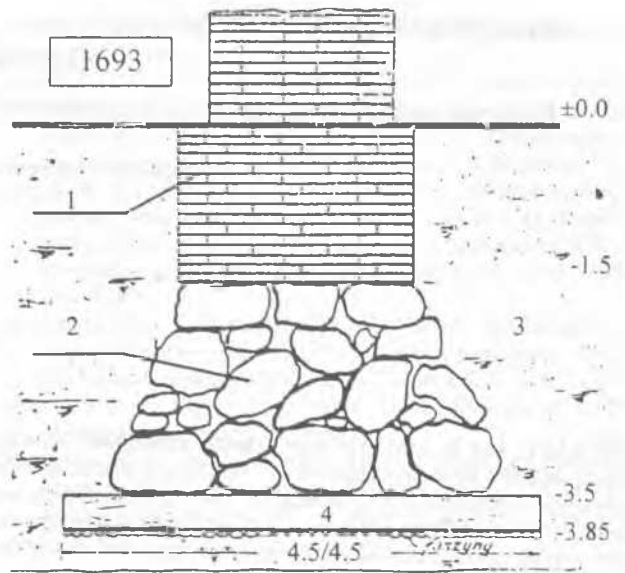
Fig. 5 Rebuild foundation under a pillar: 1- bricks and lime mortar, 2- large stones and lime mortar, 3- refill (sand and peat), 4 - wooden beams on fascine mattress (Bukowski, 1948).

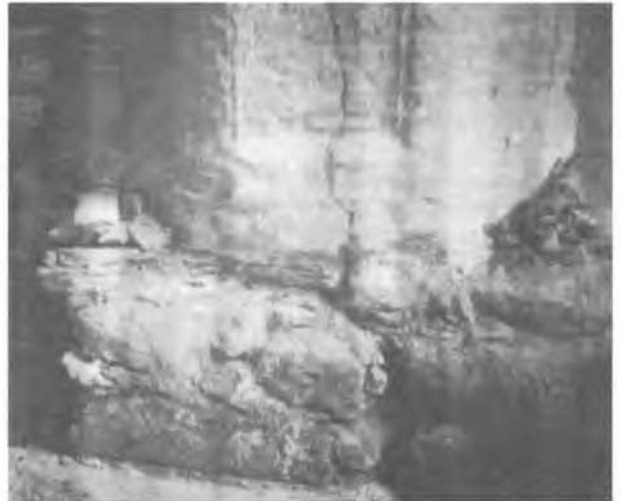
Fig. 6 Cracked pillar pedestal in the eastern part of the church (1995).

All these difficult and challenging engineering works could not, however, stop further excessive settlements. It has been estimated that total vertical displacements could reach about 75 cm from the beginning of church construction. Particularly difficult situation occurred at the eastern wall behind the altar, which started to tilt. In 1679 the horizontal displacements observed at the vault level reached nearly 100 cm (Bukowski, 1948). The outward movement of this heavy wall, transmitted to two rows of pillars through the vault structural elements, caused also significant displacements of six adjacent pillars, which additionally experienced lateral movements at the floor level in the order of 25 to 50 cm. As a countermeasure two buttresses founded on wooden piles were quickly build at the outer side of this wall and the roof in this part of the church was reconstructed and unloaded. Later on this church was also many times burned and damaged, particularly during the second world war, and subsequently partly repaired. Its technical condition became however steadily worse and worse (cf. Fig.6).

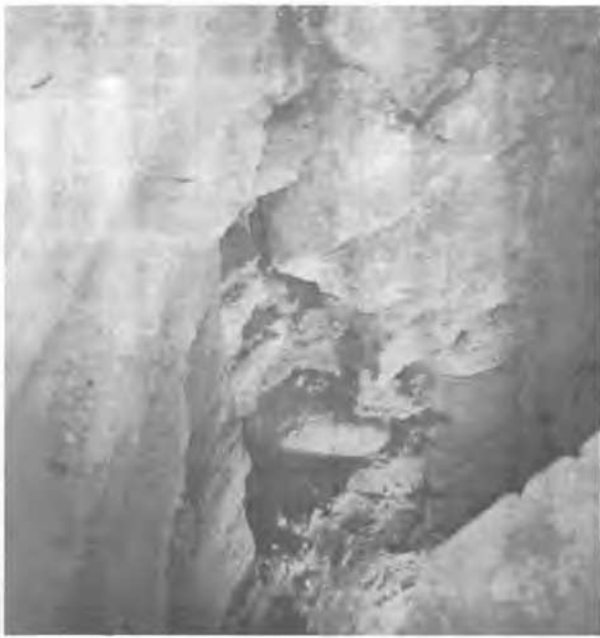
Fig. 7 Cracked stone foundation of a single pillar

The most difficult works were executed under the pillars, which carry not only high load but also have experienced vertical and horizontal displacements. Therefore it was assumed in the design that the remediation should lead to improvement of the bearing capacity in vertical and horizontal direction and to strengthening of the foundations. The latter became especially important after recognition that some of the foundations had rather wide cracks, extending to a significant depth below the pedestal (Fig. 7).

The jet grouting works started with execution of primary soilcrete elements around the expected periphery of the foundation, determined by old drawings and additional trial borings. The objective was to form a kind of soilcrete "box" around the founda-

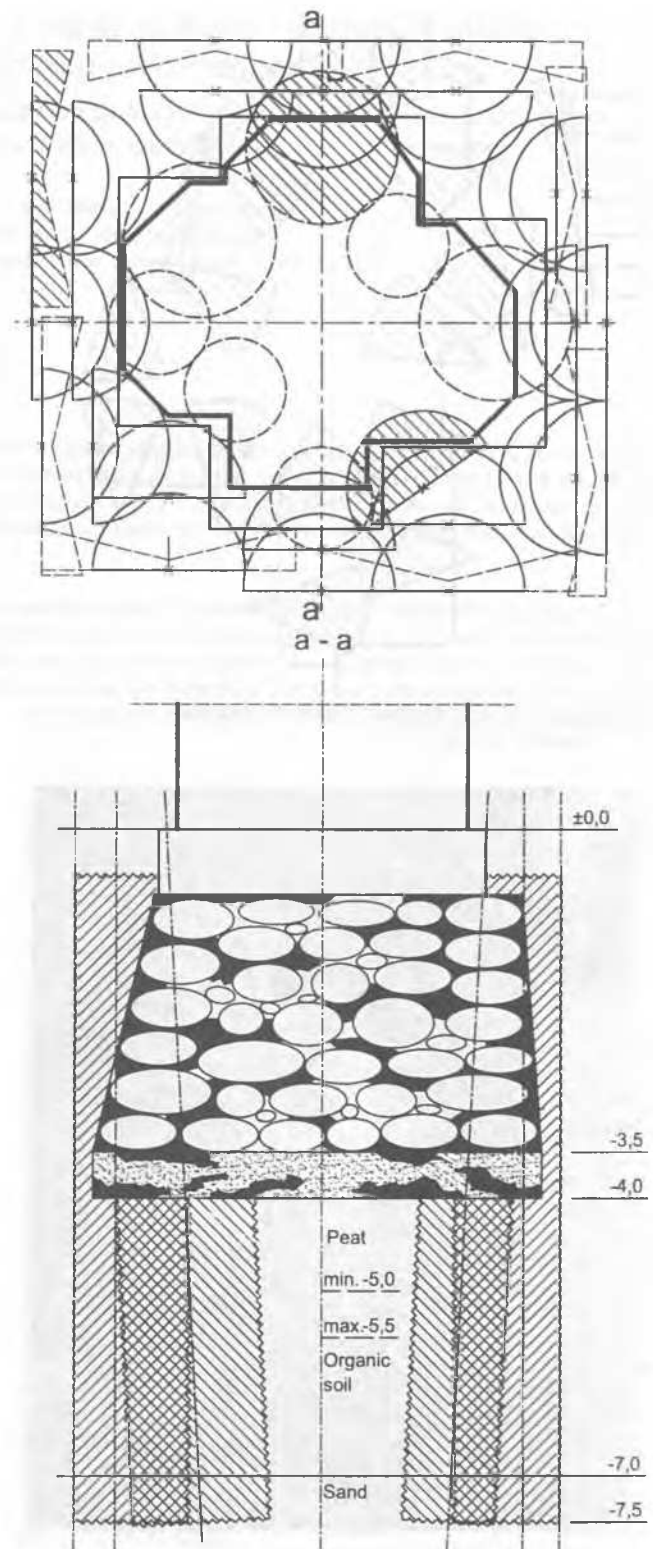
Fig. 8 Layout of soilcrete elements under a pillar C7

tion prior to any attempt to install columns directly under the pillar. These side elements were executed at the bottom part as panels, e.g. in case of pillar C7 between -4 and -7.5 m, and as half columns above the foundation level (Fig. 8). This was achieved by pulling of the drill rod without rotation to create a panel and subsequently by swiveling the rod 90° in the upper part. In this way the conical walls of the foundation were surrounded by soilcrete and the loose stones were fixed.

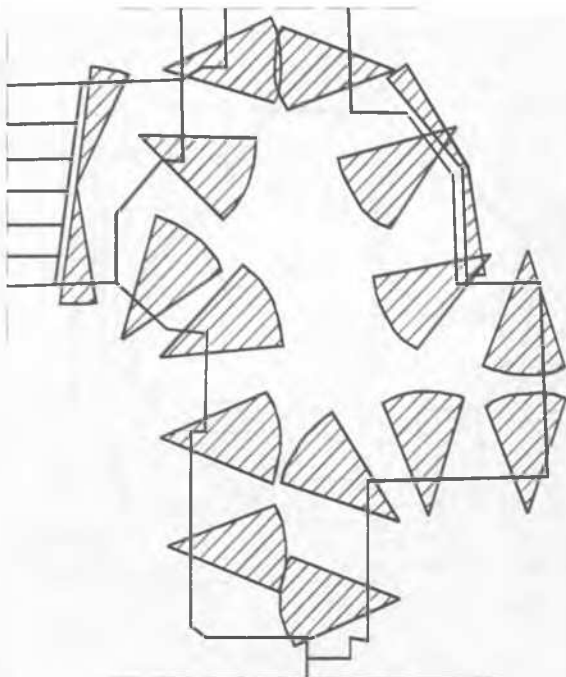
Fig. 9 Layout of soilcrete elements under the east wall (detail E, see Fig. 2)

eration required special equipment and skill of the operator, especially when loose fill was found between large stones. Once the drilled wholes were completed cement grout was injected under pressure to fill all possible cracks and voids. Then the secondary soilcrete columns were made. Under the outer walls special sector elements, the so-called wings, were applied from both sides of the wall (Fig. 9). With this advanced technique it was possible to assure sufficient support of the foundation without drilling through the stones. At the west wall the work had to be partly conducted in cellar using special drilling unit (Fig. 10). Altogether 489.4 m<sup>3</sup> and 541.8 m<sup>3</sup> of soilcrete elements under pillar and wall foundations, respectively, have been installed.

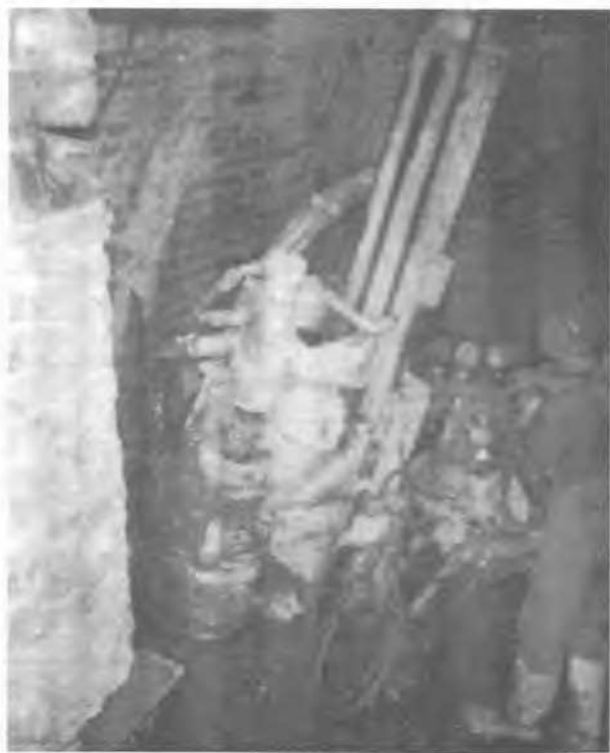
Fig. 10 Soilcrete works in a limited space in cellar

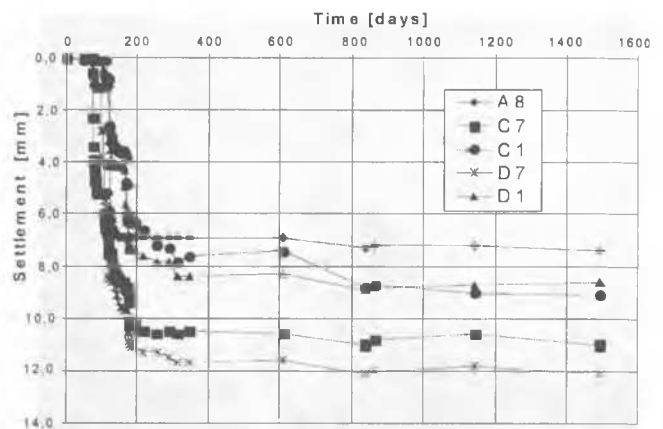
Fig. 11 Settlement recorded during and after underpinning works at 5 reference points indicated in Fig. 2 (Zurowski et al., 1995-2000)

Before, during and after underpinning works precise geodetic measurements were conducted (Zurowski et al). Figure 11 shows sample data obtained during almost 5 years of observation. The selected curves refer to observation points indicated in Fig. 2 and demonstrate the subsequent phases of underpinning works. Execution of soilcrete elements within roughly 150 days induced limited settlement of the foundations, while the settlement rates for secondary soilcrete elements are generally smaller than for the primary ones. The subsequent parts of all settlement records, referring to the state after completion of the underpinning works, indicate fairly stable behaviour of all foundations within the period of almost 3 years.
