Deterioration of flood protection dikes due to shrinkage cracking Pathologie des diques à cause de fissures de retrait

I. Lazányi & G. Horváth - Technical University of Budapest, Geotechnical Department, Hungary

ABSTRACT: An exceptionally long spell of drought in the Tisza valley, Hungary, has led to massive cracking due to shrinkage on several hundred kilometres of flood protection dikes built of rich swelling clay. An extensive research program was launched aimed at revealing the mechanism of cracking and finding effective remedial measures. Regional meteorological data and geological and soil survey data were conflicted with the occurrence and frequency of damage cases. Various geophysical methods were put on field trial in order to find the most suitable non-destructive method for the detection of cracks. Experimental evidence was found to confirm the general validity of a unique linear relationship between loss in moisture content and ensuing volume change, applicable also to the range of partially saturated soils. The mechanism of cracking and its effect on the serviceability of dikes was studied and concepts for remedial measures suggested. The paper reports on various tri

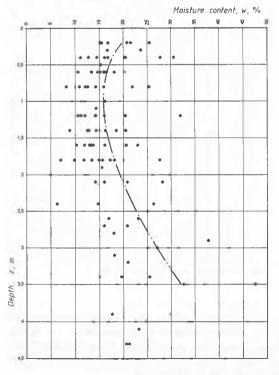
Figure 5.

being the more pronounced. Transverse cracks, not so wide, are also common causing a complete disintegration of the upper part of the dike into a discontinuous mass of blocks and columns. Figure 5 and Figure 6 show the variation of moisture content and of consistency index, respectively, with depth in a typical cracked dam profile.
