# Numerical modeling of embankment failure and its renewal

B. Majes, J. Logar & B. Pulko – University of Ljubljana, Faculty for Civil and Geodetic Engineering, Slovenia

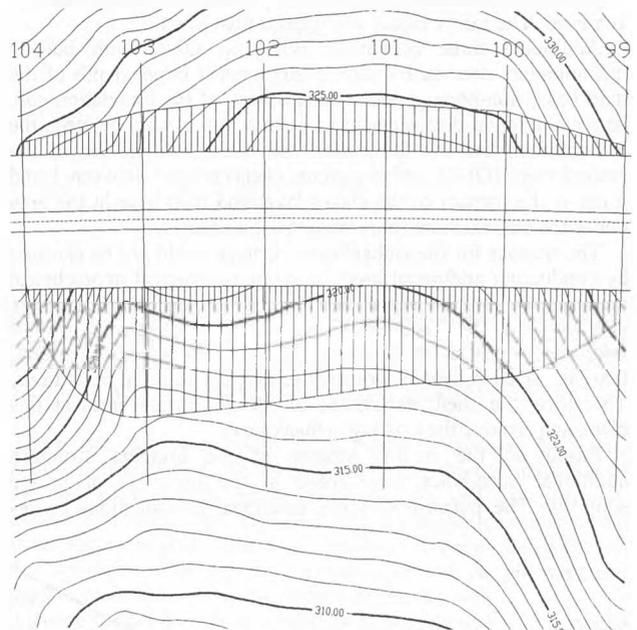
Figure 1. Designed embankment and the original surface.

A relatively high embankment (7 m in the axis and 10 m at the edge of the motorway) on a new motorway section, constructed between 1994 and 1996, had undergone large deformations before its completion. A 60 m long fissure appeared on the embankment surface. In a culvert incorporated in the embankment a 10 to 15 cm large displacement was observed. The embankment is approximately 100 m long and is shown on Fig. 1 together with isohypses of the surface before the construction. The inclination of the natural slope was 8°.

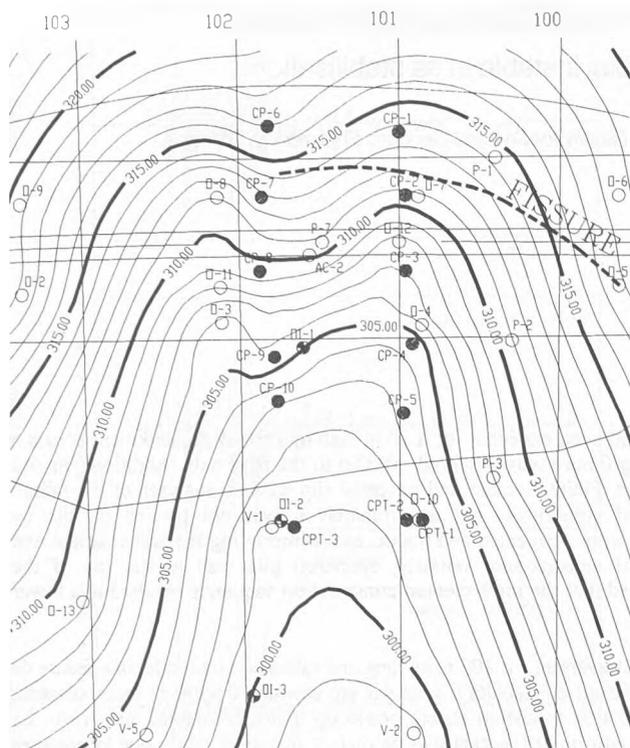
Figure 2. Locations of bore-holes and CPT tests, and the surface of the sandstone/marl base.

The earthworks on the embankment started in Autumn of 1994. The forthcoming winter forced the contractor to fill the embankment quickly. When the snow fell, the embankment had not yet been completed. Only the remaining one or two meters had to be filled in the Spring. After the thaw in the Spring of 1995 a fissure was observed, as indicated in Fig. 2. Half of the embankment was damaged. Additional five bore-holes (V-1 to V-5) were made on the slope in front of the embankment (Fig. 2). These borings showed that the clayey layer was much thicker than had been believed.

holes O-1 to O-13) was to determine the depth of the marl base, appropriate for deep foundation. New bore-holes showed even more explicit basin of marl base (Fig. 2). In the central part of the embankment, between profiles 101 and 102 (Fig. 1 and 2), the established depth of the marl base at the right edge of the embankment was 11 m under the surface of the original terrain, 15 m in the embankment axis and 16 m at the external left edge of the embankment.

The decision was to test systematically the composition of the subsoil and the depth of the sandstone/marl base with cone penetration test in the cross-sections 100, 101 and 102. The locations of CPT tests are shown in Fig. 2 (marked as CPT-1 to CPT-3, CP-1 to CP-10 and P-1 to P-3).

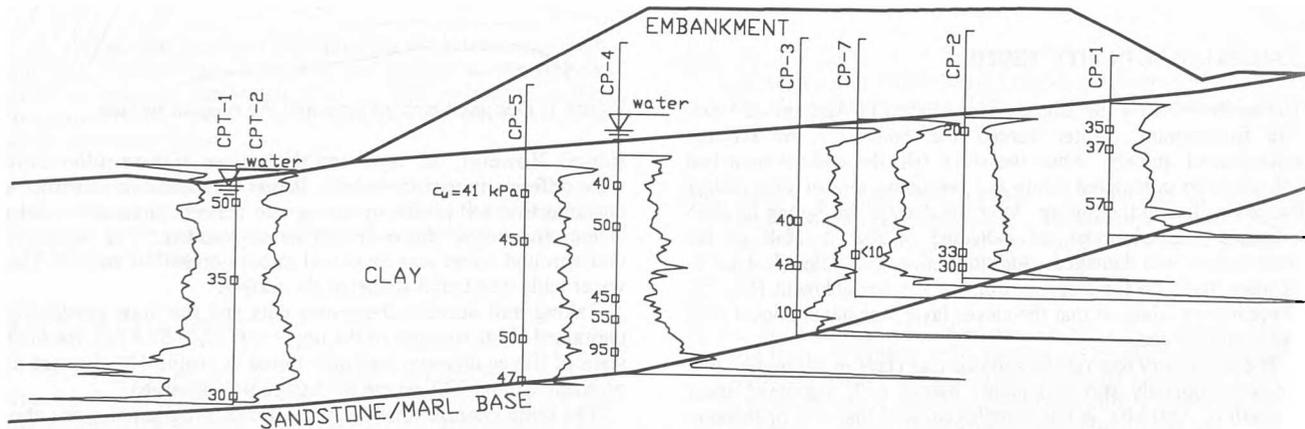
Figure 3. The transverse cross-section in profile 101 with the CPT results in terms of undrained shear strength

embankment that was previously determined by bore-holes. The measured distribution of undrained shear strength with depth by CPT showed the areas of the lowest values of undrained shear strength  $c_u$ . On average the lowest values of undrained shear strength were found to be 45 kPa with local minima, that were even smaller than 10 kPa. The CPT results are presented in profile 101 in Fig. 3.

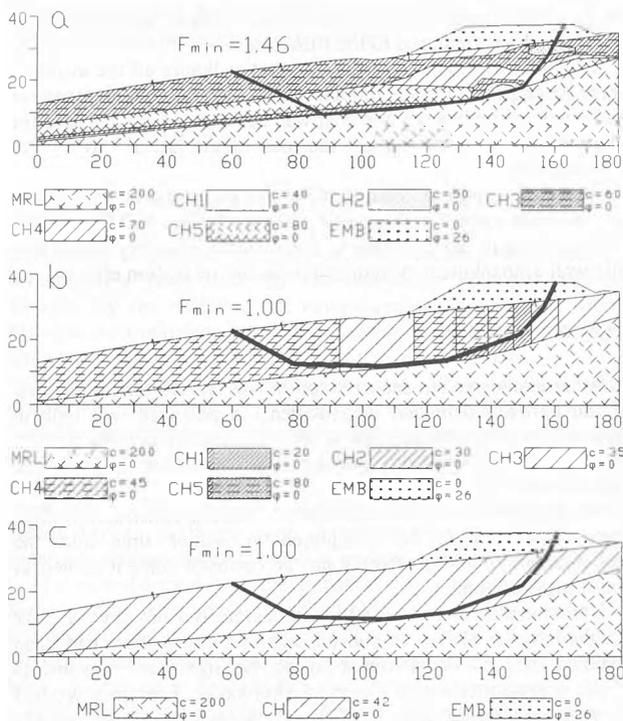
Figure 4. Numerical models for potential slip surface analyses

The first step was to determine the lines of the same values of undrained shear strength  $c_u$  with adequate numerical procedure. Fig. 4a shows the areas of the same shear strengths in the subsoil in profile 101. The performed potential slip surface analyses did not give the desired result ( $F \cong 1$ ).

The limit equilibrium state in all three profiles was found only when the polygonal slip surfaces through points with minimum  $c_u$  values (measured by CPT), were considered. There were several potential slip surfaces with safety factor close to  $SF=1$ . Fig. 4b shows the critical slip surface in the profile 101, which corresponds also to the observed displacements in inclinometers.

In each profile the average value of undrained shear strength ( $\bar{c}_u$ ) exhibiting failure in potential slip surface analyses was also sought. In the profile 101 the state of limit equilibrium was demonstrated at  $\bar{c}_u = 41$  kPa (Fig. 4c), and in the profile 102 at a slightly higher value  $\bar{c}_u = 44$  kPa.

Based on back-analyses of the current limit state at the road embankment it was concluded that deep polygonal slip surface which runs mainly along the contact of the clayey layer and sandstone/marl base is critical.

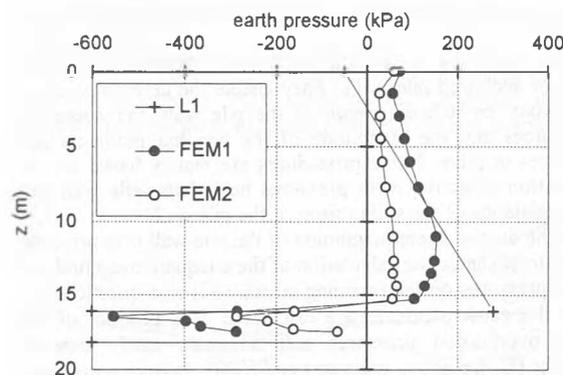
Figure 6. Calculated difference between passive earth pressures in front of the wall and active earth pressures behind the wall

The results of case L1 are similar to those of the FEM1 case. Thus the safety factors taken into account comply well with the case in which the pile wall is constructed before the embankment is filled. A rather big reduction of passive pressures is justified by high stiffness of the wall-anchor system which prevents deformations of the soil in front of the wall and thus the

The FEM2 case models the construction sequence as it occurred on site. One could observe that the earth pressures (Fig. 6), bending moments (Fig. 7) and shear forces are significantly reduced when compared to the FEM1 case.

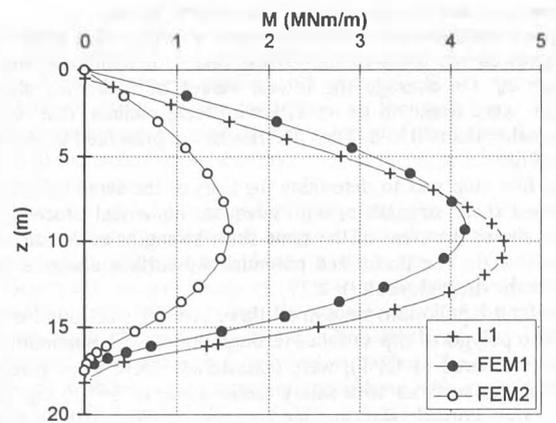
Figure 7. Calculated bending moments in the pile wall

This difference is due to the fact that at failure all the available shear strength had been mobilised and big horizontal pressures had occurred before the pile wall was constructed. In this case the pile wall had only to support the load of the last 1.5 to 2 m of embankment.
