Improvement/reinforcement of a ballasted track

Gerald P. Raymond – Civil Engineering, Queen's University, Kingston, Ont., Canada

ABSTRACT: The paper deals with the reconstructions that were undertaken to correct multiple ballasted track formation failures for a heavy gantry crane. Finally, in 1988 a satisfactory design was obtained that incorporated geosynthetics.

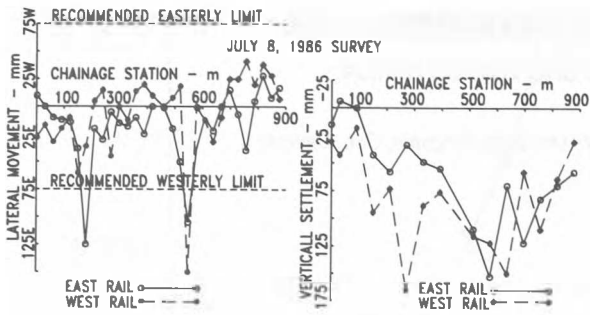
Figure 4. July 8th, 1986 measured track deformations.

Survey observations conducted on July 8 are shown in Figure 4 and record settlements up to a maximum of 0.23 m that had

occurred since the re-ballasting of May 15 to 17. The conditions of the track are illustrated by (a) Figure 5 that shows a tie that has penetrated the ballast to within 25 mm of the sub-ballast surface, and (b) Figure 6 that shows a cluster of tilting ties with some split in the rail seat area (generally the ties dipped towards the west). In these locations the ballast had been pushed laterally, both into the cribs and beyond the tie ends. Numerous bent rails and eight broken joint bars were also noted.

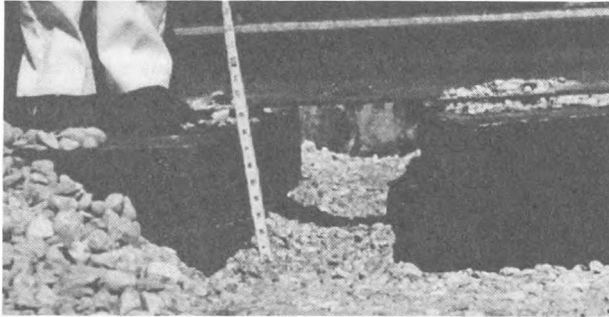
Figure 5. Example of 25 mm ballast above sub-ballast.

Poor performance of the ballast was due to the ballast's low crushed surface area. Importation of quarried granite rock (at FOB Can.\$ 50.00 per ton) was recommended as replacement ballast.

recommendations: (a) the track be stripped to the sub-ballast elevation and a 0.15 m of crushed road gravel (maximum particle size of 19 mm) be added followed by new quarried rock ballast (0.15 m thickness below the ties) to the top of the cribs, and (b) the tie spacing be reduced to 0.45 m centre to centre.

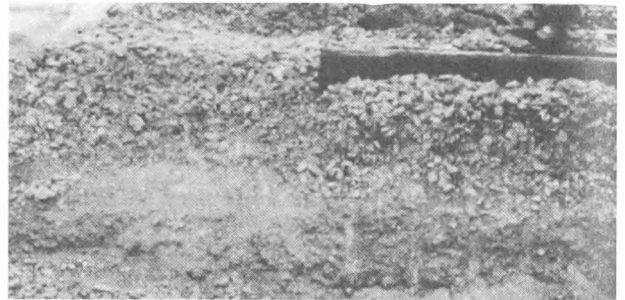
Figure 8. Ballast filled sub-ballast deformation.

The excessive track deformations observed without catastrophic failure in both 1986 and 1987 indicated a loss of bearing capacity during thaw. Cross trench excavations, illustrated by Figure 8 strengthen this opinion. Figure 8 shows a ballast filled cavity penetrating the sub-ballast surface. Figure 9 shows grading curves obtained on the existing sub-ballast and ballast. The sub-ballast is seen as a dirty gap graded gravel. Frost susceptibility tests classified the sub-ballast as medium frost susceptible for highways and airfields. A worse classification would result for the open nature of a ballasted track and this would be aggravated by the disruption to the drainage from snow, ice build up, or falling logs.

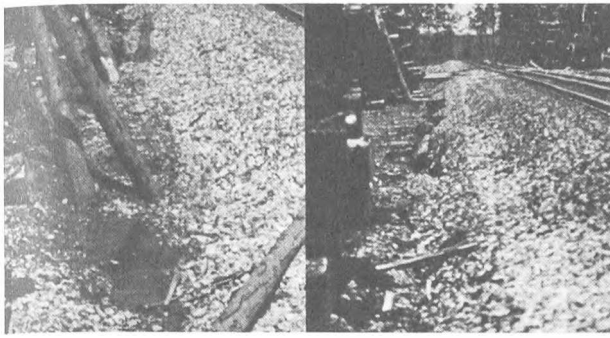
Figure 10. Water filled holes on side with no subdrain.

Confirmation of the poor drainage of surface water is illustrated by comparison of Figures 10 and 11. Figure 10 shows pot holes on the non-drain side of the track made by falling logs that are filled with water. In comparison Figure 11 shows a dry surface on the other side of the same track having a subdrain. Clearly both sides of each track need surface open subdrains.

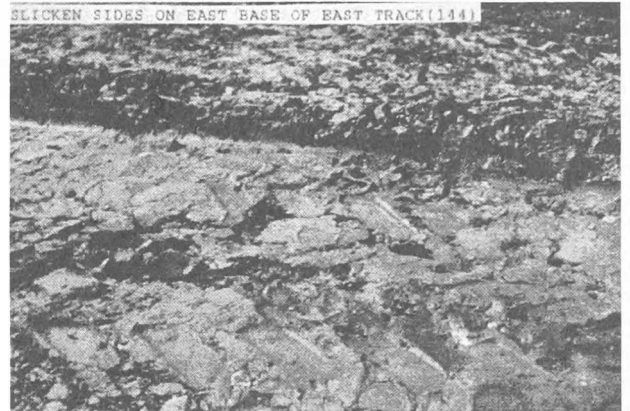
Figure 13. Example of subgrade with slickenside horizons.

soil was disturbed to a depth of about 100 mm, as seen in Figure 13. Below the 100 mm thickness of disturbed clay were slickenside shear surfaces formed on relatively firm clay. Clearly insufficient granular cover had existed either after the ties had settled during thaw or in the original design. Deep scarifying and recompaction ensured a strong subgrade.

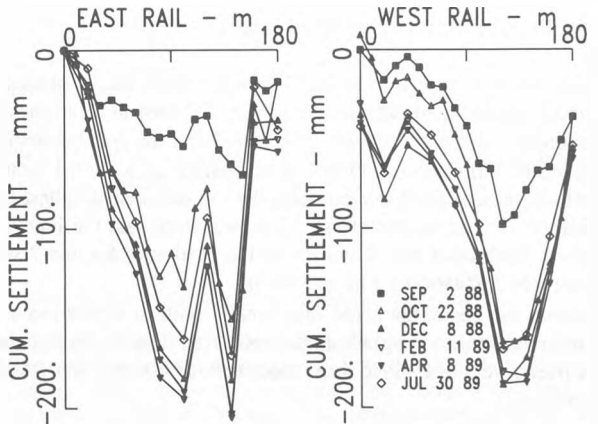
Figure 14. 1988/9 Section 1 cumulative settlements.

Once the mistake was discovered the contractor agreed to correct the fault at no cost to the owner. Immediate replacement was unacceptable. The owner had to feed the Mill. It was agreed to re-level the tracks of Section 1 as soon as a settlement of 75 mm was reached. Cumulative settlement readings for Section 1, measured until Section 1 was repaired, are shown in Figure 14.

Figure 14 shows the cumulative settlement in Section 1 involving poorly crushed sub-ballast. These results may be compared with those in Figure 15 for the correctly built sections (Sections 3 and 4). The contrast is striking.

With the new Mill in operation Section 1 had lost its strategic importance and the bridge at the former Mill feed-in location was no longer required. Calculations showed that the poorly crushed aggregate drain material placed as sub-ballast in Section 1 would perform reasonably if covered with 0.45 m of crushed ballast (an addition of 0.15 m thickness). This was done and the increase ballast depth taper this down across the portion of Section 2 still to be rebuilt (Station 1+81 to 3+66).

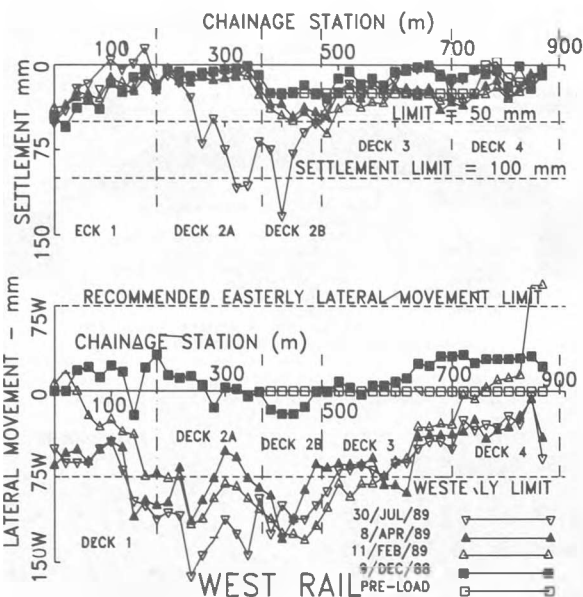
Figure 15. 1988/9 vertical and lateral deformations of west rail.

The frozen subgrade thaw failure in Section 2B is clearly evident from the settlements shown in Figure 15. Also evident are the settlements in Section 2A (the Section still to be reconstructed) during ground thawed. The settlements along the rebuilt 45 m of track adjacent to the Mill feed-in location where a geocell ballast confinement was used were very small, ranging from 3 to 11 mm with an average of 4 mm. This may be compared with the settlements shown in Figure 15 for Sections 3 and 4. The comparison shows the benefit of the geocell ballast confinement system. In addition the owners noted increased lateral stability of the track with the geocell and wished the geocell had been used along the whole track.

to the new feed-in. Due to the importance of the feed-in location the reconstruction of this failed 45 m section of track was rebuilt using a geosynthetic aggregate confinement (geocell) layer placed with a clearance of 0.2 m between the top of the geosynthetic and the base of the ties.
