# Terzaghi oration: Geotechnical aspects of the 1995 Kobe earthquake

Kenji Ishihara – Science University of Tokyo, Japan

**ABSTRACT** The background information is given on the issues such as earthquake-generating plate tectonics in the Japanese archipelago, historical seismicity and development of fault rupture in the region of strong shaking during the Kobe earthquake. The geological setting and topography are described together with the expansion of land reclamation in the port area of Kobe. Characteristics of the ground motions recorded at various sites during the earthquake are also presented. Soil conditions investigated at two sites by way of undisturbed sampling using the ground freezing technique are described somewhat in details. The gravel-containing silty sand called Masado was identified to have developed liquefaction under intense shaking. The features of liquefaction and consequent lateral spreading which occurred in the reclaimed fills are presented in terms of attenuation characteristics of the lateral displacement of the ground diminishing with distance inland from the waterfront. As typical examples of the damage to foundations, results of in-site survey are pr

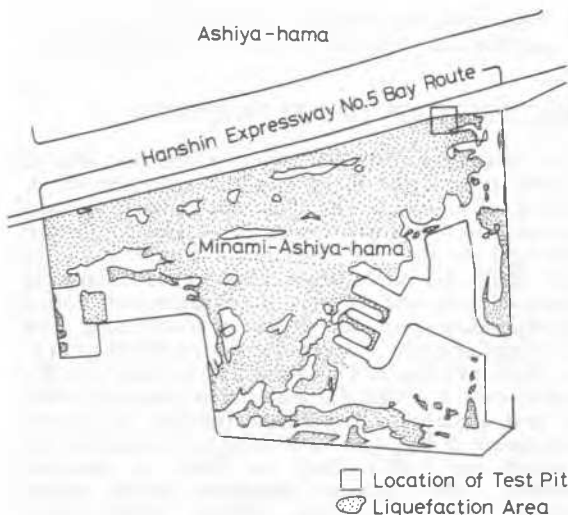
Fig.20 Feature of ground destruction in the vicinity of the pit excavation

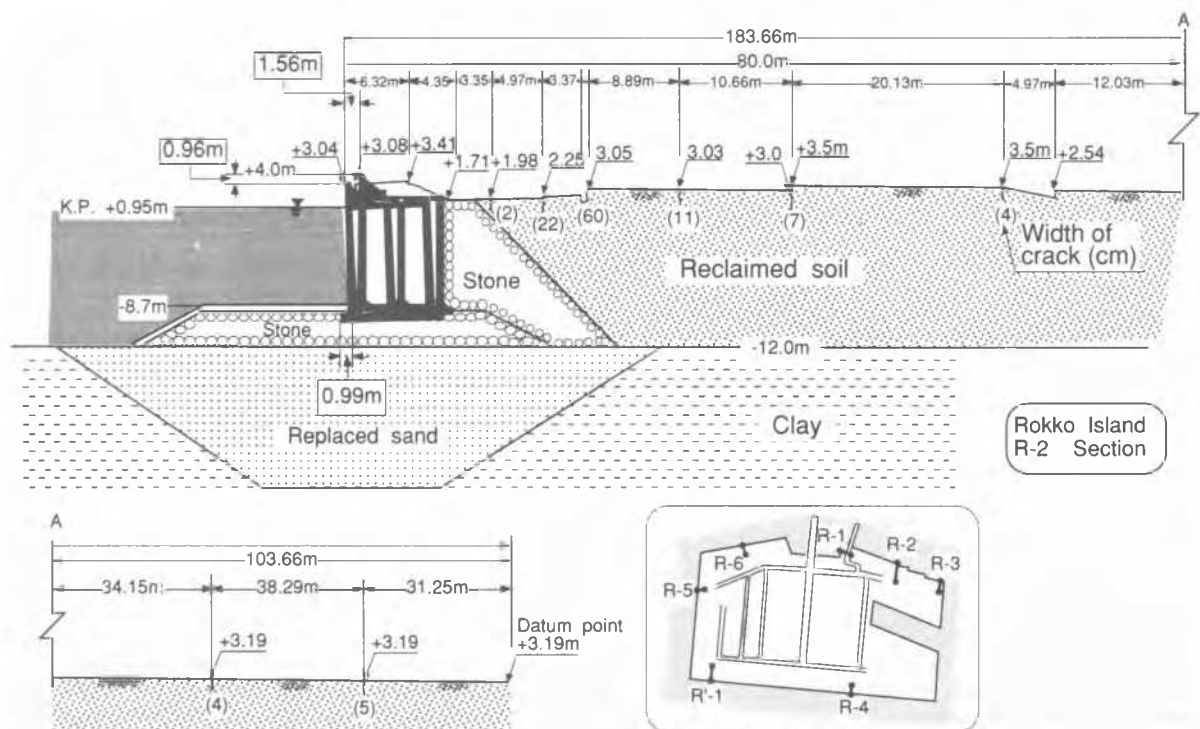
settlement of 0.96m. The displacement is shown to have extended inland as far backwards as 183.7m. A soil profile near the point R-2 is shown in Fig.37. It may be seen that the man-made fills composed of Masado soil existed to a depth of about 20m. Liquefaction is conceived to have occurred in this reclaimed fills. It is conceivable that there were dual factors which might have acted to produce the lateral displacement of the caisson walls. These are inertia force due to the intense shaking and softening of soils surrounding the caisson caused by buildup of pore water pressure. It may be roughly assumed that the effects of pore water pressure buildup including liquefaction were, by and large, the same all over the waterfront areas in Kobe port that were affected by the earthquake. However, the effects of inertia force are deemed different, depending upon the direction to which the revetment line is oriented. As a matter of fact, the records of accelerations secured during the earthquake showed motion characteristics which are largely biased to the northwest-southeast direction as indicated in Fig.12. Based on the records obtained nearby, the acceleration inferred to have acted on the quaywalls oriented in different directions were established by Inagaki et al. (1996) as indicated in Fig.38. It may be seen that the horizontal acceleration against the north- or south-facing walls was of order of 500gal whereas an acceleration of the order of 250-300gal is

Fig. 36 Detailed profile of the ground deformation at R-2 Section in Rokko Island

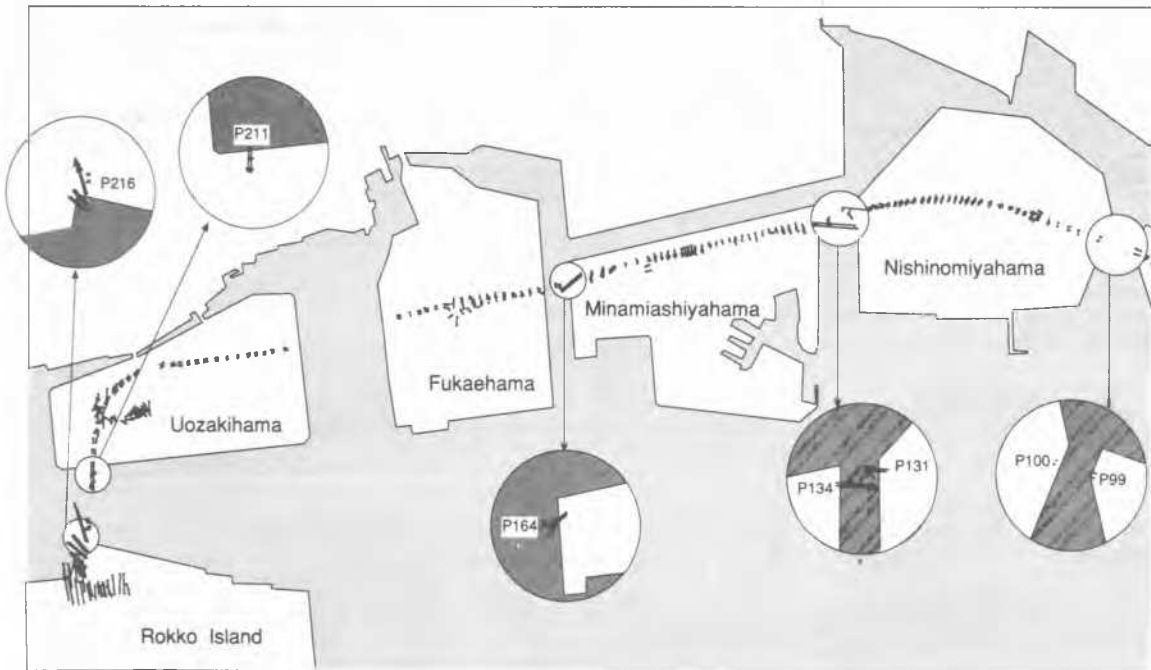
Fig.45 Lateral displacements of the bridge piers along the No.5 Bay Shore Highways (Hanshin Highway Authority, 1996)

In the case of the No.5 Bay Route, the damage to piers or superstructures were more than severe in the terrain close to the waterfront. No less destructive was the damage to foundation system such as piers or footings. The Bay Route is located in the area of manmade deposits composed of the Masado soil in Kobe. Following the earthquake, movements of bridge piers were surveyed along the Bay Route No.5 by virtue of the GPS (Global Positioning System). The outcome of the survey is displayed in Fig.45 in terms of vectors for the section from Nishinomiya to Rokko Island. It was discovered that the vast expanse of the area surveyed had moved as a whole about 20cm towards southwest for some reasons not yet identified. In the displacement vectors displayed in Fig.45, the overall movements of 20cm are subtracted from the measured data. Fig.45 indicates that the lateral displacements of the bridge piers in the vicinity of the waterline are generally larger than those in the inland area and directed predominantly towards the waterfront.

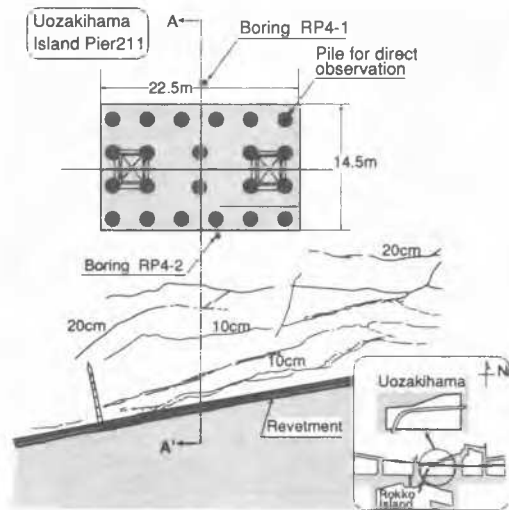
The most striking feature of the damage was movement of foundations towards the sea due to lateral spreading of the ground as a whole resulting from liquefaction of soils. Deleterious effects of lateral spreading were notably observed in performances of piers or bents of elevated highway structures standing in proximity to revetment lines. A typical example of such damage was seen in the Pier 211 of the Hanshin Expressway No.5 Bay Route which is located in the southernmost part of Uozakihama Island as shown in Fig.46. Features of the ground damage in the vicinity of Pier 211 are displayed in Fig.47 together with a plan view of the pier. Several lines of fissures are visible on the ground surface near the revetment. Somewhat

Fig.47 Ground distortion and location of Pier 211 (Hanshin Highway Authority, 1996)

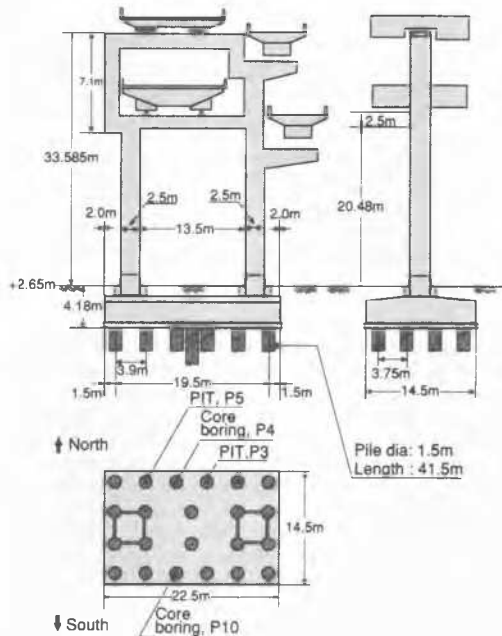
Fig.48 Plan and side views of Pier 211 (Hanshin Highway Authority, 1996)

enlarged plan view of the foundation is shown in Fig.48 where it can be seen that two-column bents sit on a 22.5m long and 14.5m wide footing which is supported by 20 piles 1.5m in diameter. The piles were constructed of cast-in-place reinforced concrete. Side views of the Pier 211 are shown in Fig.48 where it is noted that the body of the footing is embedded to a depth of 4.18m. A cross sectional view of the foundation and the quaywall across the section A-A' in Fig.47 is displayed in Fig.49, together with a soil profile. Exact location of the soil profile investigation (RP4-1) behind the quaywall is shown in Fig.47. As a result of measurements by GPS, it was discovered that the Pier 211 had moved towards the sea by 62cm, as accordingly indicated in Fig.49. It is highly likely that liquefaction developed in the reclaimed fills in the backland leading to widespread occurrence of lateral spreading as demonstrated in Fig.46. The lateral displacement of the ground in close proximity to the Pier 211 but free from its influence, may be read off from Fig.46 as being of the order of 100cm.

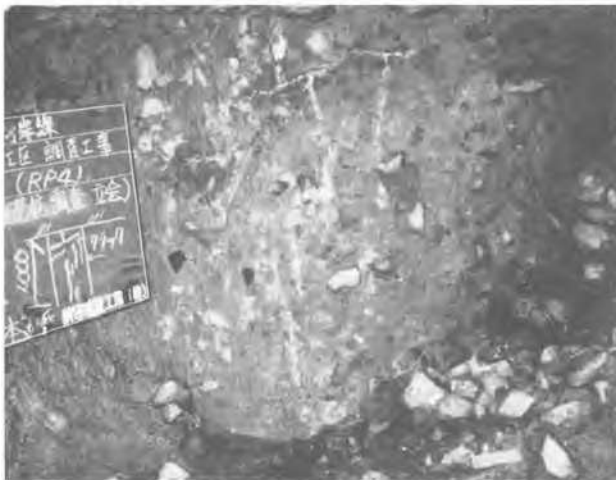
Fig.52 Crack development at the pile head, Pier 211 (Hanshin Highway Authority, 1996)

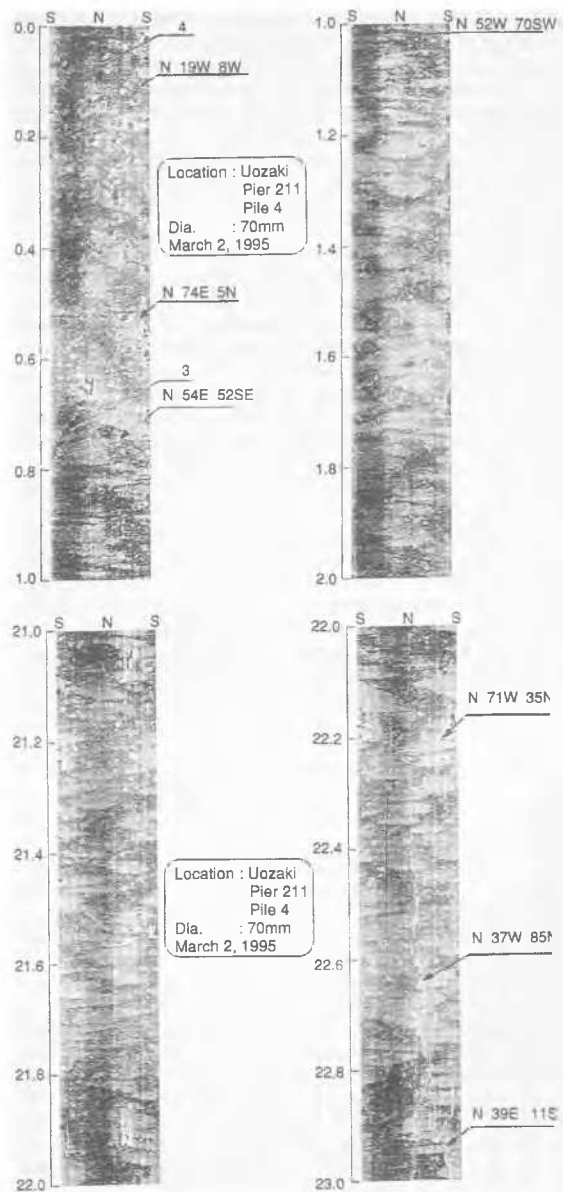
Fig.54 Feature of crack development at the pile head and mid-depth of the pile (Hanshin Highway Authority, 1996)

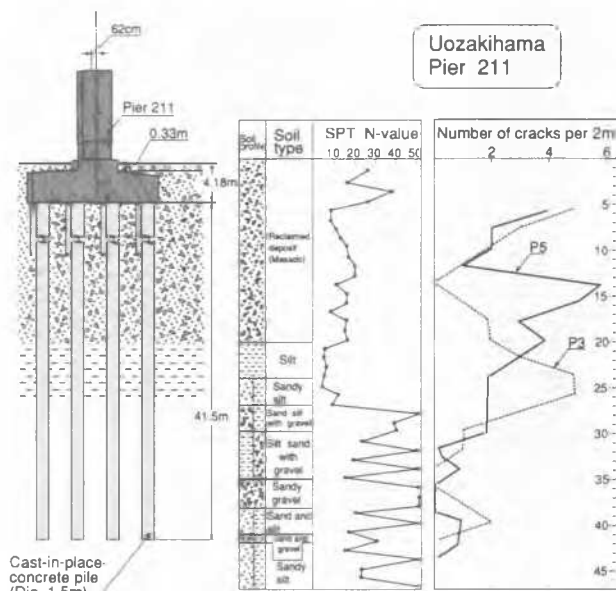
provided. It is also noted in Fig.56 that the number of cracks is large at depths between 16m and 22m for the pile P3 and at depths 9 to 15m for the pile P5. The reclaimed Masado soil at this site is considered to have developed liquefaction to a depth of about 20m, leading to considerable softening of this layer as against the non-liquefied soil deposits below the depth of about 20m. Thus, it is highly likely that the magnitude of bending moment became large near the interface of these two layers.

Fig.56 Observed number of cracks per 2m length of the piles (Hanshin Highway Authority, 1996)

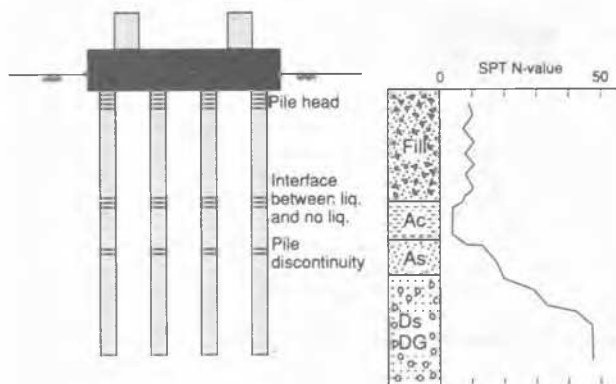
The outcome of the in-situ investigations as above revealed the fact that, generally speaking, the pile damage had taken place around the three depths illustrated in Fig.57. In practically all the piles investigated, cracks were detected at depths 0 - 3m below the bottom of the footing slab. The damage at the pile head was supposedly caused by a great magnitude of bending moment resulting from the inertia force from the superstructure during intense shaking at the time of the earthquake. The cracks near the interface between liquefied and unliquefied deposits were observed mainly in the piers located near the waterfront. The cracks were also observed at the depths where design was made to reduce the cross sectional area or reinforcement. This type of damage was identified, by and large, in the case of the piles located in proximity to the waterfront. Thus, it may be considered that the cracks at some depths were caused by the lateral spreading of the surrounding soils that had liquefied during the main shaking of the earthquake.

Fig.57 Three locations in the pile body where cracks were predominantly observed

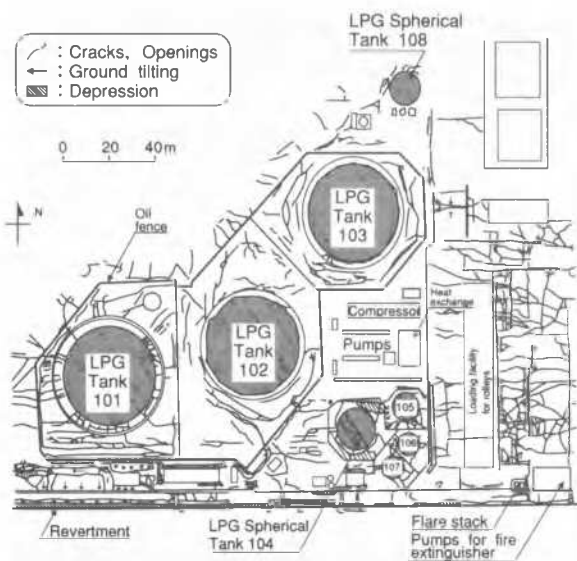
Fig.59 Ground distortion in the tank farm (High Pressure Gas Institute, 1995)

One of the LPG tanks (No.101 in Fig.59) with a storage capacity of 20,000 kℓ sustained damage at the outlet-inlet nozzle (exit of liquefied gas) installed at the flank, leading to leakage of liquefied natural gas. At the time of the earthquake, this tank contained about 6,700 kℓ of LPG and about half of the gas leaked in the premise enclosed by protection fence. The remaining half was transferred to another uninjured tank. Luckily enough, inflammable content did not catch fire, and, therefore, a disastrous scenario was avoided. Some of the evaporated gas is purported to have dispersed in the air due to wind blowing towards south and the rest of the gas seems to have seeped into the ground through fissures of the ground created by the liquefaction.

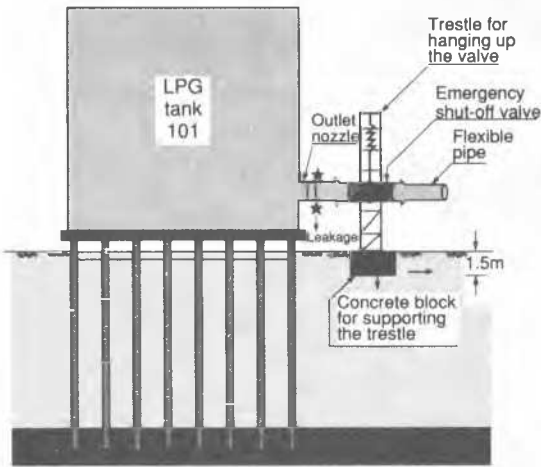
The cause of the leakage was explained as follows. (High Pressure Gas Institute, 1995). A tall steel trestle had been installed outside the tank to hang up the emergency shut-off valve which was connected to the outlet nozzle pipe, as illustrated in Fig.63. This new installation was carried out some years after the start of the tank operation to ensure further safety. The steel trestle was resting on a simple concrete block embedded

in the ground to a depth of about 1.5m. Owing to the liquefaction, the ground moved seawards about 70cm. The concrete block also settled about 70cm accompanied by sinking of the trestle. As a result, all the weight of the trestle was then applied as an external load to the emergency shut-off valve. This vertical load was transmitted to the inlet-outlet pipe rigidly connected with bolts to the flank of the LPG tank. Because of the excessive weight vertically applied, bolt-fastened flange of the rigid inlet-outlet pipe was forced to open slightly and this led to the leakage of LPG following the earthquake. It is apparent that this incident was caused by the large settlement of the concrete block supporting the trestle. As the pile-supported tank body remained unsettled, the relative settlement as much as 70cm occurred between the tank and trestle. This incident left an important lesson that the foundation of auxiliary facilities should have been supported by a common foundation with the tank body.

Fig. 63 Illustration for the gas leakage due to the differential settlement between the trestle and the LPG tank

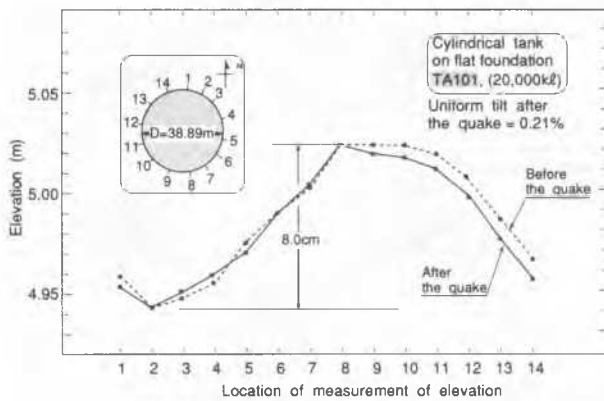
In spite of the leakage, no serious damage was incurred to the structure of the Tank101. One of the measures of the structural damage would be the magnitude of tilt or differential settlement of the tank body. Shown in Fig.64 are the results of measurements of settlements. At 14 points around the tank equally spaced along its periphery, elevations were measured. The elevations are plotted in this figure versus expanded locations of measurement points along the periphery. The tilt of the tank is normally defined as the maximum difference of settlements at any two points divided by the diameter of the tank. For the post-earthquake conditions, the tilt is obtained as  $8\text{cm}/3,889\text{cm}=0.21\%$  as accordingly indicated in Fig.64. With reference to the pre-earthquake tilt similarly calculated, it means that there has been practically no change in the tilt following the quake. According to the regulation by the Japanese Government, the allowable maximum tilt for the normal condition of operation is stipulated as being 1%, may it be prior to or after the quake. Consequently, the measured tilt for this tank was within the limit of the allowable tilt.

Fig. 64 Measurements of elevation along the periphery of the Tank101

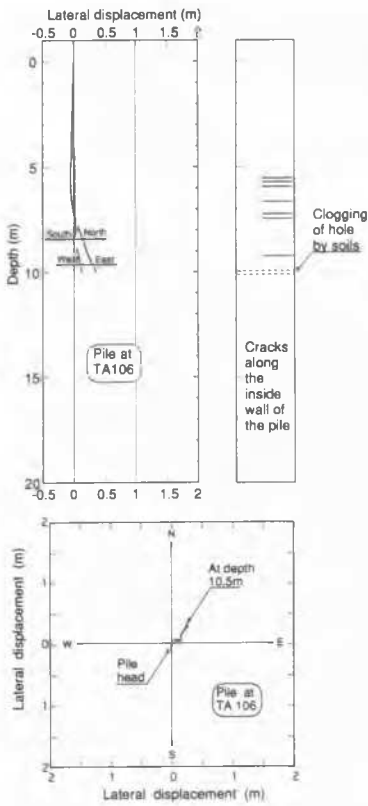
video camera was lowered into this hole to examine development of cracks around the wall. Results of the survey are presented in Figs. 75 and 76 where it may be seen that cracks developed predominantly at depth between 5 and 10m. Unfortunately, it was not possible to pull down the camera lower than 10m because of clogging of the hole. In addition, survey of pile deformation was carried out by lowering an inclinometer successively down the hole. By integrating the measured data on tilts through the depth, configuration of deformed piles was obtained as shown in Figs. 75 and

Fig.75 Lateral displacements of the pile at the Tank106 and features of crack development as identified by the video camera

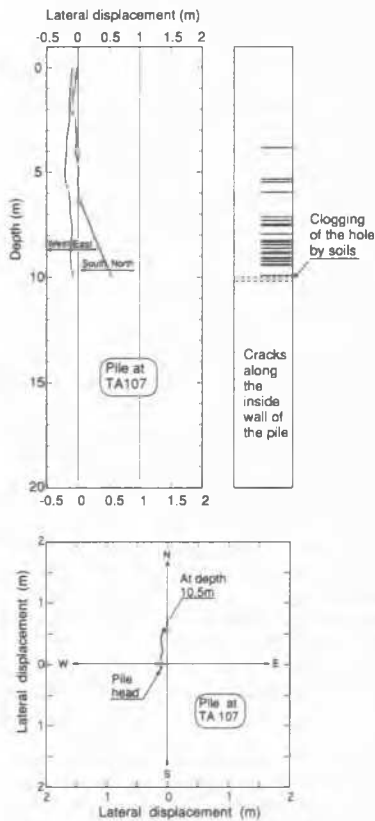
Fig.76 Lateral displacements of the pile at the Tank107 and features of crack development as identified by the video camera
