A small hole could become really big

Za-Chieh Moh – Moh and Associates Incorporated, Taipei, Taiwan

SYNOPSIS: Groundwater has been known to be potentially dangerous in underground constructions. Failures of temporary works due to ingress of water are not uncommon. At one of the deep excavations carried out in Taipei, drilling for the replacement of a malfunctioning piezometer damaged the underlying clay blanket and necessitated the flooding of the entire pit for balancing the hydraulic pressure from the groundwater. A total of 70,000 tonnes of water was recharged into the pit. The underground cavities took about 5,400 cubic meters of grout to fill. The construction was delayed by six months and the financial loss was enormous. This paper presents the sequence of events, the remedy and the rehabilitation works.

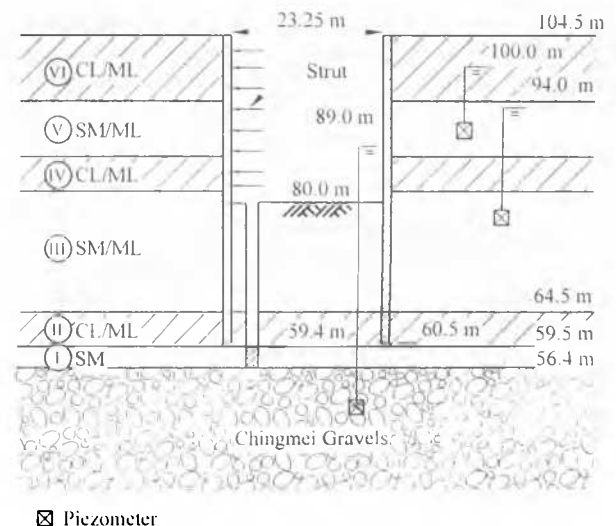
Fig. 1 Soil profile and configuration of excavation

The site is located in central Taipei City. As can be noted from the typical soil profile given in Fig. 1, there exists a thick layer of young sediments, i.e., the so-called Sungshan Formation, from the ground surface to a depth of 48m. The Sungshan Formation comprises 6 sublayers of which Sublayers I, III and V are composed of silty sands (SM/ML) and Sublayers II, IV and VI are composed of silty clays (CL/ML). Underneath the Sungshan Formation is a gravelly layer, i.e., the so-called the Chingmei Gravels.

The excavation of interest was for constructing an underground station of the Taipei Rapid Transit Systems. As shown in Fig. 1, it was 23m in width and was carried out

to a depth of 24.5m by using the bottom-up method. The pit was retained by diaphragm walls, 1.2m in thickness and 44m in length, and braced by 8 levels of temporary struts. The diaphragm walls toed in Sublayer II to provide a seepage cutoff. Sublayer II, which is an impervious layer consisting mainly of silty clay, essentially served as a seal at the bottom of soil plug which was enclosed by diaphragm walls on its four sides. With a length of soil plug of 20.5m, a factor of safety of 1.3 was obtained against blow-in for a piezometric head of 29.5m at the bottom of the plug. At the time when the incident occurred, the bottom of excavation had been reached and, except at the southern end where the incident occurred, base slab had already been cast.

The incident obviously started as the soil at the bottom of the borehole liquefied. As illustrated in Fig. 1, the tip of borehole was entering Sublayer I at the time when water started to overflow. The Chingmei Gravels is extremely permeable. The fine particles in Sublayers I and II were carried away by the fast moving water at the contact with the Chingmei Gravels. At first, water paths would propagate laterally in Sublayer I which is more susceptible to erosion than Sublayer II and the Chingmei Gravels. As Sublayer II caved in, its integrity as a clay blanket was destroyed and the water paths would propagate upward into Sublayer III which had a higher piezometric level than the

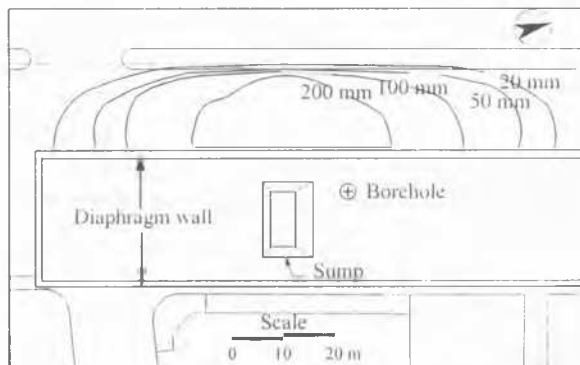
Fig.2 Site plan and settlement contour

As shown in Fig. 2, the 20mm contour of ground settlement extended to a maximum distance of 60m away from where the borehole was. Ground settlements, as shown in Fig. 3, however, were confined by an existing underground structure, which had deep diaphragm walls as retaining structures when it was constructed, and did not go too far toward the west. The maximum ground settlement was estimated to exceed 250mm.

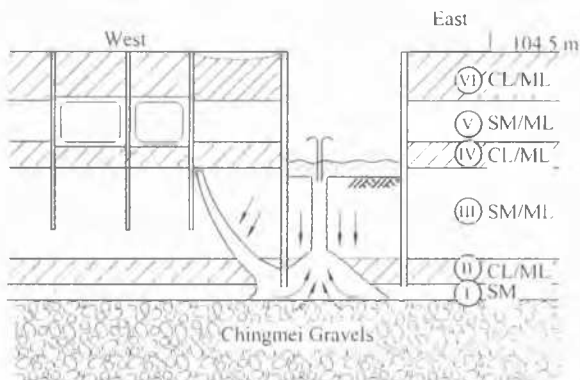
Fig.3 Scenario of the incident

Chingmei Gravels. These water paths would spread in all directions and connect each other to form large cavities. As arching effects were no longer able to hold up the ground, the roof above these cavities collapsed and ground settlements followed. The scenario shown in Fig. 3 and the extent of disturbance to the ground were confirmed by the subsequent investigations following the incident.
