## 26 YEARS OPERATION OF MANGLA DAM

*Izhar Ul Haq*

P.D. CMTL Wapda  
Lahore, Pakistan

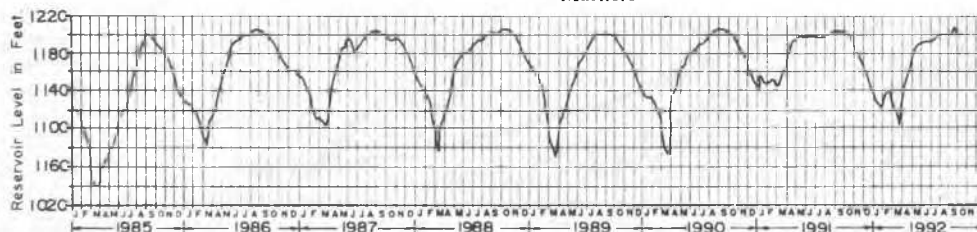
Fig.2 Mangla Reservoir Operation.

The designed minimum reservoir level is 317m (1040 ft.) Survey of Pakistan datum (SPD). During the history of reservoir operation, there were only two occasions, when the reservoir was drawn down to this minimum threshold level. Fig.2 shows reservoir operation during the last 8 years. Uptill now valuable experience, covering 26 years of actual prototype operation, has been gained based on which the reservoir operation has been optimized to give more benefits in the form of water storage, electricity generation and environmental impact. Conjunctive use of the two reservoirs Mangla & Tarbela has yielded better results.

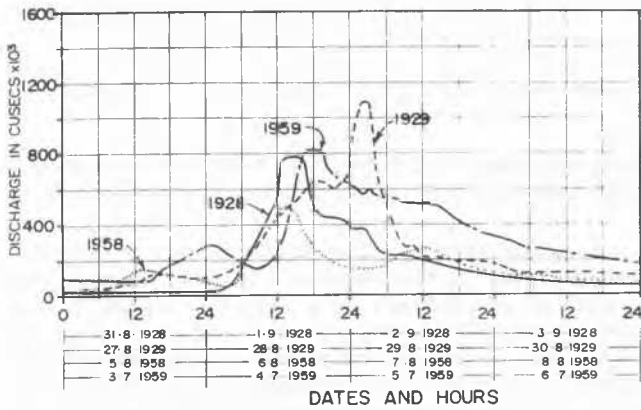
Fig.3 Hydrographs of major historic floods at Mangla.

Now we have 26 years experience of actual reservoir operation in addition to about 30 years of hydro-met data. Fig. 3 shows hydrographs of major historic floods at Mangla. During this period no sedimentation has taken place in the flood storage zone above conservation level. Based on this Harza Engineering Company, Chicago, USA in their report of February, 1992 has recommended the new flood routing scenario for flood of record by including releases through irrigation outlets, 30% main spillway capacity in addition to Emergency spillway discharge. No sedimentation allowance in the flood storage zone has been kept in this study. Recommendation was then made to raise the conservation level from 1202 to 1204 ft. SPD.

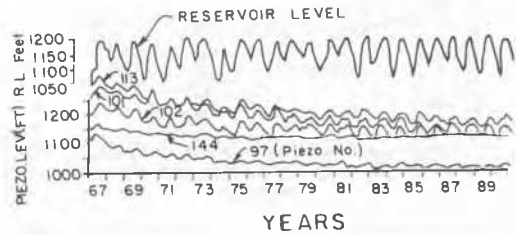
Fig.4 Dissipation of Pore Pressure in Mangla Core.

Mangla Dam has two instrumented sections at which closed circuit Bishop type hydraulic Piezometers have been installed in the Core. Fig 4 shows pore pressures of the Piezometers in the core. The pore-pressures are dissipating gradually and reducing every year. High construction pore-pressures upto 0.7 ru (Pore Pressure ratio) developed in the core. The piezometric level fluctuates with reservoir level. The peaks and troughs in the pore-pressure record coincide exactly with high and low reservoir level with no time lag. This suggests that the pore pressure changes are a result of change in static load on filling of reservoir and release of this load during draw down.

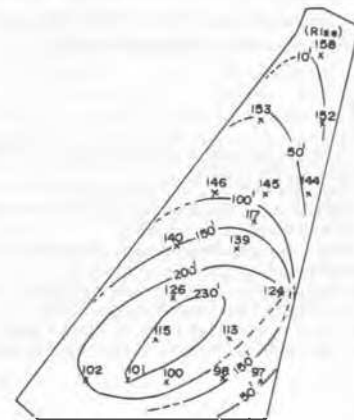
Fig.5 Equipotential Contours of Mangla Core.

Fig 5 shows the contours of equal pore pressure in the core. The shape of the contours follows the shape of the clay core. The maximum pore pressures are at the centre and in the lower part of the core which has the maximum fill. The upper part has lesser weight and lesser pore pressures. The exterior parts in contact with the upstream and downstream shells and the chimney drain have the facility of easy drainage and show lower pressures than that of the heart of the core. The lack of flownet development is also supported by analysis of the return water from the hydraulic Piezometers in the core which show large percentage of carbonates as against the return from the Piezometers with sandstone fill through which phreatic line has developed.

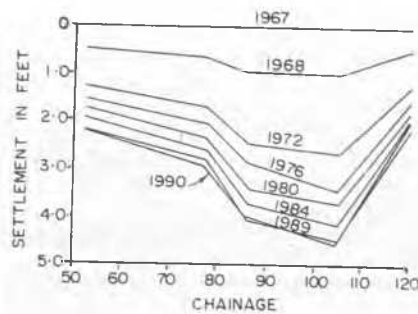
Fig.6 Settlement at Crest of Mangla Dam.

Total settlement of 1m was envisaged in the design and an allowance was made for this in construction of the dam. Until now 1.5m of max. settlement has been recorded at the crest of dam. Fig 6 shows the settlement of main dam with the passage of time. The settlement was more in the initial years. Thereafter it is reducing progressively. The max. settlement has been where the core height was maximum. However there have been no cracks or signs of distress on the dam. Maximum horizontal displacement of 1m occurred mostly on the first filling of the reservoir. This coincided with the point of maximum settlement.
