## A CASE STUDY OF ROCKFILL DAM: STABILITY EVALUATION AND REMEDIAL TREATMENT

**Hong Sung-Wan    Sohn Joon-Ik    Bae Gyu-Jin    Ahn Sang-Ro**  
**Um Yong-Sup    Park Eun-Young**

Geotechnical Engineering Division  
Korea Institute of Construction Technology (KICT), Korea

**SYNOPSIS:** Described in this paper are the stability evaluation and remedial treatments for an earth-core rockfill dam which experienced serious open cracks on the crest. Data obtained from the site investigation, the field instrumentation and the numerical simulation have been inclusively analysed to characterize the causes of the crack development. The effect of rapid drawdown of the water level has been evaluated as a possible cause to induce the differential settlement between the dam core and adjacent zones.

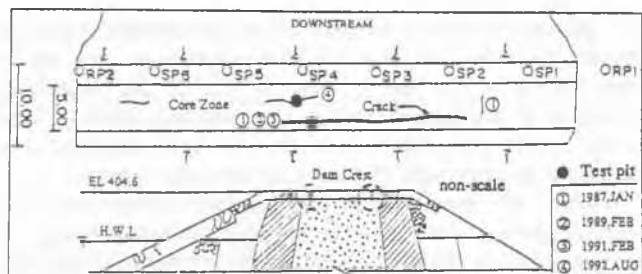
Fig. 2. Typical Cracks on the crest of the Upper Dam

Fig. 2. shows the typical crack pattern. The longitudinal cracks occurred four times, in January 1987, in February 1989, in February 1991, and in August 1992. The length of the cracks ranged from 21 to 130 m and the width of the cracks ranged from 0.4 to 5.0 cm. A 6 m-long transverse cracks were also appeared. After

Test pit was made in order to observe the depth and direction of crack development. The position of the test pit was at SP No.4., 180 m from the right abutment. Before the test pit excavation, non-soluble white paint was poured into the crack opening to trace the crack development inside the dam core.

It was observed that the cracks developed from the crest surface and continued vertically downward and laterally in the longitudinal direction, but they disappeared deep in the dam core. Down to the excavation depth of 1.4 m the crack surface coloured with the white paint was clearly visible and the width of crack opening was measured approximately 5 cm. From this depth the trace of white paint got less clear with the width of crack opening getting reduced. Also the trace of bentonite fill was shown. The bentonite was poured into the cracks in the previous repair works.

The total excavation was made down to 1.9 m where no sign of

crack development was observed. At the depth of 1.8 m the trace of white paint and the bentonite were rarely seen. But there should exist some weakening zone below this level which could not be identified from the field observation. The weakening zone characterized by means of numerical modelling will be discussed next.

The vertical direction of the crack surface indicates that the crack development would attribute more likely to the differential settlement taken place in a local zone than to the global slope instability condition of shear sliding. The considered possible causes of the differential settlements are the effective stress change induced by the repeated rapid drawdown of the reservoir water level, the possibility of the particle migration of the fine core material due to the high hydraulic gradient or poor condition of filter materials and improper condition of compacted clay core.

first longitudinal crack was appeared, the non-pressure groutings

were used for the remedial treatments. Grouting materials used were the bentonite mixed with cement and water.

filling of the bentonite solution into the crack openings but it could not be an fundamental solution. The recommendations are made tentatively as shown in Table 2. Installation of instruments was been also recommended to further include crack gages and inclinometers. The final selection of the fundamental remedial works and detailed plans must be set up after the full analyses of all available informations.

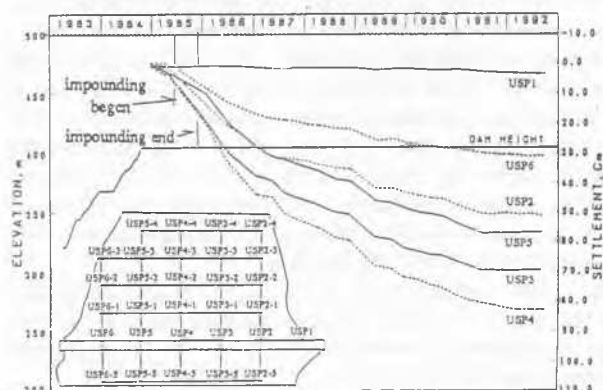
Field data include the surface settlement, horizontal displacement, and pore water pressure. Surface settlement points are located on the crest and the slopes of the dam as shown in Fig. 3.

As recorded in October 1992, the settlements at the dam crest ranged from 3.3 cm to 81.5 cm. Fig. 3. Time-dependent settlements of the dam crest ranged from 3.3 cm to 81.5 cm. The settlement is largest at the point USP4. According to the empirical formula ( $S=0.001 H^{3/2}$ ; where H is the dam height) suggested by the Lawton and Lester(1964), the final settlement is calculated to be 79.8 cm which is similar to the actual settlement measured.

When impounding began, settlements increased sharply and continued smoothly after the impounding was completed. Data for horizontal displacements show small horizontal displacement toward the downstream side in general.

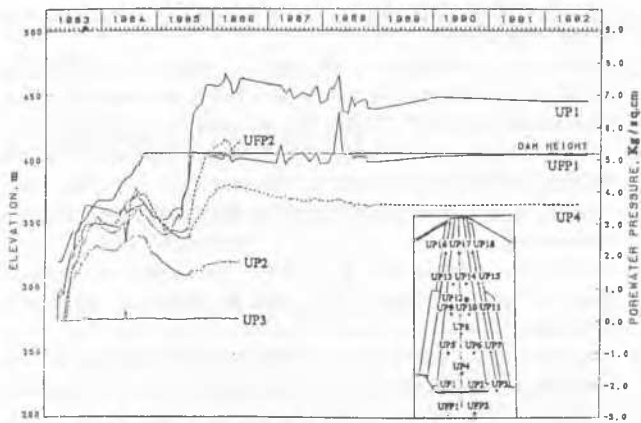
Fig. 4. Time-dependent variations of the pore pressure

Number of pore water pressure gages were installed in the core and adjacent filter zone as shown in Fig. 4. As shown in the figure, pore water pressure were increased rapidly in the early construction stage and then remained nearly constant in the latter construction stage. When impounding began, they were increased rapidly, and then started to slowly converge at smaller values. In

case of the UFP1 and UP1, pore water pressure were decreased a little from the early 1986, showed a random feature between 1987 and 1988, and increased from the early 1989.

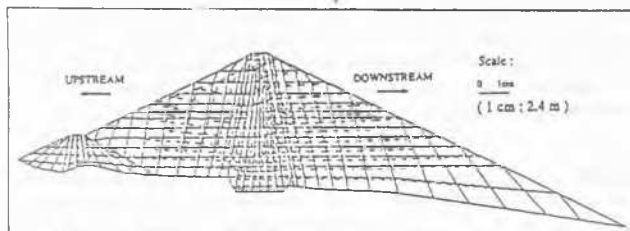
Fig. 5. Pattern of deformations in the dam structure

Fig. 5 shows the deformation pattern in the dam structure, which indicates a large settlement in the core and in the upstream shell portion. As a consequence, the crest is tilted toward the upstream direction. At the end of construction stage, the maximum settlement is 1.2 m near the center of the embankment. It continuously increased to 2.1 m in the upstream filter zone.

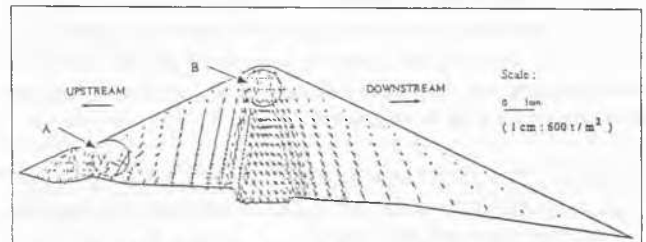
Fig. 6. Principal stress vectors at the present

Fig. 6 shows the major and minor principal stress vectors calculated for the current dam condition. It indicates that the elements of the downstream side show greater magnitude of stress levels than those of upstream side. This is because the pore water pressure is higher in the upstream side. And the rotation of principal stress vectors are remarkable along the interface between the core and the filter zones. This attributes to the development of shear stresses induced due to the differential

settlement between the core and adjacent zones.

The calculated stress ratios range in general approximately from 0.3 to 0.65 except the regions close to "A" and "B" shown in Fig. 6. In these regions,  $F_r$  was calculated to be close to one. The possible cause of the higher value of stress ratio in the zone "A" is considered to be a numerical difficulty. The region "A" is the surrounding of the boundary between the part which was used as a coffer dam and the main body. The region "B" is the area from the dam crest to the depth of approximately 15 m. The higher value of stress ratio in this zone is considered to be due to the excessive differential settlement developed between the core and filter zones. Region "A" is also the area where the largest differential settlement is taken place as shown in Fig. 5. The field investigation data indicated that the crack depth was only 1.8 m deep, but the weakening zone to have been formed below the cracks could be much deeper as this numerical data indicates. For a preciser analysis finer mesh generation is required.
