## BACK-ANALYSIS OF A LANDSLIDE IN OVERCONSOLIDATED TERTIARY CLAYS OF THE GUADALQUIVIR RIVER VALLEY (SPAIN)

It is described a landslide which took place in Almodovar del Rio (Cordoba, Spain), affecting, during the construction, the platform of the high speed train connecting Madrid and Sevilla.

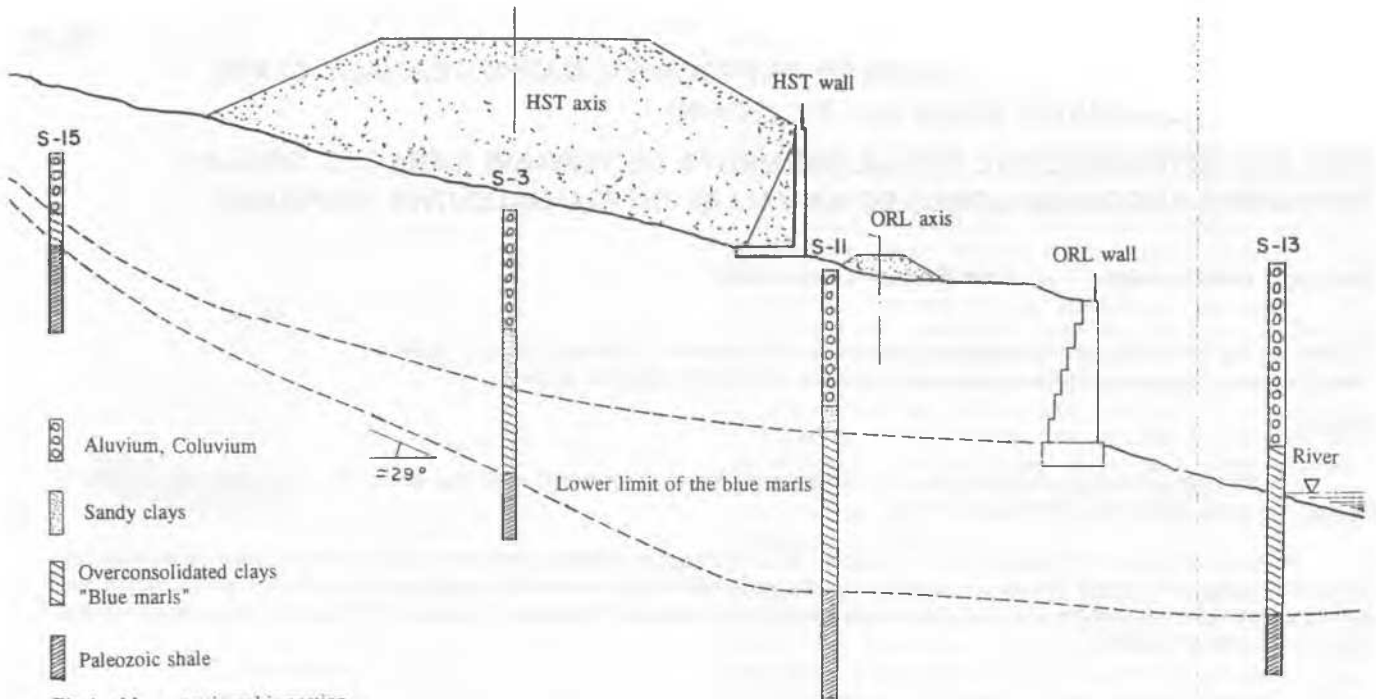
Fig. 1.- Mean stratigraphic section

The typical transversal section of the slope where both lines are situated is represented in the fig.1. The HST platform, after crossing the Almodovar hill in tunnel, continues on a fill of variable height, with a maximum of about 9 m. There exists two retaining walls, one separating the HST and ORL lines, and the second between the ORL and the river.

The transversal section of the blue marls has locally the shape of a horn-bull, with the point in the upper part of the slope, and a base 5-8 m. thick under the ORL line and river bottom (fig.1). Under the fill of the HST tracks the contact between blue marls and shales has a mean dipping angle towards the river of about 29°. Under the ORL line this contact is almost horizontal.

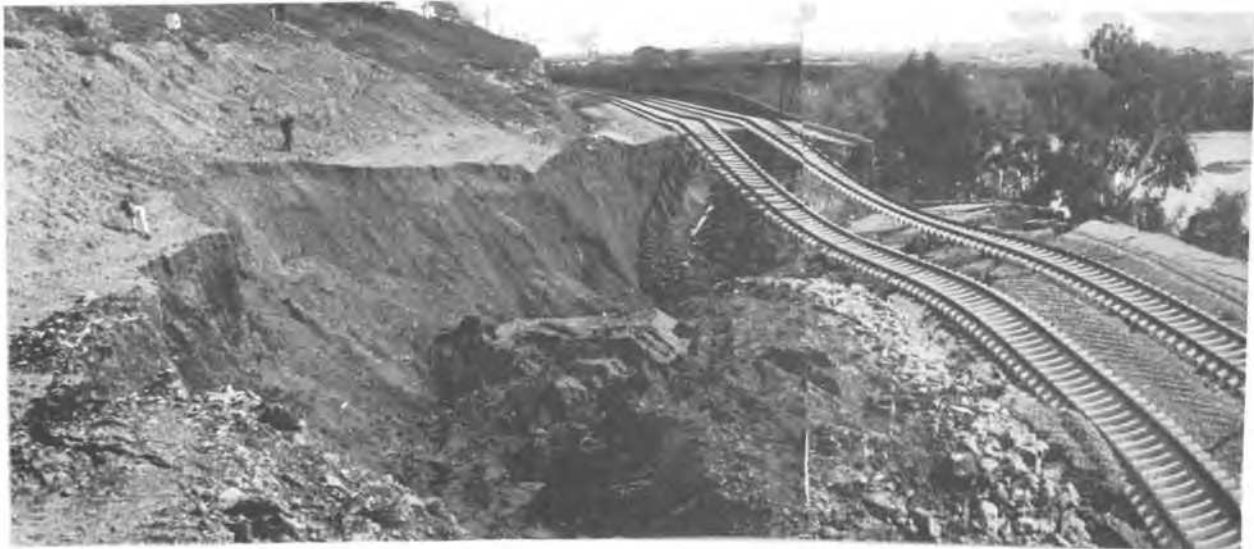
Fig 2.-General view of the landslide

On March 13, 1991, during the construction of the HST line, a landslide affected the two railway tracks. The previous days to the slide important rains fall in the region. The slope movements began with the typical symptoms of instability, such as fissures and cracks in the soil above the railway. Settlement of both tracks were observed in a length of 130 m. Finally, on the mentioned date, a sudden and quick slide interrupted the traffic in the ORL line and cutted the track of the new line. (fig 2)

A progressive failure took place also in plan or longitudinal direction. The landslide began in the Sevilla side and propagated towards the Cordoba direction (fig.2). The extension and the tensile strains of the mobilized mass of soils and rocks originated the opening of transverse cracks. Several subsidiary small slides were observed at the ends of the main slope movement.

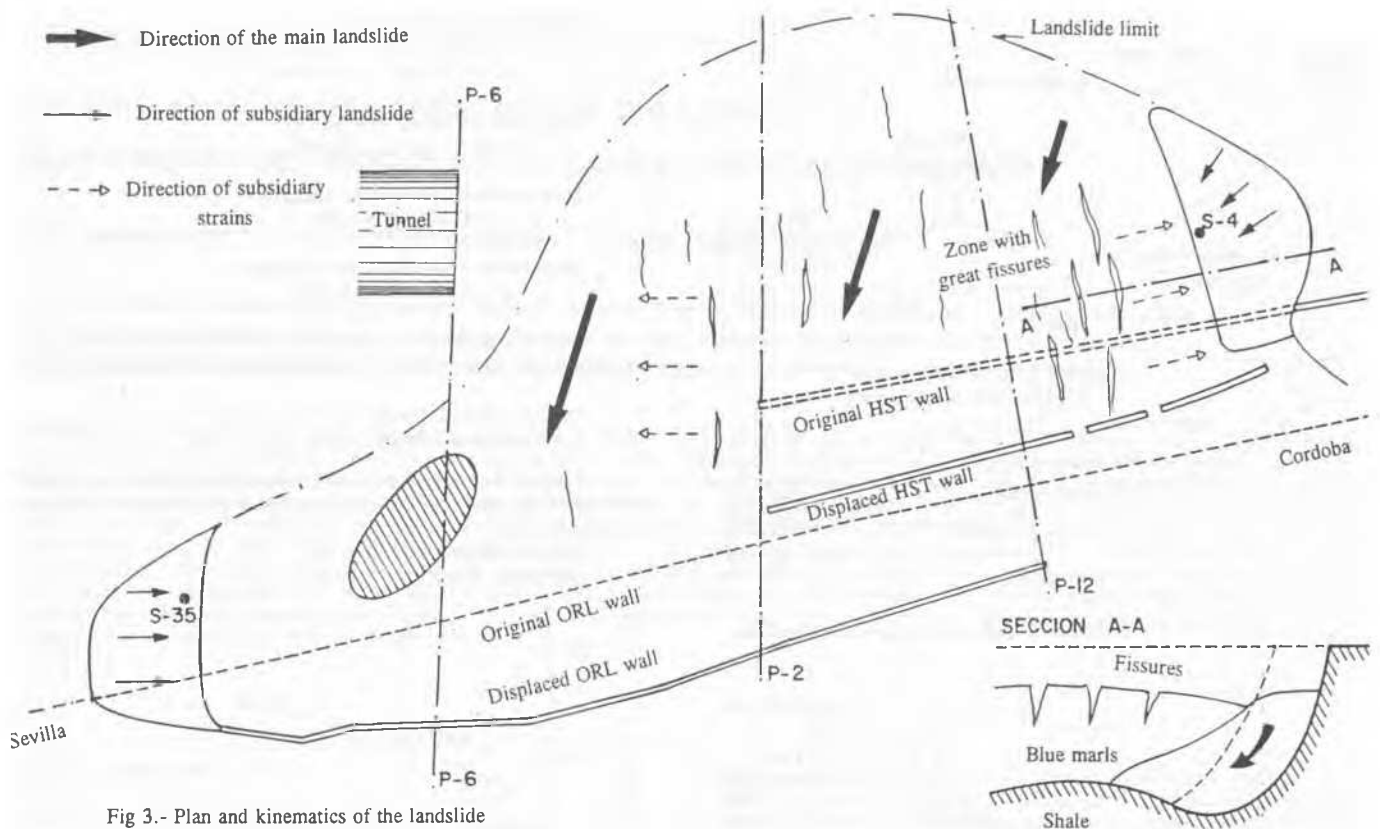
Fig 3.- Plan and kinematics of the landslide

a) In plan (fig 3), the limits of the mobilized soil and rock draw a long shell of the mentioned length in the direction of the river bank, and a width of about 60 m. in the normal direction. The height of the slide between the head and the level of the river was 20 m.

b) The central part of the old wall, between the ORL and the river, maintains its integrity in a distance of 95 m. with some moderate cracking. It was displaced about 12 m. in horizontal. The settlement of the crown of the wall was very moderate, with a maximum of 50 cm. The tilting of the wall face was also very light.

c) The new wall between both tracks was displaced in a similar way and distance, but with some cracking and inclination.

d) The river bank was displaced also in a distance of 11 m.

The fig.3 reflects the direction and the general morphology of the main slide and subsidiary movements deduced of the site investigation which follows.

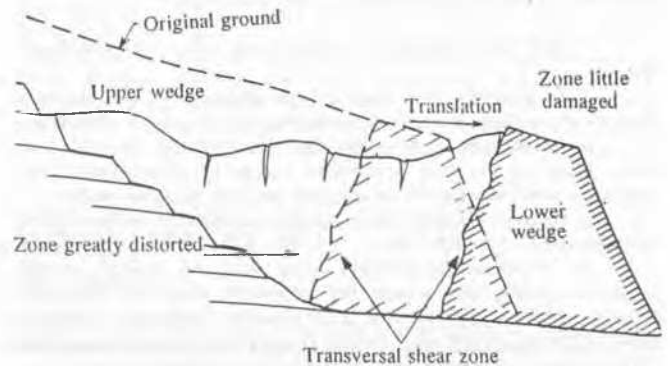
Fig 4.- Typical morphology of a landslide in miocene Guadalquivir blue marls

The blue marls have originated many problems in this region, in relation with the stability of slopes. In most cases the landslides observed and studied have a similar morphology and kinematics. In a schematic way (fig 4), two zones or two wedges can be clearly distinguished in a transversal section. The upper wedge is the first to suffer and to show the signs of the instability. It is deformed in very different ways and magnitude, depending on the local stratigraphic disposition of the soils which cover the blue marls

because it must trespass the elbow which the slip surface presents usually between the upper and lower wedges (fig. 4). By this reason the soils and rocks of the upper wedge experience distortions and cracking of very different patterns depending on the local circumstances of the rock.

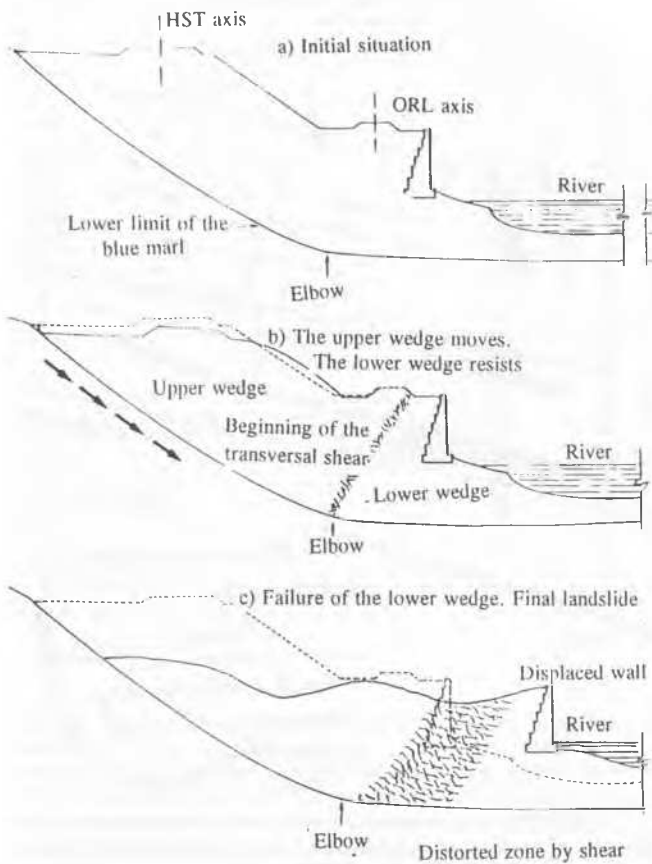
Fig.5.- Transversal cinematics of the landslide

This landslide configuration took place in the case which is now exposed (fig.5).The transversal shear zone separating the two wedges was located between the tracks of the two railroad lines. The upper wedge was situated over the most dipping zone of the contact marl-shale. The lower wedge extended from this shear zone down to more or less the center of the Guadalquivir river course, comprising the area where is located the wall and the tracks of the ORL line. The contact marl-shale is in this zone almost horizontal.

The sequence of the progressive failure and the two wedge landslide configuration is indicated in the fig.5.

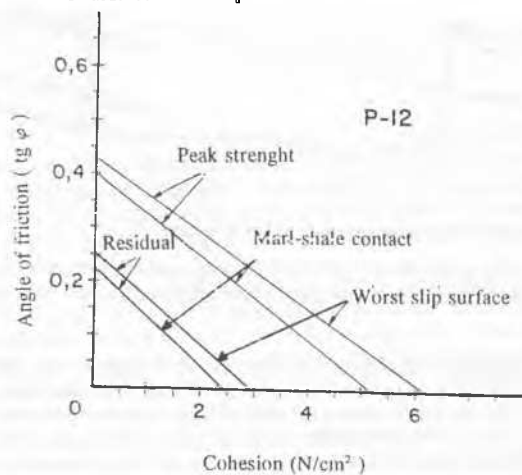
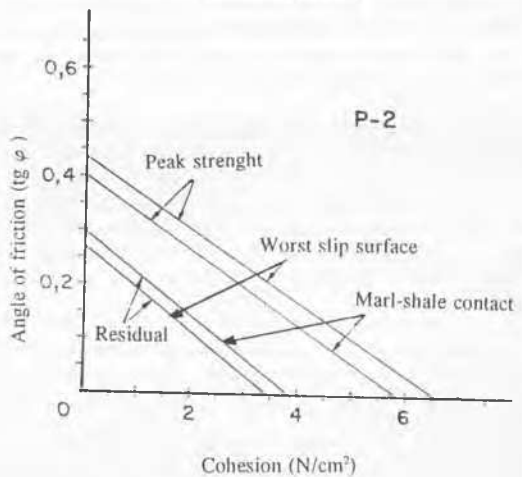
Fig 6.- Equilibrium shear strength

It was employed the bidimensional Janbū method. The following parameters were obtained for the different hypothesis (fig.6) :

Mean drained peak strength :

If cohesion  $c' = 0$  : Angle of friction  $\varphi' = 21.6-22.5^\circ$

If  $c' = 1 \text{ T/m}^2$  :  $\varphi' = 18-19^\circ$

Mean peak undrained shear strength :

$\varphi = 0$  ;  $c_u = 5.1-5.8 \text{ T/m}^2$

Mean residual drained shear strength :

$c' = 0$  ;  $\varphi' = 12.9-15.4^\circ$

Mean residual undrained shear strength :

$\varphi' = 0$  ;  $c_u = 2.5-3.6 \text{ T/m}^2$
