DAMAGE OF A BUILDING DUE TO WATER LEVEL FLUCTUATIONS IN THE NEARBY RIVER

Ernö Biczók

Consulting Engineers GTU Erdbaulabor
Hannover, Germany

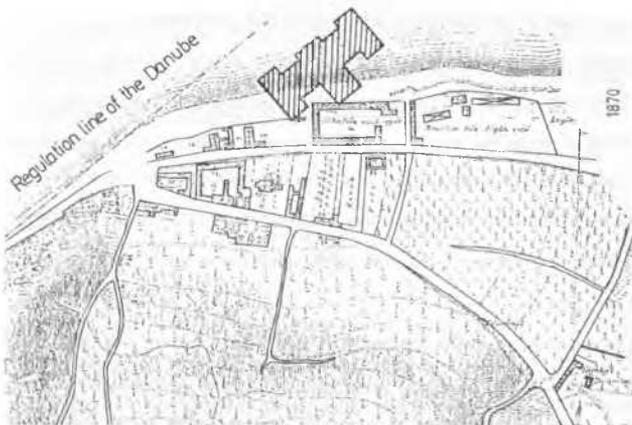
Fig. 1 Ancient map of 1870 with layout of the building

The more than 200 years old Technical University of Budapest was settled to its present location at the beginning of this century. The place, once a flooded area of the Danube, had been regained by help of a regulating dam at the end of the previous century and then refilled with earth, debris, wasted building and earth materials that were removed from the building sites of the capital city. So was built the Central Building of the University (in 1906 - 1909) with a part of it lying on a buried ancient branch of the Danube (Fig.1).

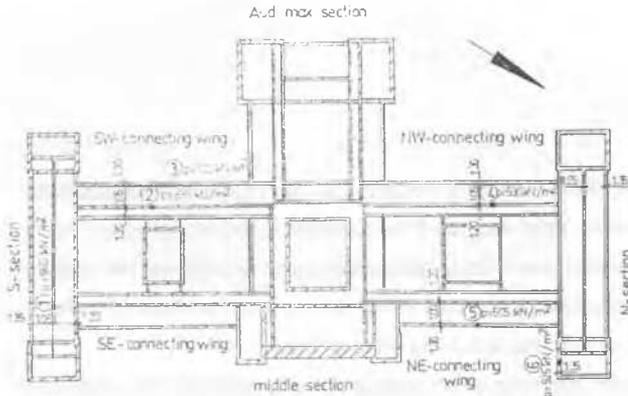
Fig 2 Foundation system of the building

The foundation system with pertinent loads in the building is shown in Fig 2. In the view of present design practice the remark has to be raised that foundation stresses achieved extremely high values ($\sigma_{max} \approx 950 \text{ kN/m}^2$), which were not allowed today under even more advantageous soil conditions.

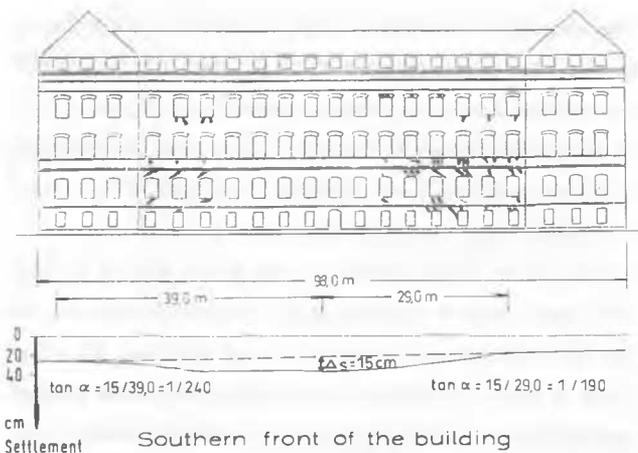
Fig. 3 Pattern of cracks on the southern front

Predominantly the southern block section, even more expressively its mid section between the two turrets and the SE connecting wing were effected by damage. The pattern of cracks on the southern face of the building (Fig. 3) refers to reasons of subground origin.

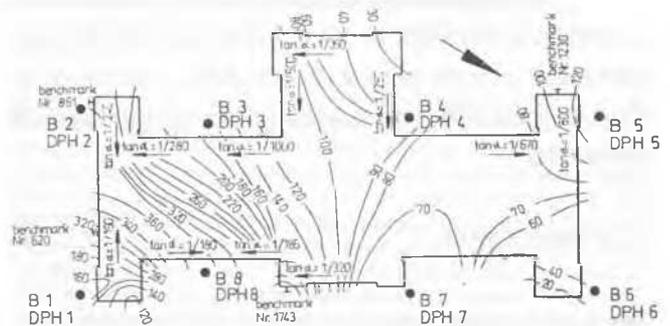
Fig. 4 Levelling data

The contour lines show a plain view about ensued settlements. In the southern building block and in the SE connecting wing total settlements amounted to 36 cm.

For numerical identification of wall movements, the relative angle of deflection is used. Values of $\tan \alpha = 1 / 180$ to 240 can be calculated for the mostly perilled front section of the building on the southern and south-eastern side. Values of other building sections can be read in Fig. 4.

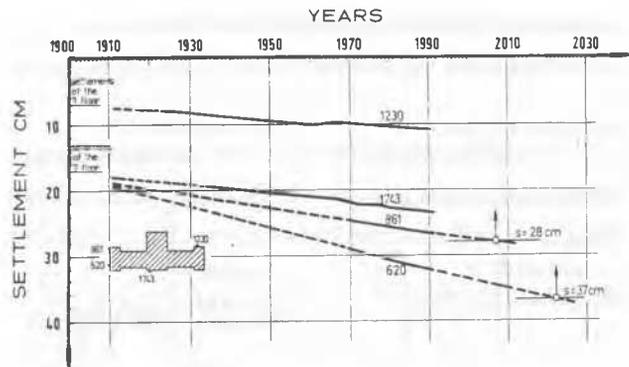
Fig. 5 Time dependent settlement of the bench marks

Time dependent settlement of the benchmarks is shown in Fig.5. Principle of this evaluation was, that measured settlements were plotted backwards in time, starting from the present elevation of the wall footing, known from most recent levelling results.

- the northern part of the building suffered less displacement than the southern part of it and even more settlement took place in the front wall to the Danube;
- the character of settlement appears to be linear and not that of a conventional consolidation curve;
- the tendency in the settlement of bench mark No 1743 shows an abrupt increase after 1967: this fact might be accounted for the influence of increased loads arisen by the reconstruction work in the roof space above the SE connecting section in 1963-64.

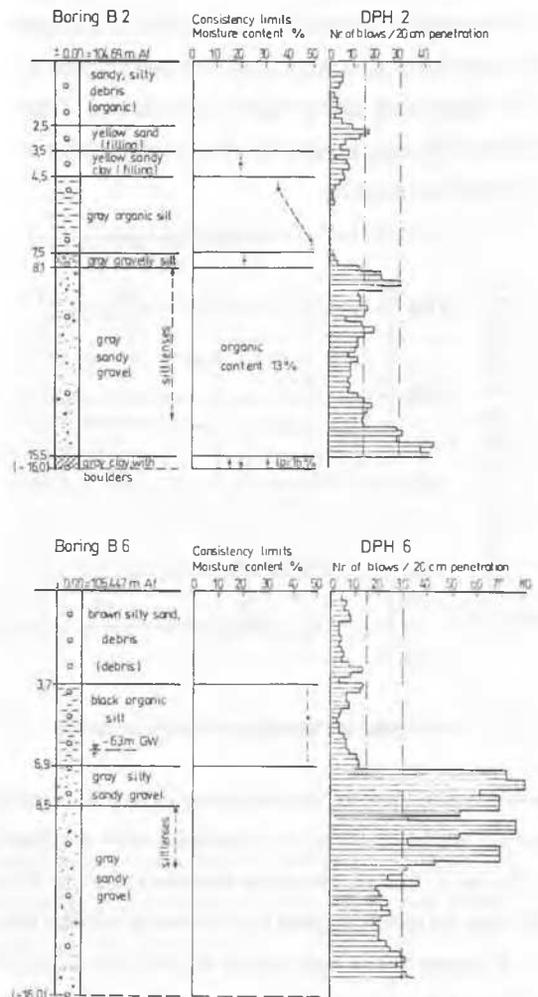
Fig. 6 Typical soil profiles and sounding results

- Results of heavy dynamic probings show significant differences in the density of the sandy gravel below the southern and northern parts of the building. In the southern part resistance of $n_{20} = 8$ to 15 has been experienced, showing a rather loose condition in the average. On the northern part values of $n_{20} = 30$, or greater were achieved i.e. the sandy gravel was in a dense to very dense condition at these places.

Fig. 6 is intended to inform about characteristic probing results below the southern and northern sections of the building.

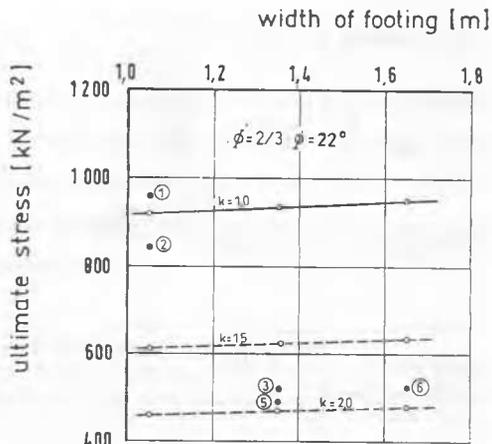
Fig. 7 Load bearing capacity and factor of safety

The stresses belonging to different safety factors ($k=1$ means the ultimate bearing capacity) vs. foundation width are illustrated on the Fig. 7. Plotting the actual stresses (dots 1 to 5) can be seen, that the factor of safety for the internal wall lies about $k = 1,0$. It means that a local failure might occur during the construction of the building. Most probably, it manifested itself in a sudden, subsidence- or collapsing-like settlement

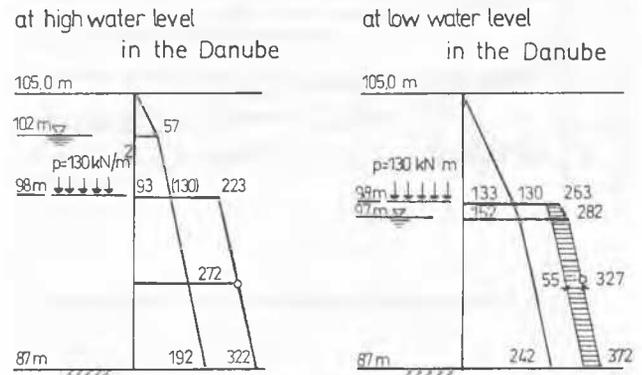
Fig. 8 Stress diagrams at high and low water level

Fluctuation of ground-water level induces significant changes in activated effective stresses in the soil. Repeated subsequent increase and decrease of stresses cause additional compression in the granular soil skeleton (Fig. 8).

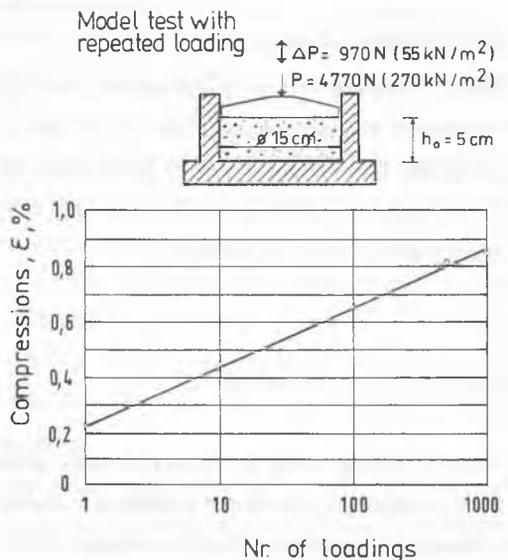
Fig.9 Arrangement of model test and test results

A model test has been completed to clarify this phenomenon. Arrangement of the testing procedure and the results are shown in Fig. 9. Alterating loads in the range of pressures caused by the dead weight, the live weight from the building

and the stress due to fluctuation of the water level in the Danube were sequentially imposed on the soil specimen. The test has proved that with increasing number of repeated loads (i. e. cycles of flood) compression is continuously progressing, though in a diminutive rate (logarithmic scale).

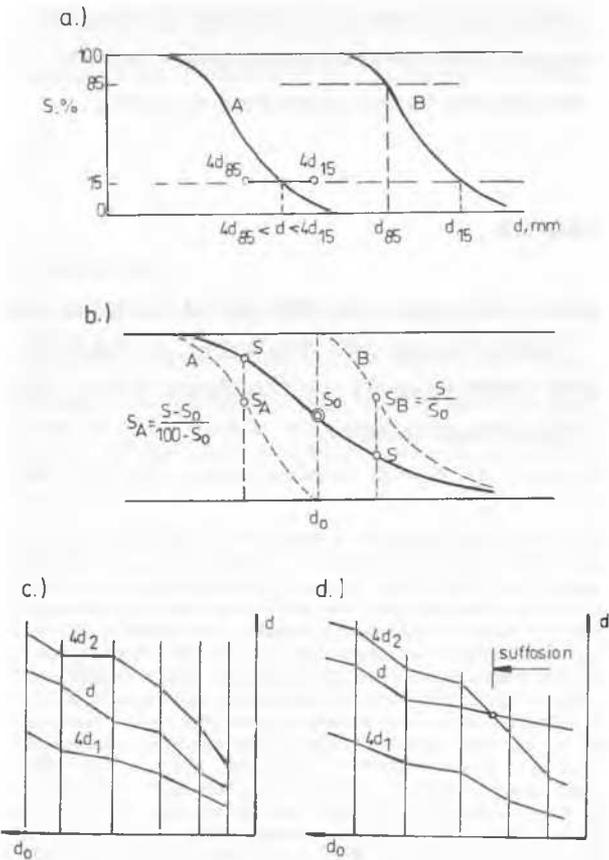
Fig. 10 Examination of self - filtering capacity

Thezaghi's filtering rule was used (Fig. 10a). When the self-filtering capacity of a soil is examined, the soil is divided in two portions at any arbitrary grain size, d_0 (respectively soils A and B, Fig. 10b). It has to be checked whether part A would satisfy the filtering rule against part B. The procedure is than

to be repeated for several d_0 grain sizes. Plotting the results in a $d_0 - d$ coordinate system, it can also be read off whether the soil was capable for self-filtering (Fig. 10c) or not, respectively which grain sizes are prone for being leached out (Fig. 10d). Fig. 11 shows an example about a completed tests. On the Fig. 12 the range of tested soil is illustrated.

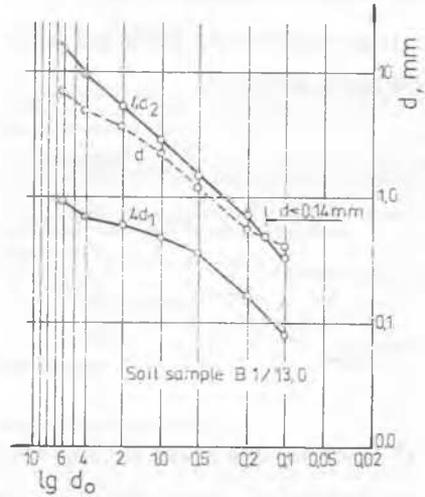
Fig.11 Result of an investigation

Our tests have proven that the sandy gravel has no self-filtering capacity and potentially about 20 per cent of the grains might be washed out from it.

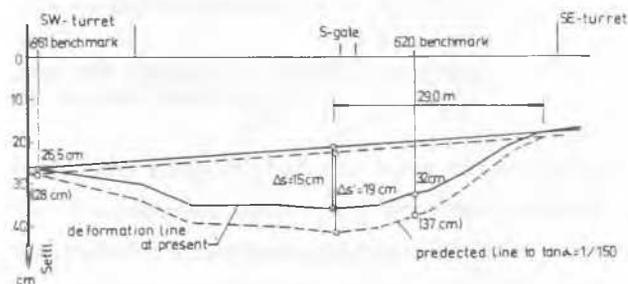
Fig. 13 Predicted deformation line to $\tan\alpha = 1/150$

Records from the longlasting observation period enable a prediction about the future performance of the building. In Fig. 13 the deformation line of the wall footing of the building's southern front is presented. Calculations show that the critical angle of deflection ($\tan\alpha = 1/150$) will be reached at a settlement of $s = 19$ cm. The corresponding deformation line can be constructed and from that curve the anticipated settlement of the bench marks can be predicted.

To stop the continuity of the settlement the loose sandy gravel has to be neutralized. Loads should be transferred to the underlying load bearing strata by means of:

- underpinning the walls by small diameter injected piles
- supporting the wall foundations by "jet-grouting"
- strengthening the loose sandy gravel by grouting.
