OCCURRENCE OF TURBID FLOWS FROM WELLS AT KHANPUR DAM

Altat Ur Rahman¹ Mansur Ahmed²

SYNOPSIS Khanpur Dam is located across Haro river which is approximately 15 Km from of Taxila. It is a dual purpose project for irrigation and municipal water supply, with gross reservoir capacity of 0.107 million acre ft. at normal reservoir elevation of 1982. The main embankment which closes the main Haro valley is 1560 ft. long at its crest and has maximum height of 167 ft. and is founded on deep alluvium (> 200 ft.) with an upstream impervious blanket.

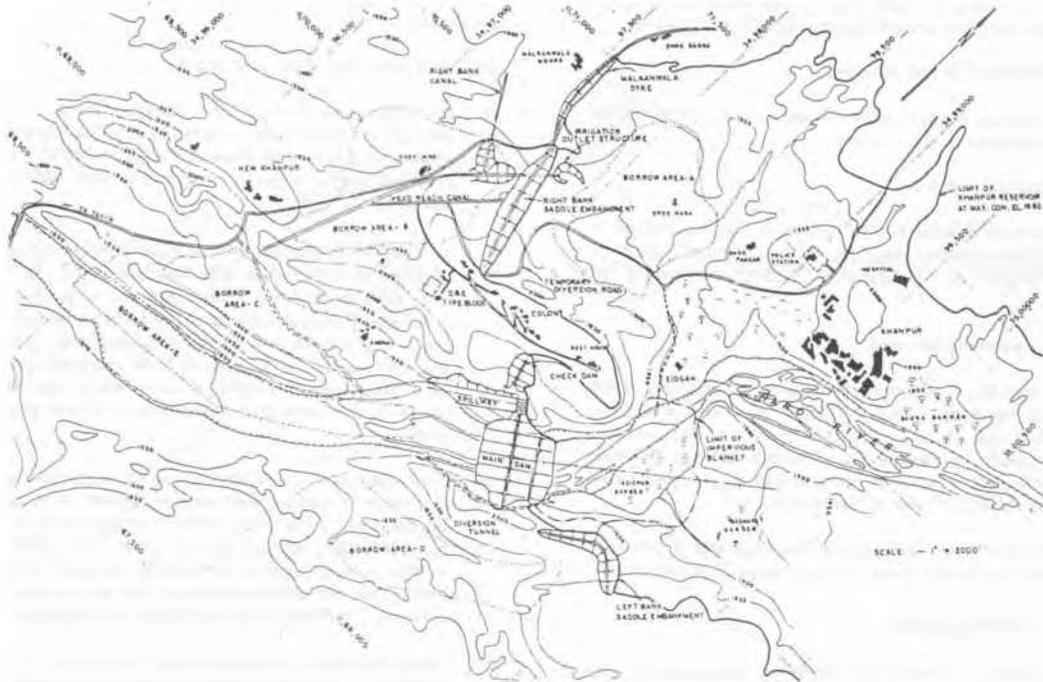
FIG. 3 Lay-out of Various Structures of Khanpur Dam

Blanket was inspected by side scan sonar survey and four minor sinkholes, were detected Figure-3 but compared to the quantity of material which came out, the volume of sinkholes was insignificant, the quantity of fines was estimated at 25,000 cubic feet (cft) from wells however considering flow from ditch etc the estimate would be 50,000 cft. The fines were finer than 80 u, consequently o73 about 250,000 cft of material of blanket/ core when processed would have produced the 50,000 cft of fines passed through wells/ ditches.

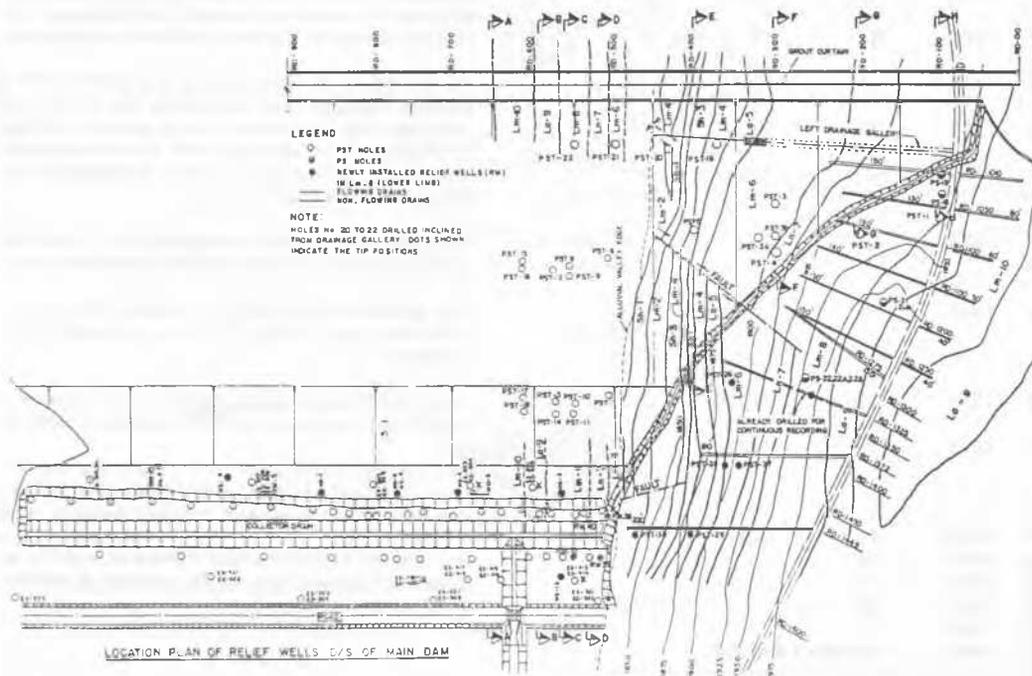
FIG. 4 Location of Drainage Wells at Khanpur Dam

- a) Possible route through the bedrock joints of left abutment through the lower limb of syncline into the limestone strata LMB day lighting below relief wells RW10 and RW37 which were the drainage wells through which the first event turbid flows occurred Fig.4.

All the filters in wells around the screen and the downstream drainage mattress have deteriorated due to the mudflows more so when the mud flow ceases. This is evident o73 from high pressures downstream of the drainage wells. No. adverse boiling or piping has happend as downstream of dam large amount of waste fill was dumped to some distance.

However the filters need rehabilitation as it would affect the seepage control features of the dam and may eventually lead to piping failure.
