CASES OF TUNNEL FAILURES IN TWO HYDRO-ELECTRIC PROJECTS

V.M. Sharma

Director
Central Soil and Materials Research Station
New Delhi, India

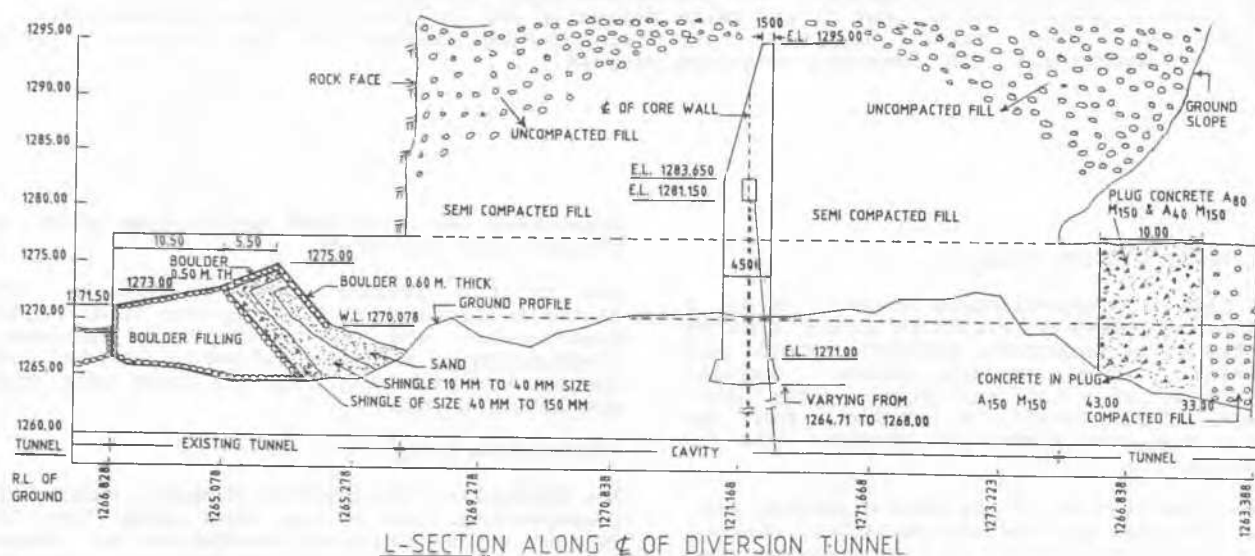
uprooted trees and debris along with it, smashing everything that came its way. Roads on either side near Gangnani village were washed out. Five to six road bridges were washed out. The diversion tunnel was daylighted for a length of about 40 m. Large cavities had been created below the sill beam of the gate and also on both sides of the tunnel inlet. The flood waters found its way into the tunnel through these cavities below the intake structure.

Following the damage to the diversion tunnel due to the flash flood, it was decided to create a barrier in front of the diversion tunnel by dumping crates filled with boulders, stones and sand bags. This had to be done before the arrival of the next monsoon flood. It was however, not found very effective and as this operation was going on in the month of May and June, 1979, it was seen that a new cavity was formed on the right side of the inlet portal of the diversion tunnel, cutting off the road. The main cavity formed in 1978 also

started to widen after the monsoon set in and further damage to the roads took place. It was then decided to divert the river water over the spillway section. A diversion channel and a coffer dam was accordingly constructed. The bulk head gate from the tunnel was removed by cutting piece by piece, and the diversion tunnel was plugged by concrete portions of the diversion tunnel which had daylighted were converted into a compacted rockfill section with a concrete core wall.
