DIFFICULTIES ARISING FROM THE INTERACTION BETWEEN THE EMBANKMENT AND THE FOUNDATION AND REMEDIAL MEASURES

E.J. Loukola

Board of Waters and Environment
Helsinki, Finland

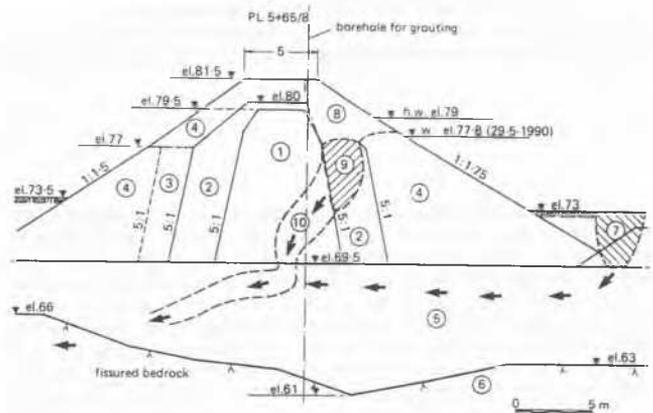
(Fig. 1), where piping occurred in a glacial till foundation and weathered bedrock. In this case, reconstruction of the dam (Fig. 2) included grouting, a bentonite clay mattress and enlargement of the core structure (Kuusiniemi 1991).

Fig. 1. Uljua earth dam. Cross section of the dam failure, where: 1 = core of glacial till; 2 = filter of sandy gravel; 3 = coarser filter; 4 = supporting rockfill; 5 = glacial till; 6 = weathered bedrock; 7 = crater; 8 = sinkhole; 9 = cement and grouting equipment; and, 10 = gravel tube.

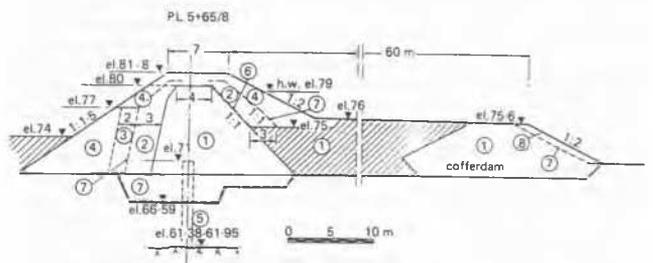
Fig. 2. Uljua earth dam. Cross section of the reconstructed dam, where: 1 = core of glacial till; 2 = filter of sandy gravel; 3 = coarser filter; 4 = supporting rockfill; 5 = diaphragm wall; 6 = bentonite clay mattress; 7 = geotextile; and, 8 = riprap.
