The closure of a leakage in the sealing system of a dyke

H.ARMBRUSTER, Federal Institute of Waterway Engineering (BAW), Karlsruhe, FRG

SYNOPSIS: The measurement of hydraulic, thermal and geoelectrical fields makes the detection of leakage points possible in embankments, i.e. their effects on the relevant area. The example given describes a case of damage, where the position on the leakage in an embankment on the water-side was known, but where the measurements were necessary to ascertain the length of the stretch requiring repairs and to establish the success of the measures taken. The repairs were carried out with the help of a hydro-cut diaphragm wall at a medium depth of 25 m.

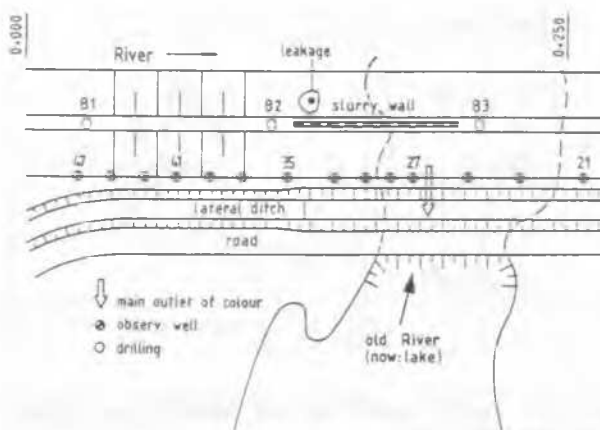
fig. 1. Layout of the dam, observation tubes

In the summer of 1987, when the damming was partly reduced (fig. 1), a sinking hole was found in the water-side of the embankment, into which approximately 10 l/s gurgled through. On the dry side of the embankment in the air no outflow of water could be seen, either at the dam toe or in the lateral ditch, so that a concentrated flow over a short distance was not expected, however, the possibility of a water leak via a possible pipe in the lake nearby could not be excluded. Consequently a decision was made in-situ to fill in fine material on the water-side, in order to plug the pipe, which obviously existed at least in some areas. In the next 5 days approximately 5 m³ sand were washed into the sinking hole.

The position of the temporary wall (length 70 m) can be seen in figure 1. The construction of the wall took place from 19.10 - 29.10.87.

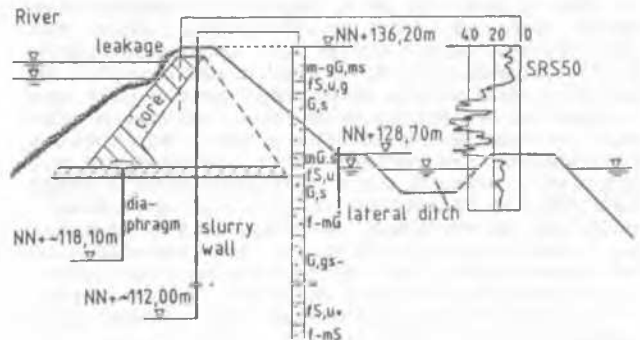
fig. 2. Cross section with drilling and driving rod tests

The lateral dam of the Rhine, which is about 10 m high at the point observed (fig. 1,2) was

When the leakage occurred observation tubes 21, 23, 25 and 27 (fig. 1,2) already existed, which measure the water level and the temperatures in the berm (pipes approx. 4 m deep). Afterwards pipes 29 to 41 were driven into the holes prepared by driving rod tests. Further driving rod tests were carried out on the crest of the dam in a 2 m grid on both sides of the seepage point. While the filling-in was still being carried out, a colour tracer (Uranin) was inserted into the sinking hole, which already came out after 2 hours at one point in the lateral ditch (fig. 1), and after 3 hours however at several points. No colour tracer was observed in the lake.

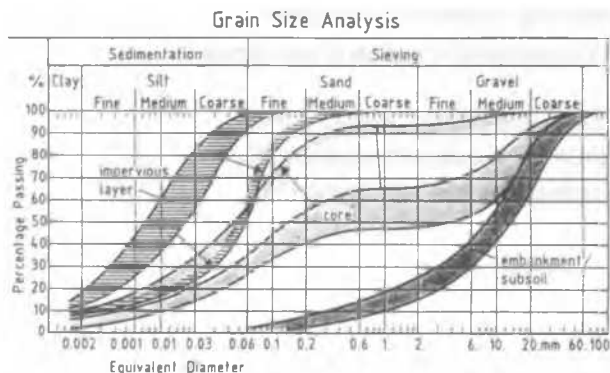
fig. 3. Grain distribution curves of the dam and subsoil

The sealing of the upper gravel layer was achieved by means of a diaphragm wall, which was sunk from the base of the dam, before the construction of the dam. A connection between the wall and the core was made by laying the head of the wall bare. The embankment consists of the sandy gravel in the subsoil (fig. 3).

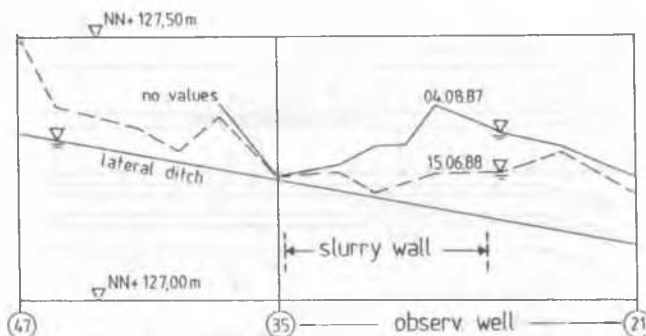
fig. 4. Water table of the observation tubes along the dam toe

The measurements of the water table and the temperatures were continued on the extended system in order to determine the success of the sealing measures (fig. 4). The longitudinal section (compare before and after) shows that the phreatic line has dropped between pipes 23 and 33. However, the lowering of the water level at the end of September 1987 (fig. 5) is due to the fact that all vegetation had been cleared away from the lateral ditch and so the water level sank.

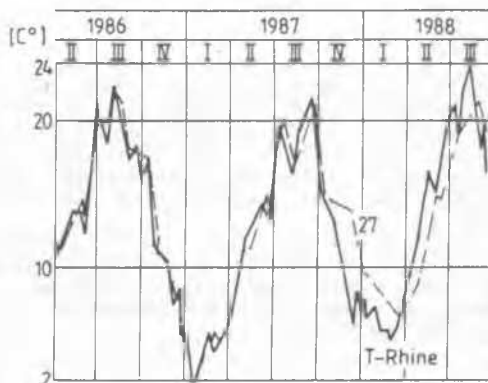
fig. 6. Temperature progress lines of the Rhine and of tube 27

There is also a change in the course of the temperature, which in the course of time (fig. 6) is clearer than in the longitudinal section. The temperatures at a depth of 4 m below the ground without any sealing are very strongly influenced by the temperature course of the Rhine (slight phase-shifting, a slight differences in the reduction in both amplitudes). After the construction of the wall a clear change in the temperature behaviour can be seen. The amplitudes in the measuring pipes become smaller, the extremes are shifted in phases by about one month (by the most at measuring tube 29 (fig. 7). The sinking of the water table in the lateral ditch resulted in a temperature jump in the measuring pipes. However, there are no typical tendencies after a repair (phase shifting, jump in amplitude).

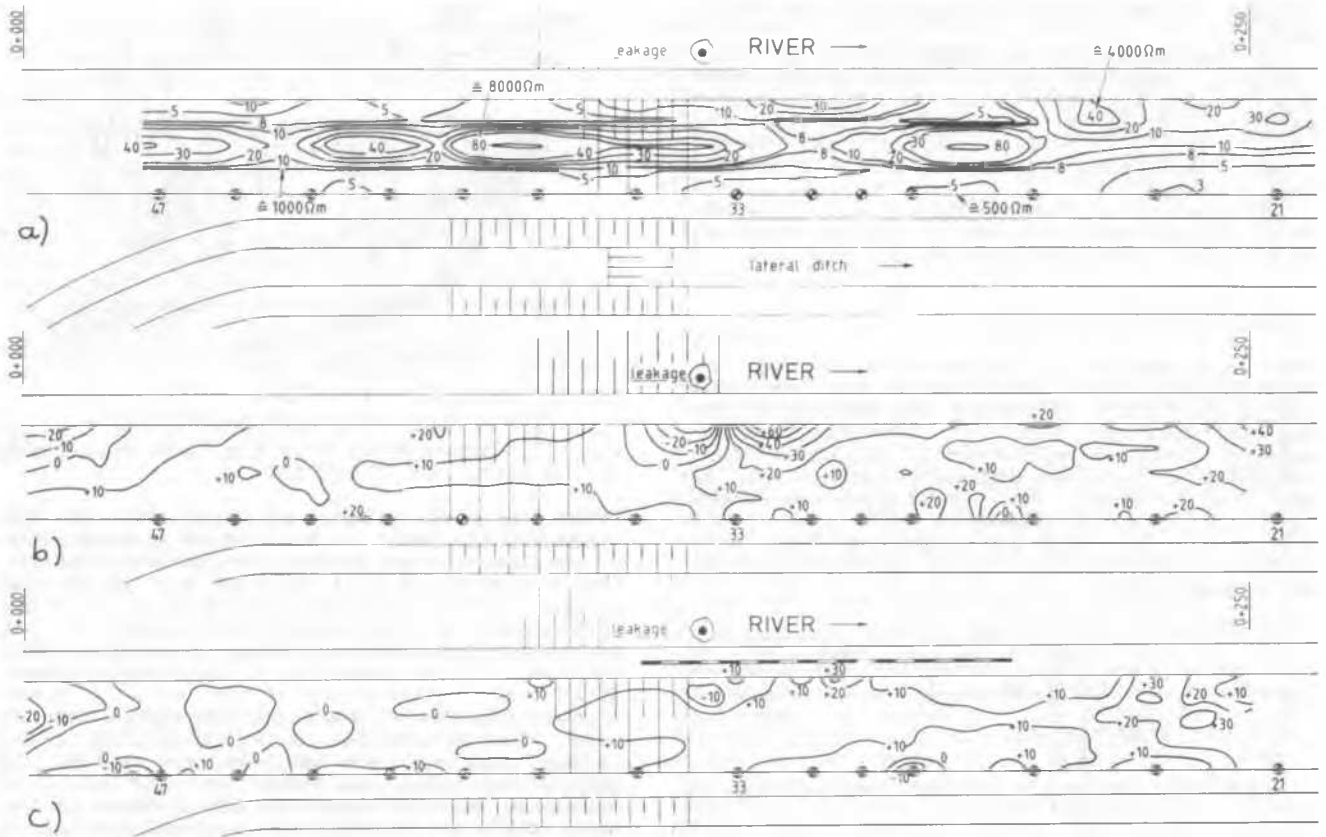
fig. 8. Resistivity and self-potentials: a) resistivity (a = 10 m), measured on 23.9.87 b) self-potentials, measured on 13.10.87 before the construction of the wall c) self-potentials, measured on 27.9.88 after the construction of the wall

The measurements of the electrical resistance were carried out for 2 different depths of penetration, one of which is shown. Figure 8 a indicates clearly the inhomogeneity of the dam subsoil. The high values (up to 8000 Ω m) clearly indicate dry areas without fine material, which are to be found most, where the colour in the tracer test reached the lateral ditch first. The low values (800 Ω m) in the middle of the embankment indicate an area with far more finely grained dam material, which is attached in a lenticular manner.

The measurements of the electrical self-potentials before the construction of the wall (fig. 8b) clearly show an anomaly in the form of a dipole with potentials between -40mV and +60mV. Numerical modelling according to Corwin/Wilt (1988) using the parameter in figure 8a give an average position of the leak of 6 m below the ground. The calculated results given by the two-dimensional schematic model suggests that the seep area is situated between 2m upto 10 m below the dam crest (high-permeability leakage pathways). The measurements taken about 1 year after the construction of the wall (fig. 8c) no longer show this distinctive anomaly (fig. 8b) and the longitudinal section of the dam crest show fig. 9. This strong percolation due to the leak has thus disappeared due to the construction of the wall.
