# A landslide stabilized by an unloading excavation

W.E.JUBIEN, CN Rail, Edmonton, Alberta, Canada

B.C.ABBOTT, CN Rail, Kamloops, British Columbia, Canada

**SYNOPSIS:** A natural area of unstable hillside on the north shore of Kamloops Lake has affected train traffic on the Canadian National Railways main line for many years. The movements have a history of starting and stopping without an obvious cause. In 1985 after the rate of movement gradually increased over 3 seasons an unloading excavation was made at the top of the active unstable zone. This excavation stabilized the track movement without upsetting the stability of a zone of ancient landsliding located above the excavation.

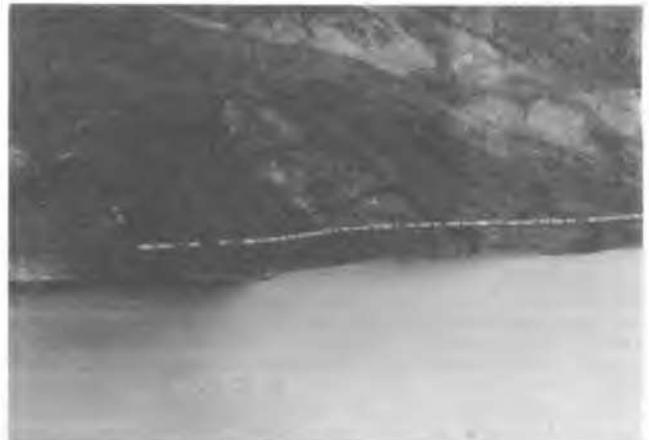
Figure 1. General View of the Site

At Mile 15.8 Ashcroft Subdivision the CN Rail track is hemmed in between Kamloops lake and a low mountain ridge to the north. A general view of the site is shown on Fig. 1. An area of landslide topography between two rock outcrops extends northward from the lake on an average slope of 17 degrees to a height of 130 meters above lake level. Above the

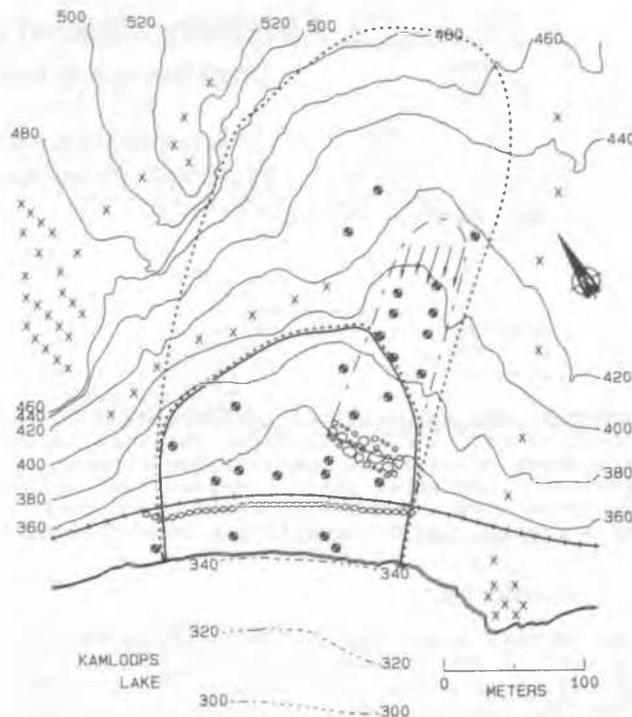
FIG 2 PLAN OF SLIDE AREA

1. An area of ancient landslide topography shown on Fig. 2 was identified in the air photographs.

Late in 1982 after 4 years of stable conditions the track started to move again. A crack was found on the ground surface at the location identified on Fig. 2 as the boundary of the area of active landsliding. This crack did not extend around the entire area identified as landslide topography on the air photographs. It appeared that there was differential movement within the landslide terrain.

The location of all borings is shown on Fig. 2.

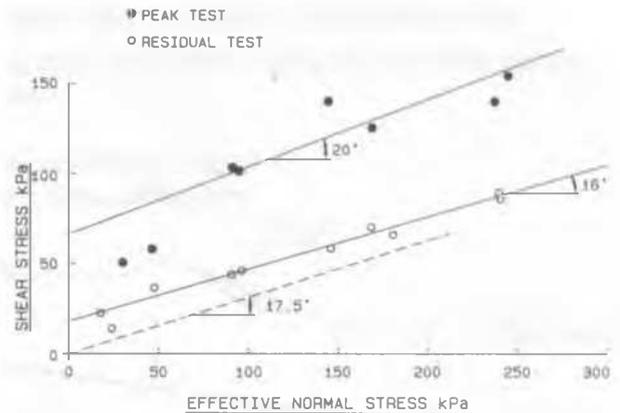
FIG 4 DIRECT SHEAR TEST

The results of consolidated drained direct shear tests on samples taken from near the shear zone are shown in Figure 4. Peak and residual tests were run on undisturbed and remolded samples respectively. The laboratory conducting the tests reported that true residual conditions may not have been achieved during testing. Residual strength parameters are therefore viewed with some skepticism.

1. As shown in Fig. 4 the back calculated friction envelope lies below the laboratory

measured residual strength envelope for all normal stresses significant in the analysis.

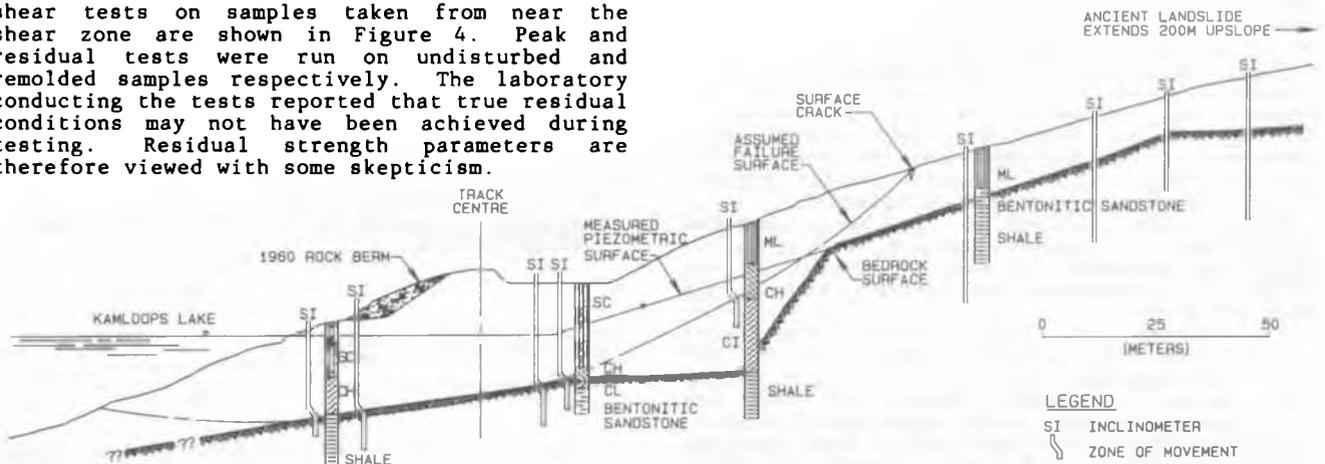
FIG. 3 PROFILE OF LANDSLIDE

2. The results of subsurface exploration are illustrated in Fig. 3.

Surficial soils at the site are clayey sands and silts trending to highly plastic clays with depth. Traces of gravel and fragments of angular broken rock are evident throughout. The underlying bedrock was identified as shale and bentonitic sandstone. Particularly significant is an abrupt rise in the bedrock surface about 70 meters north of the track. This rise roughly coincides with the boundary between the unstable and stable sections of the ancient landslide.

The model failure surface selected runs from a visible scarp through a series of points defined by inclinometers to an arbitrarily chosen toe beneath Kamloops Lake. As shown in Fig. No. 3, the failure surface was characterized by a classic circular arc.

In view of the history of ground movement at the site, effective cohesion along the model failure surface was assumed to be zero. Back calculation employing the simplified Bishop technique yielded an effective friction angle of 17.5°. Although the back calculated friction angle appears high relative to the laboratory measured residual strength, a value of 17.5° was employed in all subsequent analyses.
