Assessment of risk for road widened over unstable rock slope

I.J.A.BRACKLEY, Steffen, Robertson and Kirsten Inc., Johannesburg, South Africa

SYNOPSIS : During the improvement of a road on the south coast of South Africa it was necessary to extend the carriageway over a rock slope with a history of instability. The road widening was achieved by the construction of half-viaducts supported on piers founded on bedrock.

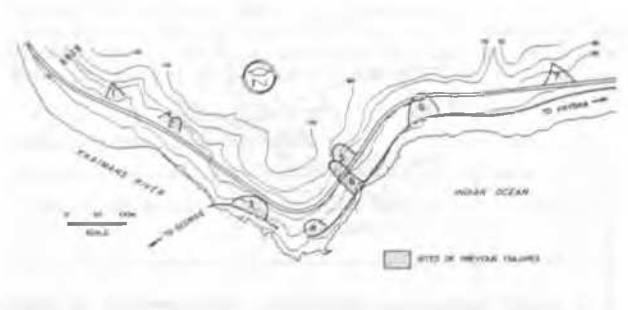
Fig 3 : Plan showing previous slope failures

Several slope failures have occurred in the recent past, and an inspection of air photos has revealed additional old failures (Fig 3). It is probable that most, if not all, of these failures have been caused by the construction of the road or the railway, either because of the cutting-back of the slope or the changes in surface water drainage.

Of the eight failures (Fig 3), the two most significant are considered to be the recent failures 6 and 1. The most recent (6) occurred in 1981 after heavy rains, causing extensive damage to the road and the railway line. The slip took place through the weathered zone, leaving an exposed scoured surface of competent phyllite, and the road was reinstated by constructing a retaining wall directly upon this surface. Fig 7 shows a section through the failed slope.

Failure 2 was a recent, fairly large, steep-angled slip. Although there is evidence of failure through some intact material, the rock in this area is soft, micaceous and highly weathered. 200 m west is a recent, large three-plane wedge (1), also above the road. The plane along which failure has occurred is the bedding, with two major joint sets providing release surfaces.

An old and large failure surface exists between the road and the railway line (8). The surface itself is no longer exposed, but from the slope orientation and the present slope angle, it is likely to have been a bedding plane failure. Above the road, in the vicinity of this slip, a recent shallow slip on bedding is evident. A minor proportion of the failure appears to have passed through intact rock (5).

An old, large, shallow-seated failure between the road and the railway line (3) gives evidence of recent small failures on the edges of the old surface. The dip direction of bedding relative to the slope is oblique, and failure is thus not considered to be bedding-related. Evidence from the recent failures and the shallow nature of the original surface suggests that failure occurred through soil and highly-weathered rock only.

A fairly small planar slip (7) has taken place in moderately to highly-weathered quartzite at the eastern end of the section.

Finally, above the entrance to the railway tunnel, a small shallow failure of highly-weathered rock has resulted from a localised steepening of the bedding dip angle (4).

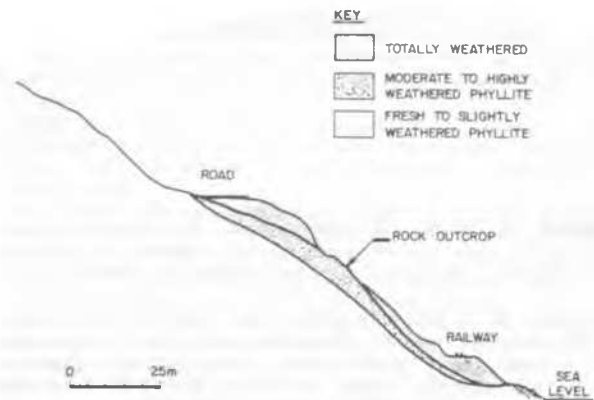
Fig 6 : Typical section through phyllite slope

The rock slope varies in geometry, but the surface is generally covered by a loose boulder layer in a soil matrix. Part of this zone is a natural scree, resting on loose material which has weathered in situ, but there is also debris from the original road cuttings. A typical section through the phyllite slope is shown in Fig 6.

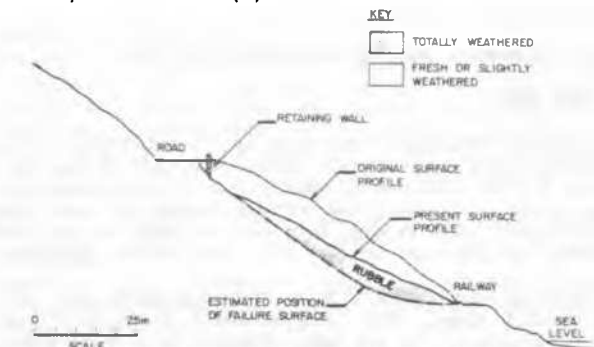
Fig 7 : Section through failure (6 on Fig 3).

Three of the previous failures were studied (6, 2 and 3 on Fig 3). The surface topography was surveyed and the position of the failure surface estimated. The section for failure 6 is shown in Fig 7. The mode of failure was similar in all three cases, and was simulated using the Simplified Method of Janbu (1954) in a two-dimensional analysis. Strength parameters were varied until a factor of safety of unity was obtained. The pore pressure parameter was 0,2,

Location of Failure (Fig 3)	Effective Cohesion (kPa)	Effective Friction angle
6	0	35
3	15	38
2	10	38

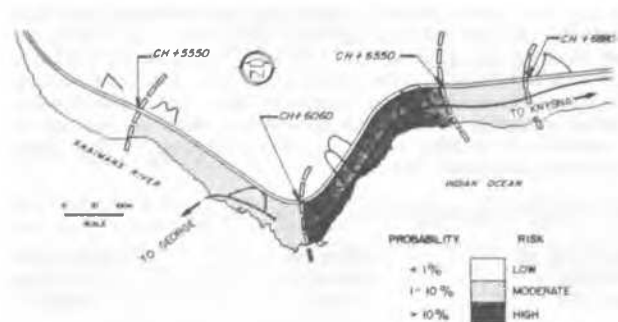
Fig 9 : Hazard plan

a plan was derived, delineating the different hazard zones below the road (Fig 9). It will be observed that the area of high risk is the phyllite slope, facing toward the south-east, in the same direction as the dip of the bedding joints.

The five zones shown on Fig 9 are listed with the factors relevant to the determination of the hazard in Table 3.

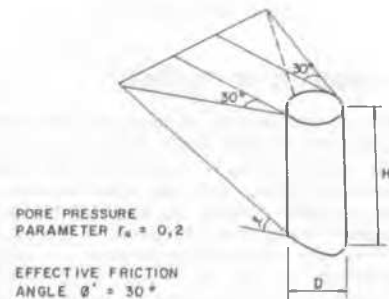
Fig 10 : Wedge of loose material against pier

It has been stated that the piers would be founded on competent bedrock, below the loose rock and highly-weathered phyllite, implying that the common shallow failures would not pass beneath the base of a pier. Nevertheless, a slide or a movement of the superficial material could apply a load to the back of a pier. The force exerted by sliding loose rock was calculated assuming that it would form a wedge pressing against the back of the pier (Fig 10).

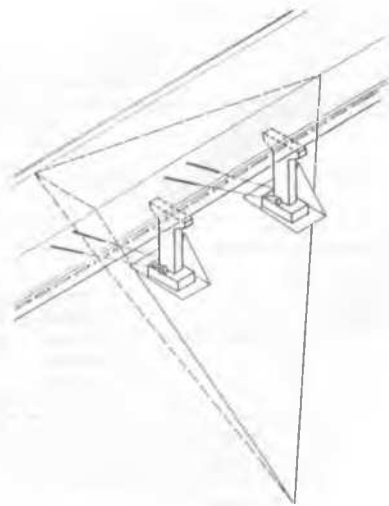
Fig 11 : Potential, large, deep-seated wedge failure, involving two piers

Fig 11 shows a large potential wedge failure involving two piers on the south-east slope. It was calculated that the largest wedge involving a single pier would require an anchor restraint of approximately 300 tonnes to ensure a factor of safety of 1,5 for the wedge as a whole. It was considered that the wedge would not move monolithically, instead dividing along the ubiquitous vertical joints. This implied that to be effective in preventing the development of a failure, anchor restraint would need to be applied down the slope, and not merely at the pier base itself. It also implied, on the other hand, that the piers themselves could be protected by a lesser restraint of approximately 120 tonnes applied at the position of the bases, if a failure downslope of the bases were permissible.

Various wedges involving one or two piers and two or three joint sets were analysed, with the required anchor force being in the range 100 to 200 tonnes. These forces were those required to retain the piers in position, but not necessarily to prevent slope failures. It was accepted that a failure could damage the road between piers, but that the design restraint would prevent the failure of the pier bases. This was considered to be the correct engineering solution from the economic and the ecological point of view. The application of large numbers of anchors on the face of the slope would have entailed the destruction of a large part of the indigenous vegetation, which would be unlikely to recover.

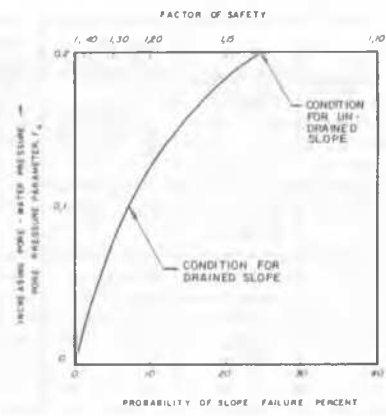
Fig 13 : Effect of water pressure within the slope on the probability of failure

It has been mentioned that increased pore water pressures probably played a part in the previous failures, and the effects of an increasing water pressure were noted in Table 2. Fig 13 shows graphically the relationship between the pore pressure parameter and the probability of slope failure. Using the admittedly arbitrary assertion that the installation of adequate drains in the slope will reduce the maximum pore pressure parameter from 0,2 to 0,1, it follows that a high

probability of failure would reduce to an acceptable value of below 10%. However debatable the assertion, it is clear that effective surface and subsoil drainage will considerably reduce the risk failure, and design recommendations to this effect were made.
