Deformations in a weathered rock crust next to a dam

G.STEFANOV, Professor, University of Architecture and Civil Engineering, Sofia, Bulgaria
 N.KOSSEV, Professor, University of Architecture and Civil Engineering, Sofia, Bulgaria
 T.GERMANOV, Professor, University of Architecture and Civil Engineering, Sofia, Bulgaria

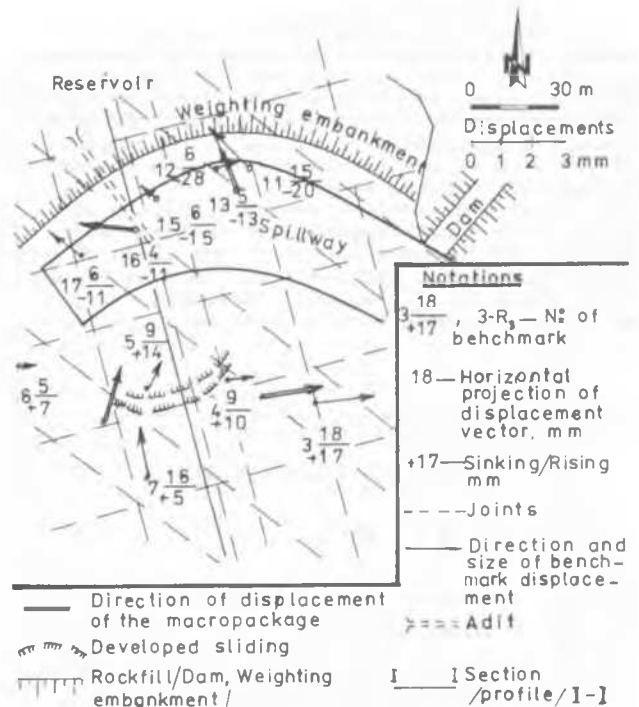
a very wide range in the adit - from 28° to 61°. The layers in the flysch complex and the sedimentary cracks have a dip direction opposite to the slope inclination (towards the massive). Three systems of tectonic cracks were established (Fig. 2), one of which has a strike azimuth, coinciding with that of the sedimentary cracks. The tectonic cracks have an inclination of 75° to 85° and a dip towards the river.

Figure 2. Cracks in the massive and displacement of the benchmarks

A network of 50 benchmarks was laid to survey the deformations in the spillway blocks, the retaining walls and the bottom of discharge canal and the area around it (Fig. 2). The measurements conducted as early as 1982 indicate a relative stabilization of the displacements. Small visible movements as the benchmarks only on the spillway slope, and a slight tilting of some of the blocks towards the reservoir are noted. The size and the inclination of the displacement vector for a 5 year period of observation of the separate benchmarks are given in Table III.

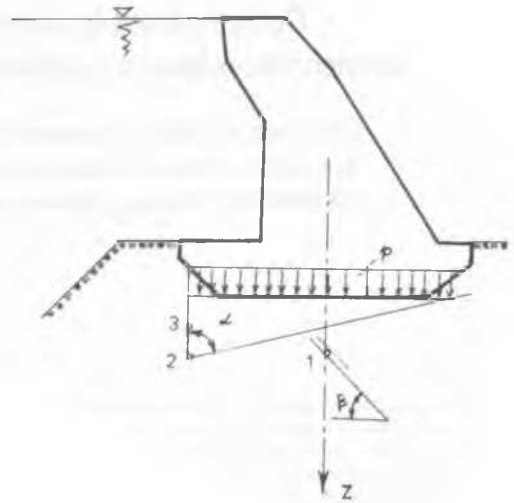
The spillway structure was erected in 1979. Two years later deformations were established, consisting in cracking and displacement of some blocks and of the discharge canal bottom. The basic cause of these deformations was the incorrect grouting techniques adopted for the seepage control curtain under the spillway and the areal cementation. Reasons for this assertion were also the observations after the suspension of the grouting works, which indicates a relative stabilization of the deformations and the lack of new cracks in the slab and in the spillway blocks.

The first observations showed a tilting of the spillway blocks towards the upstream side. This tilting is possible due to non-uniform, although very small, deformations. This is proven by the checking of the local strength, expressed by the strength condition of Mohr-Coulomb:

Figure 3. Section across the spillway

Three points are considered - under the edge, and in the spillway axis - according to Fig. 3. The calculation results are given in Table I.

The results of Table I indicate that under the adopted prerequisites the condition of local stability nearly missed being fulfilled. This confirms our assumption that the tilting of the spillway blocks was possible because of the minimum deformations of the subgrade due to insufficient local strength in the cracks with clay filler.

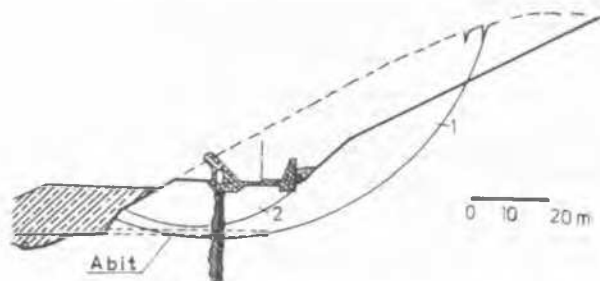
The stability of the circular cylindrical surface passing through the edge of the spillway structure was checked (Fig. 4). The condition at rapid emptying of the reservoir (i.e. complete saturation of the massive) is considered and the effect of the seismic forces is taken into account.

The calculations give a safety coefficient $F = 1.02$ without weighting embankment and $F = 2.0$ with embankment consisting of an ad-

To prove the general slope stability an investigation was carried out along the circular cylindrical slip surfaces (Fig. 4) based on the landslide and the data from the adit. The safety coefficients for $\varphi = 25.75^\circ$ and $c = 66\text{kPa}$, established with shear tests of rock material in a large cassette, and for $\varphi = 25.75^\circ$ and $c = 0$, are given in Table II.

In the investigation of the second case (Table II) the weighting embankment erected in the slope under the spillway is taken into account. Table II shows that the construction works have not decreased the slope stability in the direction under consideration. The condition of the natural slope was close to the limit state.

Figure 4. Section I - I for stability calculation

ditional upstream rockfill. On the basis of the calculations it is recommended to erect such a rockfill as an obligatory condition guaranteeing the local stability of the structure.

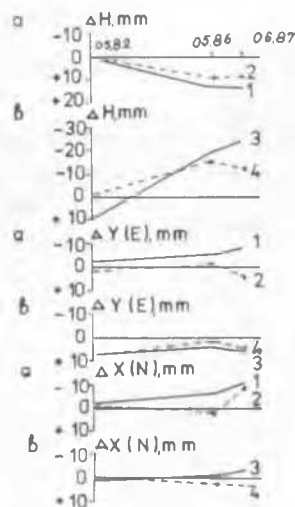
Figure 5. Displacement of benchmark groups
a - Massive; b - Spillway; E - East; N - North; Arithmetic average:
1 - for benchmarks R_3 and R_4 ;
2 - for benchmarks R_5 , R_6 and R_7
3 - for benchmarks R_{11} and R_{12}
4 - for benchmarks R_{14} ; R_{16} ; R_{17} .

In order to characterize the movement of the micropackets in the slope, the benchmarks are grouped according to their direction of movement. The displacement of the benchmarks during the period of observation is shown in Fig. 5. Fig. 2 gives the sum of the horizontal projections of the benchmark displacement vectors and the direction of movement of the vector groups. The cracks in the massive, the deformations in the spillway and the benchmark displacement direction allow the demarcation in the rock massive of zone of different character and direction of movement of the macropackets (Fig. 6).

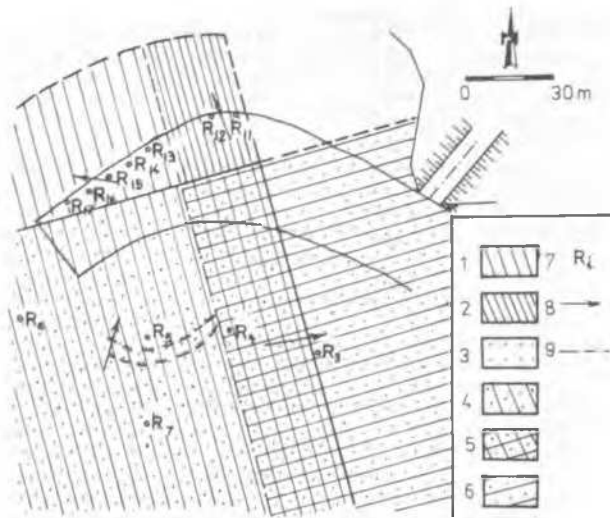
Figure 6. Zoning after the character of the displacement of the rock packets.
 1 - Zone of rising; 2 - Zone of more intensive rising; 3 - Zone of sinking; 4 - Active rock packet with north-northwestward movement; 5 - Active rock packet with displacement varying in time and in space: north-northwestward and east-north-eastward; 6 - Packet with east-north-eastward displacement; 7 - Benchmark No.; 8 - Displacement direction of the rock packets after the indications of the benchmarks; 9 - Probable boundary of the zones of rising and eastward displacement

(1) Deep gravitational movements (creeping) have existed and continue to take place in the weathered crust of the massive in the spillway slope. These have no direct effect on the stability of the dam and its appurtenant structures. Certain separate deformations are only temporary.

(2) The construction works have not impaired the stability of the slope as a whole. Just the opposite - the dam erected perpendicularly to the slope has produced a favourable effect for slowing down and stopping the slope creeping. This effect is reinforced by the arched-shaped layout of the dam. A positive effect on the slope stability has been exerted also by the fill erected upstream of the spillway. These factors have changed the creep direction of the rock packets towards the river into a new direction along the river flow, with a probable slowing down and final stabilization.

(4) In case there is any danger for the spillway, it will be necessary to remove rock masses from the slope in the area of the active rock packets (Fig. 6) and to increase the resistance against rising and horizontal displacement eastwards, possibly by anchoring.
