Monitoring rock slopes at Loktak project India

C.SUDHINDRA, Central Soil and Materials Research Station, New Delhi, India

SYNOPSIS: The slopes at Loktak hydro-electric project located in the north eastern Himalayan region have been failing ever since the construction started. Several remedial measures were taken up including monitoring their performance with the help of inclinometer. Significant movement has been recorded over a period of last two years. The problem of slope stability and its monitoring are presented in this paper.

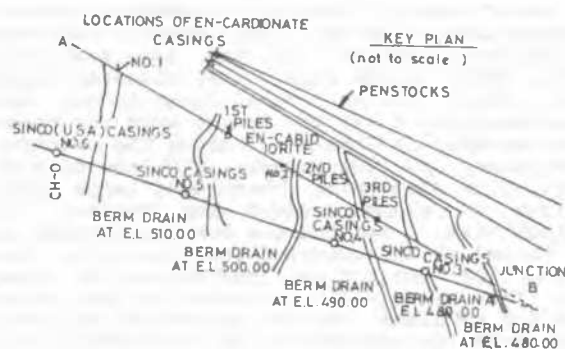
Figure 2. Key plan for inclinometer casings in penstock area.

A total of eight sets of measurements including initial set covering over a period of 2 years have been presented in this paper. The SINCO casings were installed in boreholes numbers 3 to 6 in Penstock area between anchor blocks 11 and 12 as shown in key plan (Figure 2). The geological section along BC is shown in Figure 3 along with depth and position of the casings.

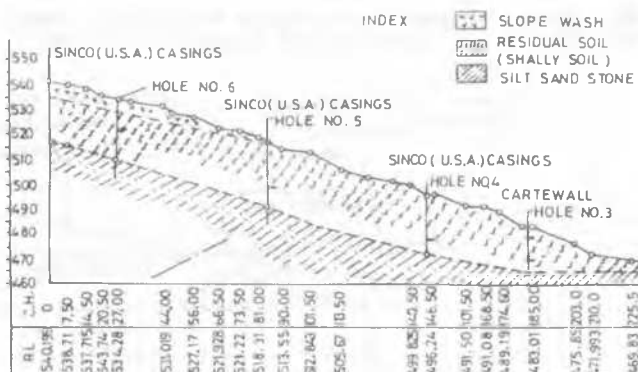
Figure 3. Geological section along BC.

The net displacements at specific depths have been arrived at by the two displacement vectors from A+A- and B+B- directions. Figure 8 shows the variation of the net displacement with respect to time which shows that the displacements have increased with time. The maximum movement recorded over a period of 2 years (excluding hole 3 due to failure) is about 24mm which occurred at a depth of 12m in casing no. 6. The depths at which maximum displacement has taken place, have been marked in Figure 3.

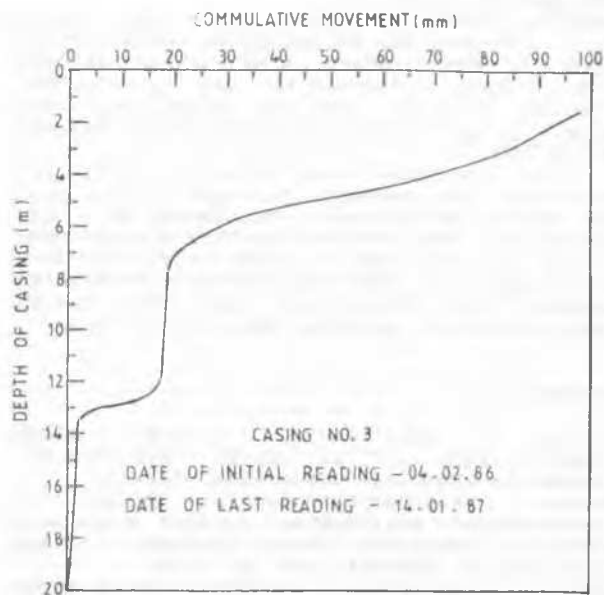
Figure 4. Cumulative movement versus depth of casing for borehole 3.

Figures 4 to 7 show the resultant cumulative displacement recorded at various depths in boreholes 3, 4, 5 and 6 respectively. The displacements have been computed based on the difference between the present and initial set of readings for two mutually perpendicular directions. The resultant displacements have been arrived at by summing up vectorially the displacements recorded in two directions. The resultant displacements have been added up from the bottom to the top of the casing for getting the cumulative movement. The inclinometer probe got stuck at 4m depth in borehole 3 (the casing nearest to the powerhouse) indicating significant movement around this depth. During the earlier observations, the maximum movements in this casing were noted at the depth of 4.5m and 12.5m which apparently has prevented the probe from going down. A small slip on the surface had also occurred in this area during the rainy season of 1987. The data obtained from this casing are shown in Figure 4 while Figures 5 to 7 show these obtained from other three casings.

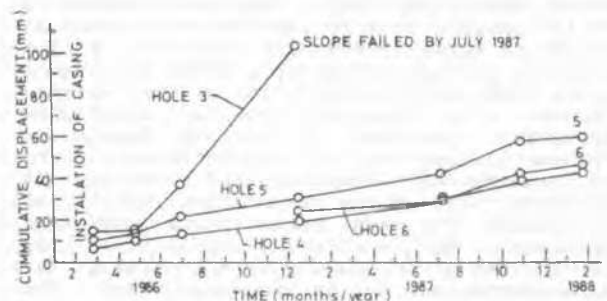
Figure 9. Cumulative displacement versus time plot for all casings.

The net cumulative displacements with respect to time have been shown in Figure 9. The maximum movement of the order of 103 mm has been noted in casing 3. It is also seen from the observation that the least movement is noted in casing 6.

From the observations of the inclinometer system carried out by CSMRS, it was established that there are positive indications of movement in the penstock area. The maximum displacement at a particular depth was of the order of 25mm and a cylindrical surface appeared to be developing. The rate of movement over the period also increased. Corrective measures were therefore called for to reduce further movements.
