## Crest sinkholes related to the collapse of loose material upon wetting

**SYNOPSIS:** During first reservoir filling, three sinkholes (2 to 3 m deep) developed along the crest of two large embankment dams of the La Grande Complex, Phase I. Their occurrence is clearly related to the collapse upon wetting of localized areas of poorly compacted unsaturated materials adjacent to the instrumentation riser pipes. Instrument data and test results give a clear picture of the in situ progressive collapse of the soil as well its magnitude.

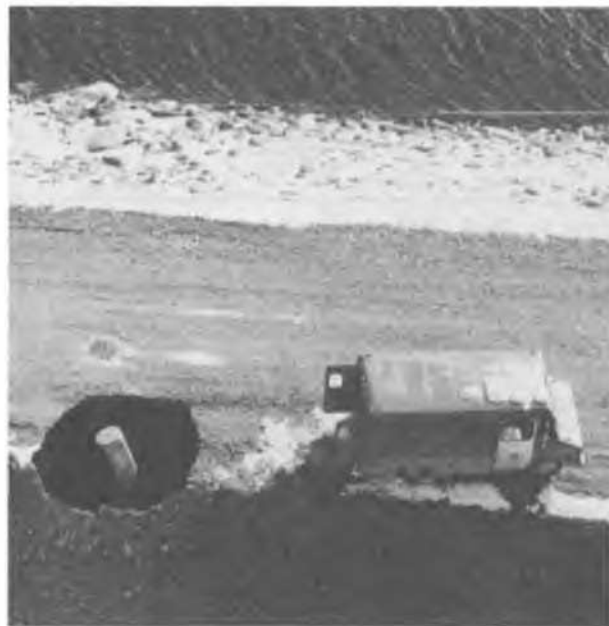
In October 1983, at the end of the LG 4 reservoir filling, a sinkhole appeared on the crest of the QA-8 dyke downstream of the center line involving some 30 m<sup>3</sup> of material (Fig. 1). The dyke, founded on bedrock, is designed with a central till core and granular filters and shells. The sinkhole was located on the highest section (92 m) of the embankment, near the edge of an instrument island. A sharp reaction of the piezometers (2 m rise) and of the inclinometer (Fig. 2) indicated that the collapse affected the core to a depth of 55 meters below the crest.

Although similar sinkholes occurred with the same type of glacial till over untreated fissured rock foundations at the Churchill Falls Project (Seemel and al.), such an internal erosion process was rejected after analysis as the cause of the QA-8 sinkhole. As no deficiency was found in the quality and placement procedure of the filter, the most probable cause was the one related to the lack of compaction of partly saturated material which would have collapsed upon wetting due to reservoir filling. The location of the sinkhole in the instrument island was a very strong clue to the relationship between the phenomena and its cause.

Figure 1. QA-8 dyke - Crest sinkhole and raiser pipe.

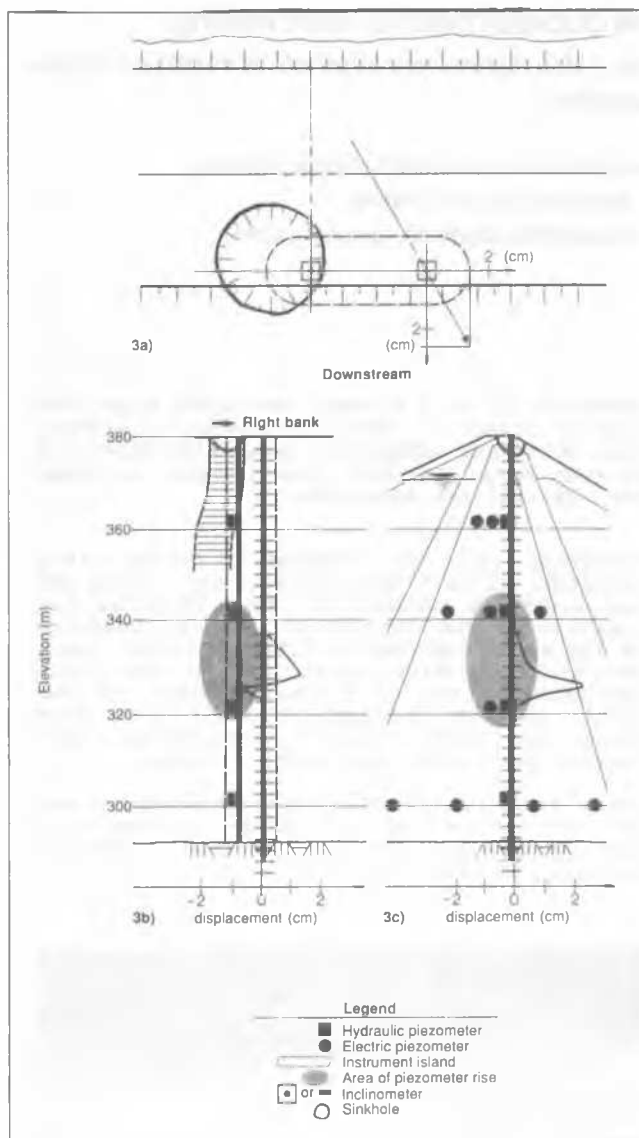
Figure 2. QA-8 Sinkhole - Instrument Reaction: Plane view, Longitudinal section, Transverse section.

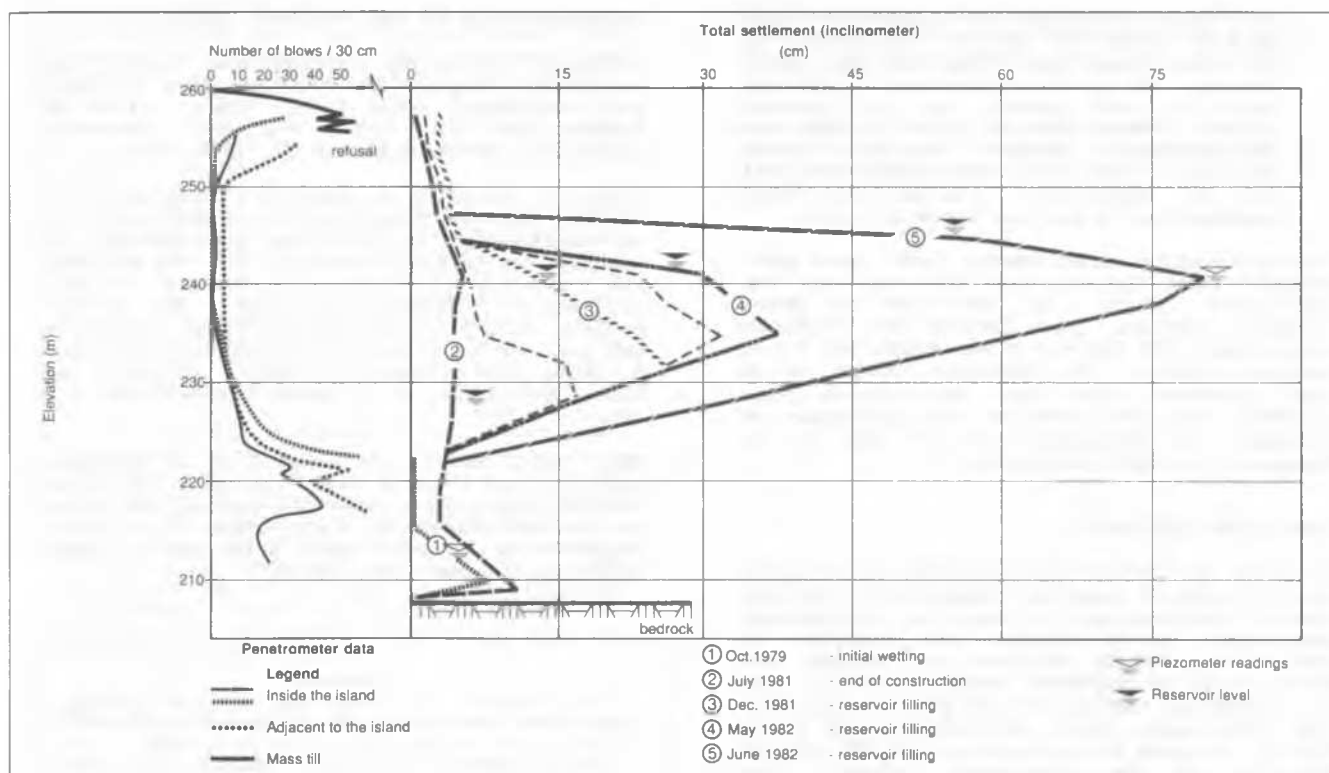
The instrument data which best illustrated the collapse process was obtained from the TA-10 dyke inclinometer (Fig. 3). This embankment, with a till core and granular shoulders, has two instrument islands. The protection islands were built over a 1.5 m radius around the instruments, with the same material as the surrounding till but with the following modifications: the gradation size limit was 75 mm, the compaction was to be made in thin lifts of 150 mm using a vibratory plate or small roller. In addition, a finer material (max 19 mm) was placed on a 150 mm radius around the inclinometer tube to limit damage caused by coarse material along the inclinometer tube. The instrument islands were built one meter above the surrounding fill, offering a good protection for the instruments against heavy construction equipment.

When reservoir filling started, the inclinometer showed a rather peculiar behaviour (Fig. 3):

- The first wetting of the core occurred in 1979 during the construction period. This affected the base of the core above the rock foundation, between elevation 207 and 213 m and a settlement of 90 mm occurred while the overlying material between elevations 213 and 222 m settled by much less and never collapsed (penetration testing in 1986 showed the existence of arching).
- Inclinometer data taken between June 1981 and June 1982 shows the progressive collapse of the column accompanied by a loosening of the upper part, during reservoir filling (Fig. 4). The collapse and reconsolidation of the collapsed material reach a strain equal in magnitude to 5%. The rupture of the inclinometer indicated possible voids of 80 cm in the top of the island.

Figure 3. TA-10 - Penetrometer and Inclinator data.

- Five dynamic penetration tests were done in 1984 at TA-10, one as a reference in the mass till, away from the instrument islands, one in the piezometer island and three in and around the inclinometer island. These results (Fig. 3) show for the instrument island, a radically lower resistance than the surrounding mass till and a resistance profile in good agreement with the inclinometer data.

The surrounding penetrometer tests show good evidence that the collapse affected only the instrument island. At the time of penetrometer testing, just before the sinkhole occurrence, the top 4,5 m was supported by an arching effect. The sinkhole volume is in good agreement with the inclinometer settlement data and confirm the magnitude of collapse or settlement of 1% and 5% as measured in other locations.

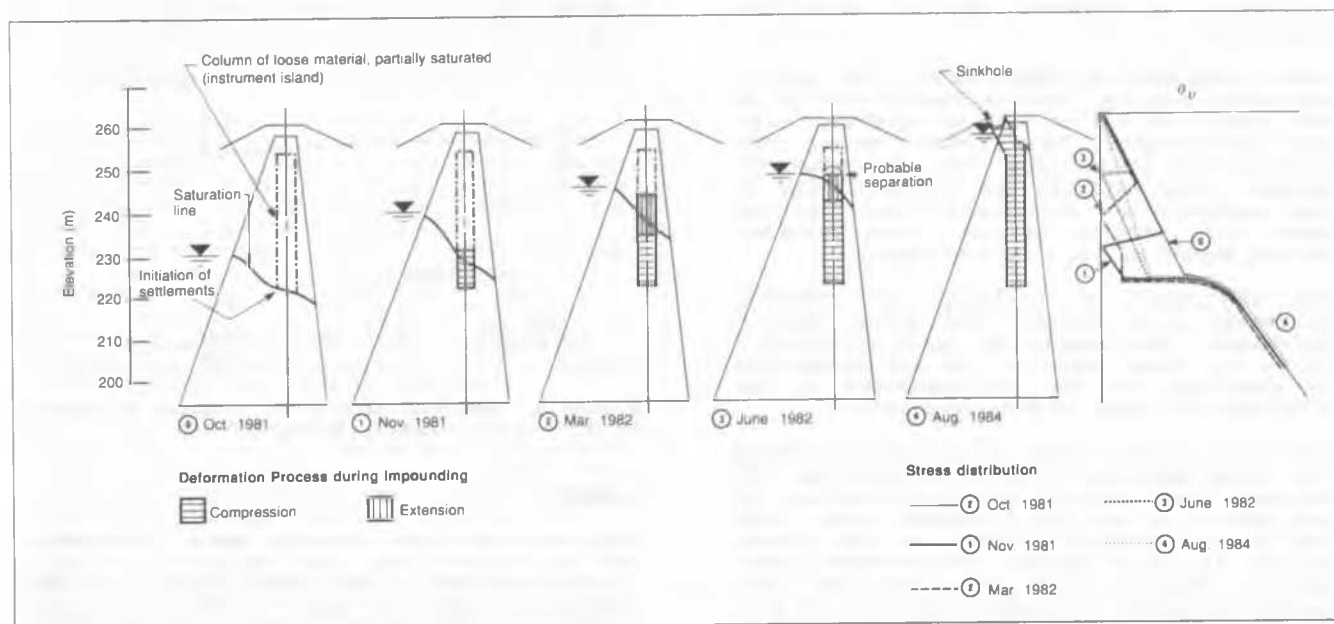
Figure 4. TA-10 Dyke - Schema of Movements and Stress distribution upon wetting.

Figure 4 presents a schematic interpretation of the instrument protection island behaviour as the reservoir filling was progressing. By assuming no lateral movement, one can estimate the variation in vertical stress as the soil collapsing phenomenon develops. The corresponding stress state path for various parts of the collapsing column is presented on Figure 5, using the oedometric results of dense and loose materials at a water content of 6.6% (Wopt = 1,5%)

This simplified interpretation is in agreement with the inclinometer data and with the penetration resistance measured before and after or before sinkhole occurrence. It fully supports an in situ soil structure collapse magnitude in the order of 5%.

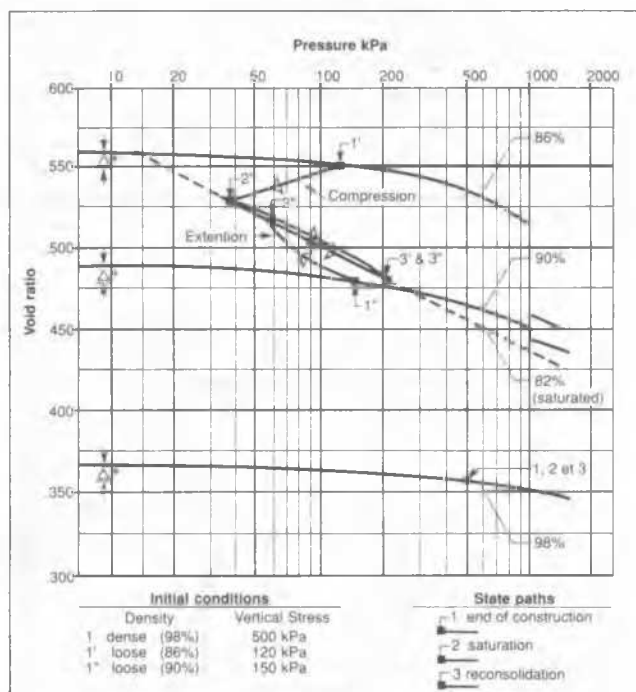
Figure 5. Compression Curves (Samples prepared at  $w = 6.6\%$ ) - State Paths.
