Subsidence due to special geological and groundwater conditions

A.CARRILLO-GIL, Principal Professor, Head of the Soil Mechanics Department, National University of Engineering, Lima, Peru

SYNOPSIS: This paper presents the results of a geotechnical investigation performed at a site where large structural damage occurred as a result of surface subsidence. The site is located at a mining area in the peruvian andes.

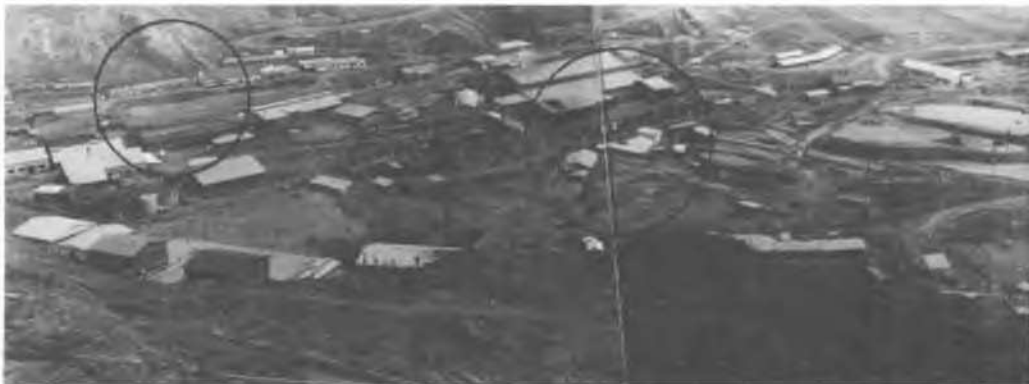
The exploitation of "Veta Pozo D" (an ore body under the mining camp) started in June of 1979; and as a result of it large surface subsidence occurred. As result, heavy structural damage occurred affecting the mining operations (Figure 1)

Figure 1. General view of the site plant area and location of the damaged structures

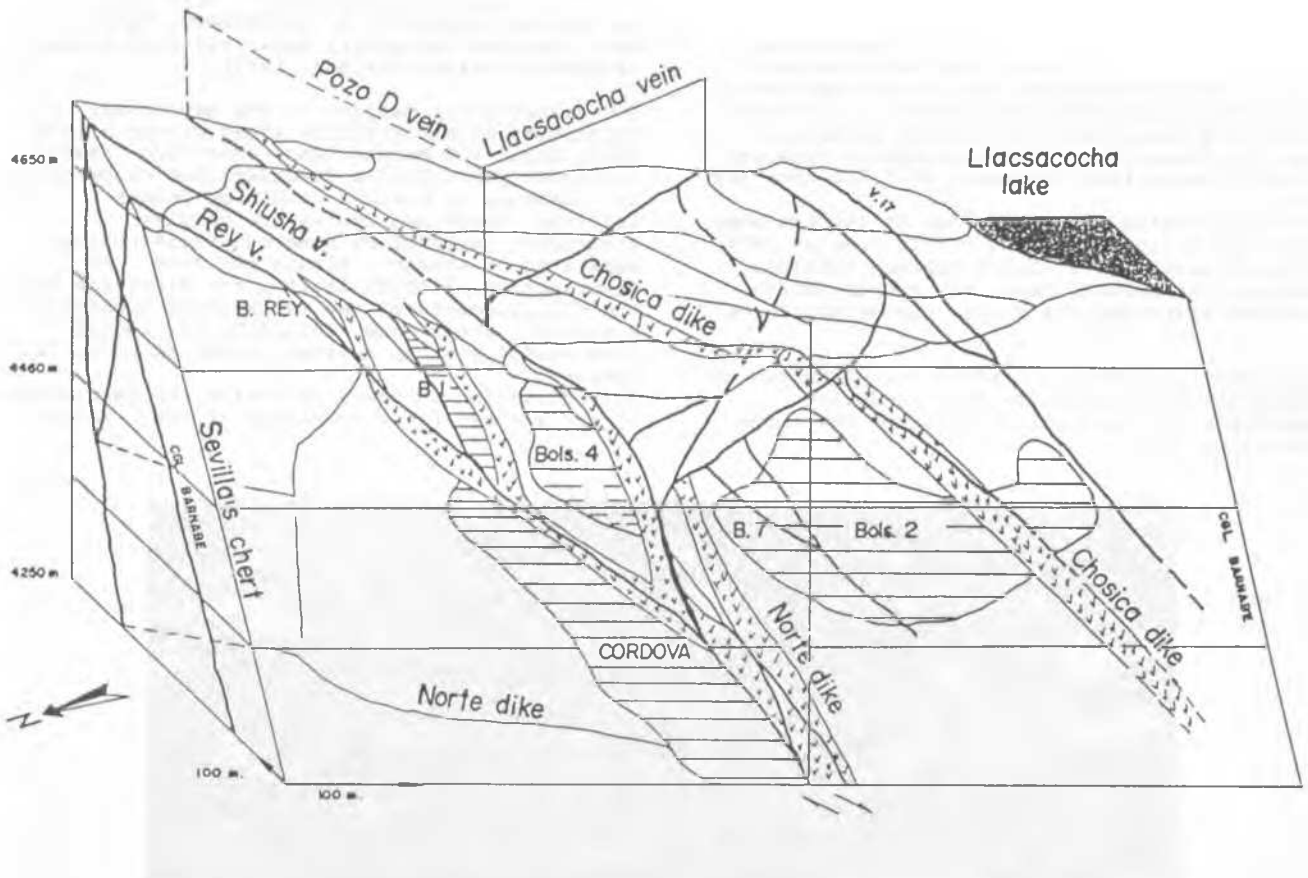
faulting) in east-west direction, these mining faults intersects the large faults locally in the east-west direction, also there is a presence of small mineralized segments with the same strike of main fault. Non-mineralized minor faults also show the same re-openings (Figure 2).

Figure 2. Sketch of the intersection Llacsacocha and Pozo D faults

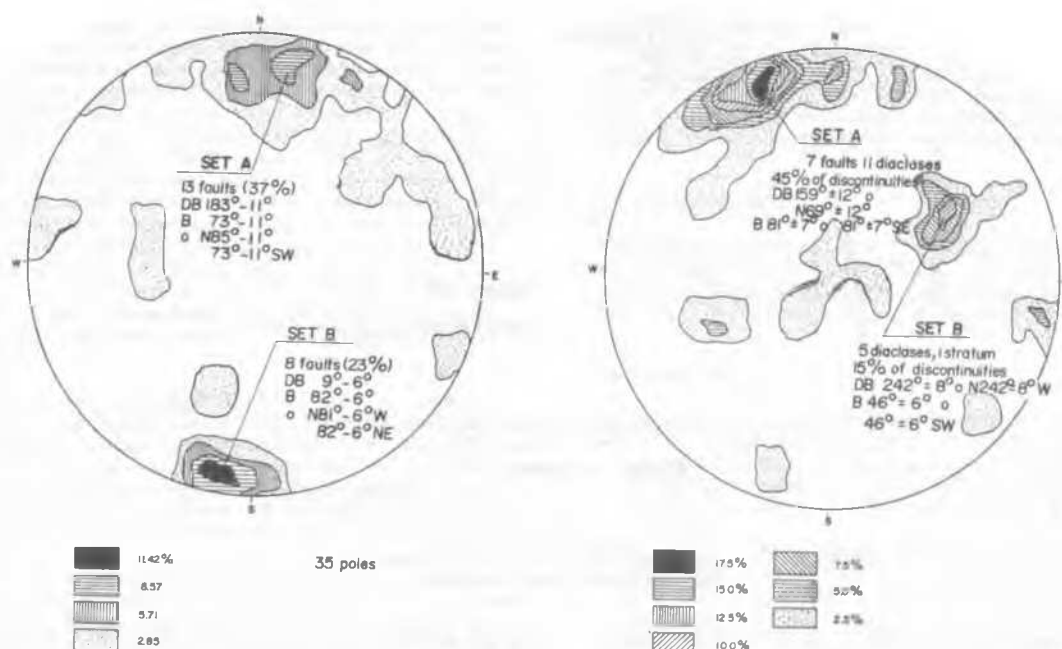
Using the results of the borings and geological mapping a structural analysis of the area was carried out. The results are presented in the stereographic diagrams (Figure, 3).

Figure 3. Stereographic Diagrams

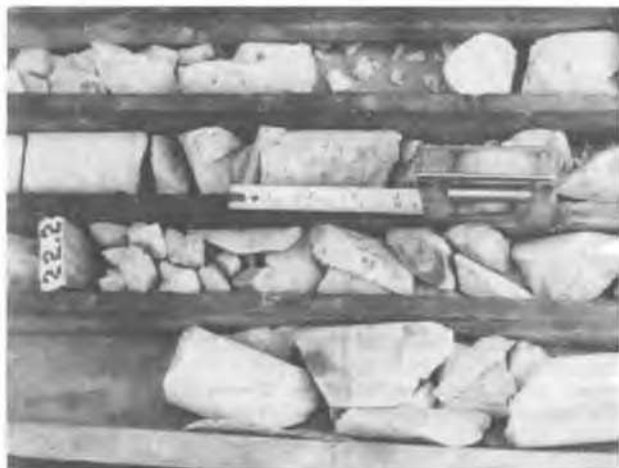
Geotechnical borings performed by diamond drilling indicate that the rock mass situated around the mine's principal buildings are highly fractured, there is an abundance of discontinuities of various orientations and dipping generally 80 to 85 degrees in a sub-vertical direction. Hence, the complete recovery of drill cores has been an exceptional case (Figure, 4). The alteration of the rock is almost external and the joint are filled by materials ranging from clay to sandy silt, the geometry of the joints suggest that these deposits were formed in a secondary manner by infiltration of water from the surface.

Figure 4. Typical highly fractured core samples

The fillings are also partly due to weathering of the rock itself. This weathering is prevalent along the lengths of all the borings investigated. Also the effect of minor faulting can be inferred from the high degree of fracturing and jointing identified from the core samples.

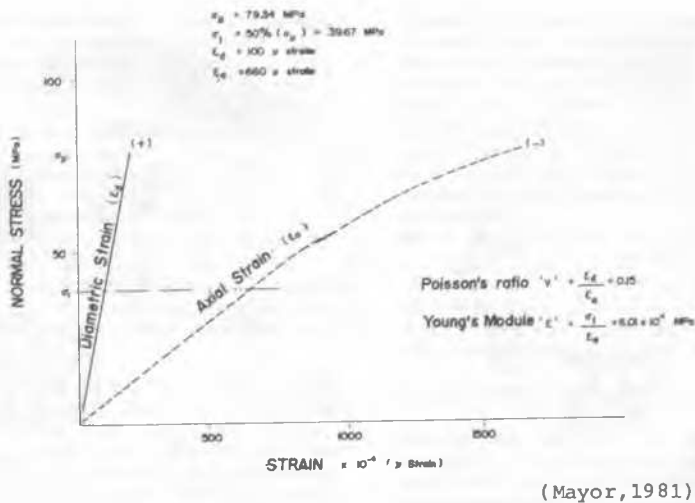
Cohesion	: 100-150 KPa for the rock of poor quality.
Angle of internal friction	: 30-35 degrees for the rock of poor quality
Angle of internal friction	: <30 degrees for the rock mass of very poor quality
Unconfine compressive strength	: 0.43-1.37 MPa for the rock of poor quality <0.43 MPa for the rock of very very poor quality
Elastic Modulus	: Due to the quality of the rock, the elastic modulus is in the range of inelastic behaviour (Figure 5)

Figure 5 Deformability of rock material in uniaxial compression
