A catastrophic debris flow near Gupis, Northern areas, Pakistan

D. F. T. NASH, Department of Civil Engineering, University of Bristol, UK
 D. K. BRUNSDEN, Department of Geography, King's College, University of London, UK
 R. E. HUGHES, International Disaster Institute, London, UK
 D. K. C. JONES, Department of Geography, London School of Economics and Political Science, UK
 B. F. WHALLEY, Department of Geography, Queen's University, Belfast, UK

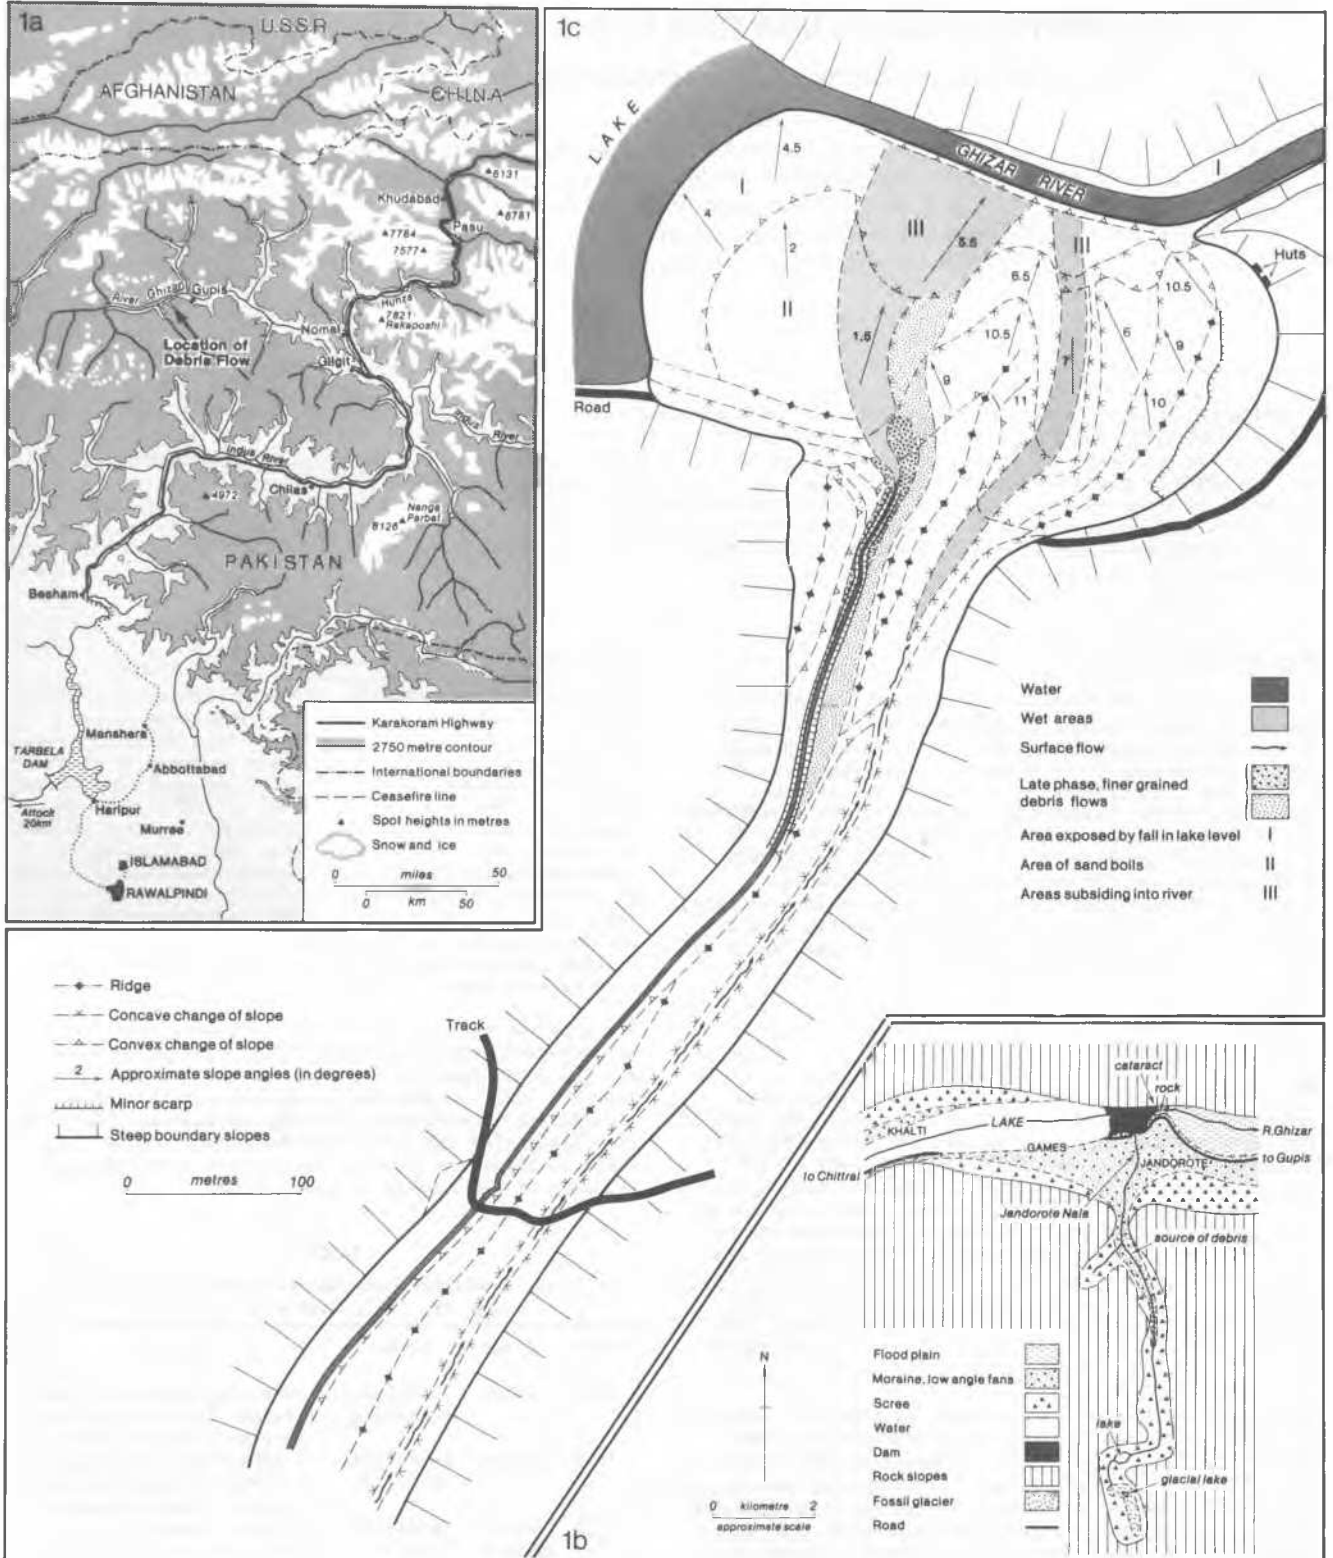
Fig 1: a) Location Plan. b) A sketch plan made before the overflow of the lake had taken place. c) Detailed survey of the lower track, lobe and lake overflow, measured on 6th August 1980.

The debris flow occurred about 5 km west of the confluence of the Yasin and Ghizar rivers, at a point where the Ghizar river flows through a narrow rocky cataract (see Fig. 1b). Upstream and downstream from the gorge the river crossed alluvial plains bounded by low angle fans to the south and rocky slopes to the north. Emerging from a side valley to the south, the Jandorote Nala joined the river just upstream of the cataract. With a normal summer flow similar to a mountain stream, the Nala flowed down a deep channel cut through the fan, approximately 80 metres wide at its base. Local people had constructed a dozen channels to tap the water for irrigation purposes. The road from Gilgit to Chitral crossed the Nala where it emerged into the main valley. At the time of the debris flow the weather was fine and there had been no significant rainfall in the area for some weeks previously. There were no earthquakes felt or recorded in the area that day.

By that evening the frequency and size of the waves had diminished and a flow of water and mud had started, eroding the surface of the debris track. At this time the dam was about 30 metres high, 200 metres along its axis with the downstream toe right through the rocky gorge. The maximum slopes of the dam were determined with an Abney level as 3.5 to 4° while the average slope of the debris track was 11.7°. A lake had formed which extended upstream about 5 km covering two villages and rendering 500 people homeless. At about midnight the dam was overtopped, but the level only dropped gradually at the dam eroded. There was no flooding downstream.

dam and in places there were numerous sand boils. The surface of the dam and the lower part of the debris track was surveyed during the period 4 to 6 August and this survey is shown in Fig. 1c.

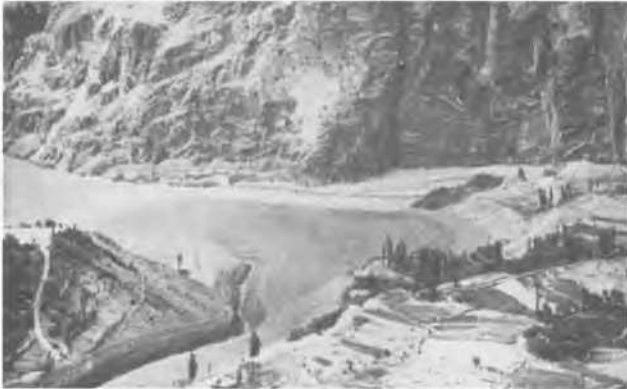
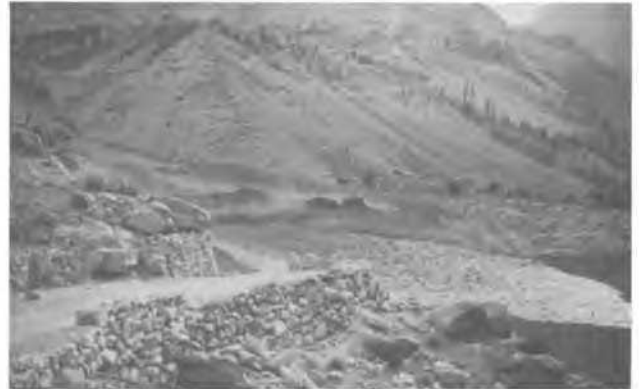
Over the following three days the river cut down the surface of the dam and the lake dropped by about 1 metre. During this time the topography of the dam changed significantly and the crest slope increased to 10° near the river. Standing water appeared on the surface of the

Figs 2a), 2b): General views of landslide dam and debris track.

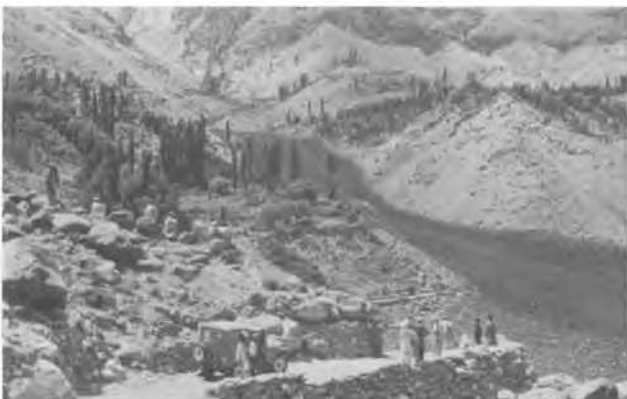
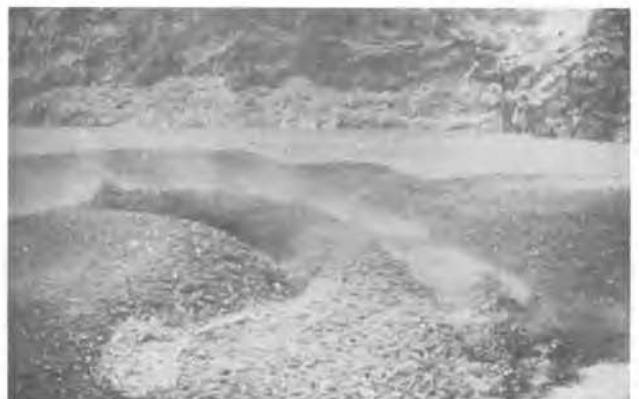
At approximately 1630 hrs on 27 July 1980 a wave of mud and boulders swept down the Nala destroying crops, houses and livestock as well as the road, flowed across the alluvial plain and blocked the Ghizar river. Eyewitnesses said there was no warning and that thereafter waves of debris emerged very frequently so that the flow was almost continuous. By next morning (1100 hrs) when two authors (DN and REH) arrived the waves were arriving about four times per hour. The first indication of an approaching wave was aural giving 1½ to 2 minutes warning (the source was about 3 km away). Soon the wave

could be seen slewing from side to side of the channel as it went round bends until with a deafening roar it reached the bottom of the Nala. At this point the wave was the full 80 metres width of the channel, up to 5 metres high and travelling at speeds of perhaps 100 km/hr, throwing up debris and boulders as it passed (see photos Figs. 2, 3). The wave then spread out when it reached the surface of the landslide dam which rose and fell like jelly. The scene closely resembled a breaking wave passing through the narrow entrance to a tidal inlet. When all the movement had ceased the surface of the fresh debris was firm enough for people to cross the Nala, and the debris had the consistency of a freshly mixed concrete.

Figs 3a), 3b): Views of debris waves emerging from Nala and spreading across dam.
