Prefabricated sand filter drains used at Tarbela Dam

HAQ IZHARUL, Dr. M.Sc., Pakistan
 ABDUL KHALIQ, M.Sc., Pakistan

SYNOPSIS The left bank rocks of Tarbela Dam are highly fractured and contain solution channels, fissured zones and erodible gouge material. Seepage through the bed rock was controlled by grout curtain and drainage system from the galleries. Problem arose when substantial amount of fines were passed by some of the drain holes. Different types of drains such as polymer bonded filters, epoxy bonded filters and sand filtered drains were tried and finally the latter were selected. The concept of the sand filtered drain consists of two concentric slotted PVC pipes prefabricated with filter sand in the annulus. The latest design has been the result of a thorough re-appraisal of the filtered drain concept. These drains have been successfully used at Tarbela Dam.

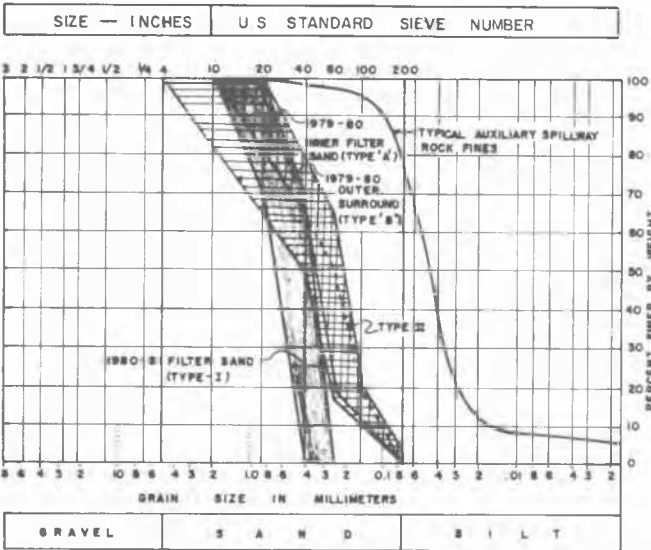
Fig.2 Gradation Of Rock Fines And Sands Tested For Use In Drains.

PVC pipes under controlled conditions. A slightly coarser filter sand was placed in the annulus between the 75 mm PVC pipe and the wall of the hole. Performance of 1980 indicated discharge of fines from some additional drains. It was clear that the gradation of the fines was not suitable to form a natural filter pack behind the slots of the PVC pipes. The gradation of the silt sized fines is shown in Fig.2.

To prevent the movement of these fines a filter was required which would not only retain these fines but also transmit the seepage water so that pressures would not build up. Furthermore a large number of drain holes had been drilled upward from the galleries. Placement of filter sand

The slots on both the pipes were 0.5 mm wide, 50 mm long and at 100 mm c/c vertically. After being filled with sand, the units were transferred to the vibrating table and were subjected to vibrations for 3 minutes obtaining final sand density of 1.84 gm/cc. After vibration, 3 number 6 mm dia PVC dowel pins inserted into predrilled holes located close to the end of the pipe and at the mid points of the area to be filled with Barosa resin to seal the ends of the unit. The average production rate during 24 hours was 160 units with a crew of 12 men. Cost per foot was \$ 10. Locally obtained river sand, oven dried and specially graded to conform to the requirement shown in Fig.2 was used in the annulus of the drains.
