Soil fracturing – An injection method for ground improvement

HERBERT SAMOL, Member of GKN Keller GmbH, Ground Engineering Contractors, Offenbach, FRG
HEINZ PRIEBEL, Dipl.-Ing., Member of GKN Keller GmbH, Ground Engineering Contractors, Offenbach, FRG

SEWAGE PLANT DORNBIRN

VEB BUNA, SCHKOPAU

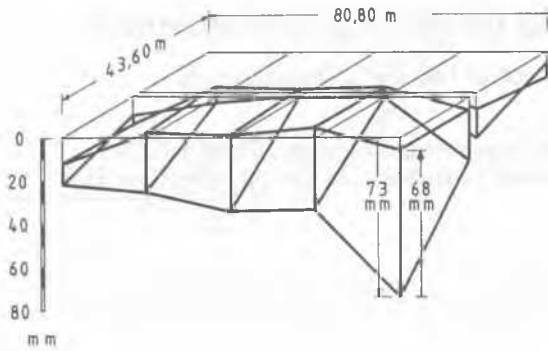
connecting pipe-lines required special foundations. For the two rather large aeration basins each 80,8 m long and 43,6 m wide the upper soft layers were improved by stone columns. By this process the varying strata were considerably homogenized in order to achieve fairly uniform settlements, induced by the lowering of the ground water table. Moreover stone columns could not possibly fail, because the load from the basin was not in excess of the initial overburden. However, during and after the construction period one of the basins suffered from differential settlements. It was observed that the outer edge - in relation to the entire plant-settled considerably. Especially the corner section, resulting from the arrangement of the expansion joints of the foundation raft had settled in an order exceeding the allowable limit of approx. 4 cm. When re-adjustment measures were started at the end of January 1982, maximum settlement amounted to 73 mm (Fig. 1)

The main reasons for this unfavourable development has to be seen in the following facts. Due to a former real estate border the area was primarily covered with less overburden and thus less pre-consolidated. In addition it was filled subsequently which implied unforeseen load.

Fig. 1: Schematic graph of the settlement and heave of the aeration basin

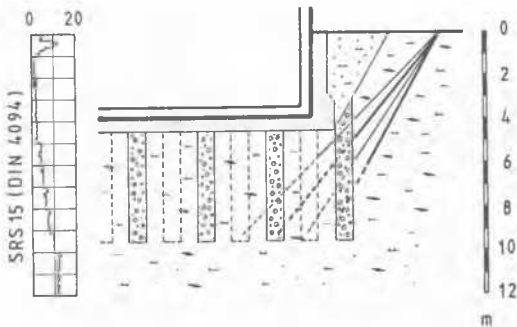
Fig. 2: Scheme of the borings for the sealing of the stone columns including a sounding before the re-adjustment

The re-adjustment by soil fracturing should not disturb or even destroy a drainage system which had to assure safety against uplift in case of empty basin. Therefore, the stone columns, which normally represent drainage paths, had to be sealed in their upper portions below the drainage and above the soil fracturing injection level. This sealing was performed by jet grouting, which was considered to reach the stone columns even if the borings deviated somewhat. The sealing works included 14 x 3 borings at the frontal edge and 88 x 2 borings alongside (Fig. 2).

Altogether approximately 150 m³ grout were injected at a rate of 300 kg blast-furnace cement and 200 kg limestone powder per 1000 l water, stabilized by 25 kg bentonite. It is self-explanatory that during the jet grouting procedure, as well as during the following soil fracturing works, the drainage system was constantly observed.

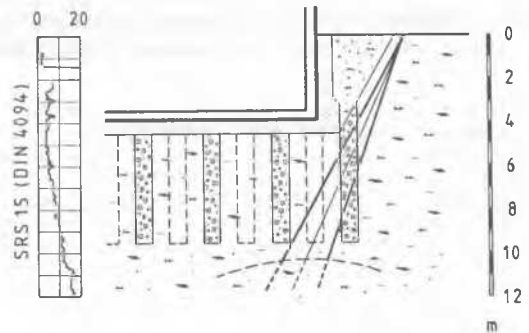
Fig. 3: Scheme of injection pipes including a sounding after re-adjustment

The soil fracturing works included 4 x 5 borings at the frontal edge and 11 x 5 bor-

ings alongside the basin. These borings were equipped with injection pipes suited for injections at three stages minimum within the lower portion (Fig. 3).

A total of approximately 450 m³ grout were injected at a rate of 400 kg blast-furnace cement and 800 kg limestone powder per 1000 l water, stabilized by 25 kg bentonite. Measurements of heave, inclination of the walls and width of the joints were carefully taken and the quantity of grout was limited accordingly. Due to little overburden and soft soil, the pressures were low except for the immediate bursting of the valves, but sounding before and after the re-adjustment proved to have a compaction effect (Fig. 2 and 3). Undesirable leaking of the grout at the surface were prevented by fast-setting admixtures.

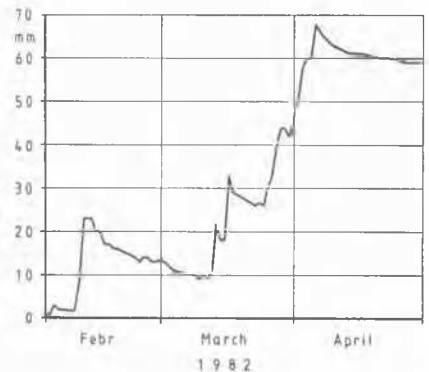
The soil fracturing process proved to be suitable for the re-adjustment of a large basin of a sewage plant. The works took two and a half months, including all preliminary efforts. At the longitudinal edge of the basin settlements were more or less completely adjusted. The remaining slight inclination of the frontal edges was left to compensate the effect of the filling of the basins (Fig. 1). However, the corner of the basin, which was mainly affected by settlements, was lifted by 68 mm (Fig. 4).

Fig. 4: Heave at the corner of the basin

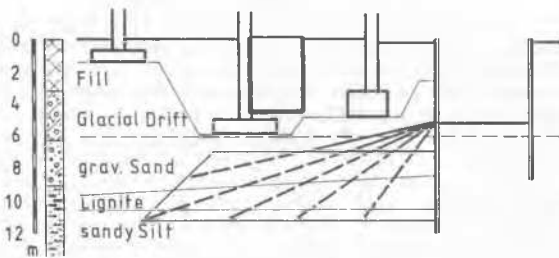
According to the investigation report and the results of additional core borings the subsoil varies from noncohesive to cohesive layers with partly organic components. Glacial drift immediately below the footings is underlain by loamy gravelly sand and silt to sandy silt with varying content of lignite (Fig. 5).

Fig. 5: Schematic graph of the foundation including injection pipes

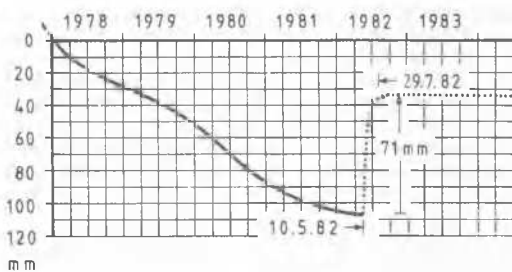
From a broken pipeline an unknown quantity of highly concentrated caustic soda solution seeped unnoticed into the ground. It effected chemical reactions with the lignite which partly led to a nearly complete loss in bearing capacity. The resulting settlements amounted to a maximum of 106 mm at

Fig. 6: Settlement and heave at column D-6

column D-6 before the re-adjustment measures were started.

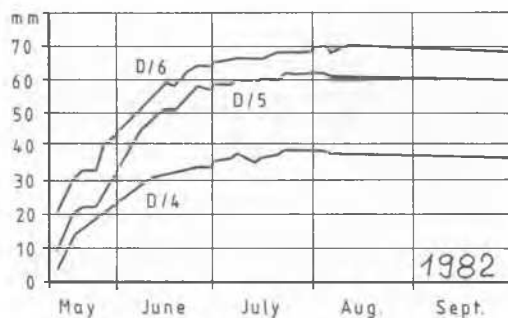
The maximum heaves were attained at the columns D-4 and D-6 (Fig. 7). At the beginning the heave per shift was approximately 2 mm. This was more and more reduced with growing values.

Fig. 7: Heave of the columns in row D

The soil fracturing works were carried out with hydrostatic pumps in different stages and passes through the injection pipes. Construction period was from March 10th to August 12th, 1982. The saturation phase was already achieved after few days. After that, position and output of the injection was adjusted to the intended heave of 9 footings within tolerances of 1 to 2 mm. Altogether the columns were lifted as follows:

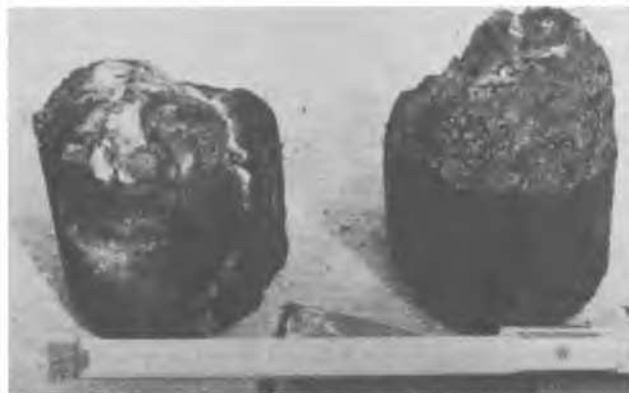
Finally qualification tests were performed. Therefore, 4 core borings were executed with complete core recovery. The visual examination and in-situ tests proved soil-fracturing to be a successful method for treatment in the present case (Fig. 8). Laboratory tests completed the in-situ observations. From core samples the relevant characteristics were determined:

Fig. 8: Cores from the improved lignite

The very soft layers of lignite were drained and compacted so much that the bearing capacity was higher than initially. Furthermore the existence of ramified cracks, filled with set grout, were proved within the cohesive layers and the lignite, forming a permanent load supporting frame.
