Mangla dam project – Behaviour of Siwalik clays/sandstones

G. S. BUTT, Pakistan
CH. ALTAF UR REHMAN, Pakistan

SYNOPSIS Mangla Dam Project structures have foundations/abutments of Siwalik formation of Plio-Pliostocene era. Since the completion of the Project in 1967, the foundation/dam have gone through 18 cycles of impoundments & drawdown. Residual shear strength parameter for clays was used for the long term satisfactory performance of slopes & foundation. The slips in the reservoir/one in tailrace of emergency spillway confirm the wisdom of using residual values. Bedrock sandstone is weakly cemented fine to medium grained. Boiling has been rampant d/s of Sukian Dam, a low dyke along a ridge. It is possible to control the boiling by vigilant observation and treatment with inverted filters. Clays/sandstones have performed satisfactory as fill materials for core/shoulders.

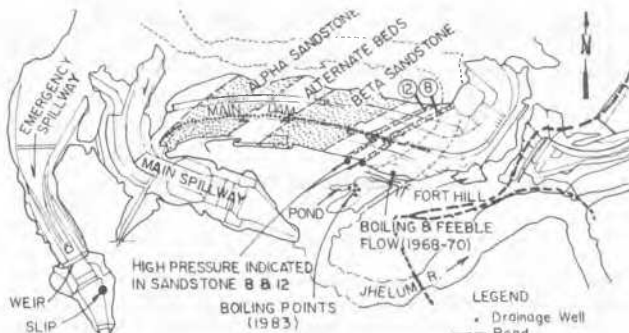
Fig.1 Layout Plan Mangla – Main Dam/Boiling Locations & Geology

The design of Main Dam has a line of wells at 3.8m centres downstream of the core under the chimney filter (Fig-1). This is a good location for the line of wells, however, the experience of having minor boiling at toe, dictates that it would have facilitated if working of drainage curtain & individual performance of wells were known. The boiling apparently has not involved the components of the zoned dam. However, there are pressures higher than ground level at the toe, in 2 sandstone beds. Extensive drilling has been done to know pressure at the toe as well as confirming the lithology at toe. It is proposed to install relief wells in the sandstone with higher pressure. Sukian Dyke sited on a ridge (Fig-6), with deep cuts (nalas) on upstream & downstream, has experienced boiling/piping through the weakly cemented sandstone downstream of dam. Boiling is occurring sometimes at distances of more than a mile & continues long after reservoir depletion due to time lag. Sandstone strata close to dam exhibiting boiling has been treated with inverted filters. It is proposed to try blanketing upstream exposures.

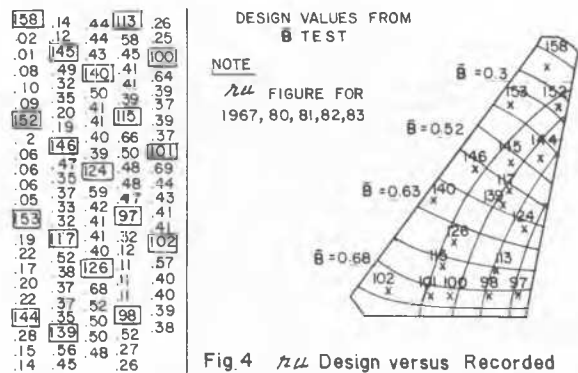
Fig. 4 μ Design versus Recorded

Mangla Main Dam has a rolled clay core, constructed of excavated Siwalik clays which was watered, broken & stockpiled. It was then laid at OMC (Optimum Moisture Content) to OMC+2 % in 0.3m layers. High construction pore-pressures upto 0.7 ru (Pore-Pressure ratio) developed. Over the last 17 years, pore-pressures have dissipated but no flownet seems to have developed, is apparent and would take much greater time (Fig-2, Fig-4).

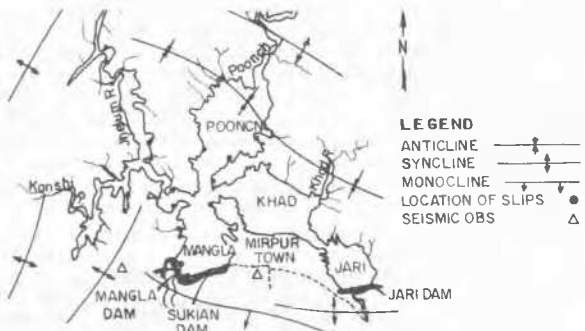
Fig. 3 Reservoir structural geology - locations of slips

Slide in tailrace of emergency spillway occurred along bedding plane shear zone at 12°, caused by rain water seeping along the shear zone & reducing the effective stress. Wedge type failure occurred upstream of emergency spillway, along reservoir helped by impounding & drawdown along dip at 12°. There has been no slip because of earthquake in recent times, however since the tectonic movement, Probably in the middle of Pleistocene epoch & consequent development of shear zones where strength are in most cases at residual values, erosion/weathering leading to removal of several thousand feet of deposits has occurred and may have been helped by slides due to earthquakes, but no such signs exist. The slips in reservoir are few, even with now 18 impounding & drawdown with slopes dipping into the reservoir & clays having sheared zones (Fig-3). This is probable, as only part of slopes are being subjected to saturation/drawdown. Also wedge type failures are helped by tension crack or free surface on upstream. It is apparent that dips of bedrock in reservoir area are substantially lower than average shear strength along a slip plane refer above table except for Jari where no slips have occurred (Fig-3) although the bedrock contain larger percentage of clays. This is probably due to silt blanketing providing a toe weight/flat topography.

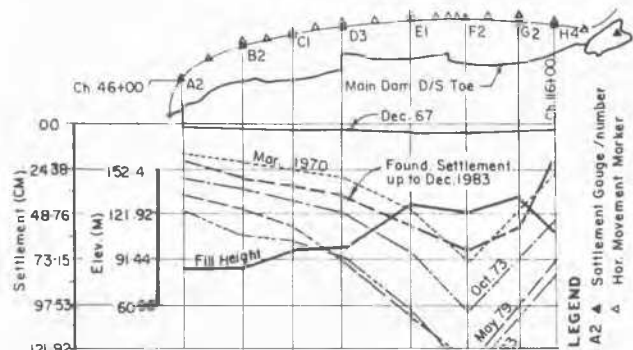
Fig. 5 Main Dam-Settlement Pattern

Settlements of the dam is continuing & post construction maximum is of the order of 1.3m & obviously at the location of maximum fill refer settlement pattern (Fig-5). Extension/compression over the full length of dam (+2741m) has been measured over the years (Fig-5) & reveals extension, near the left abutment (Fort hill) uptill now of 0.2m in a length of 273m. Looking at the maximum settlement/extension in the same reach of the dam, so far there has not been any transverse/longitudinal crack (Fig-1 & 2). However, it was noticed that a crack appeared at location of top edge of the core on the access road from spillway early (1969) & produced a marked depression on the downstream face of the dam in continuation.

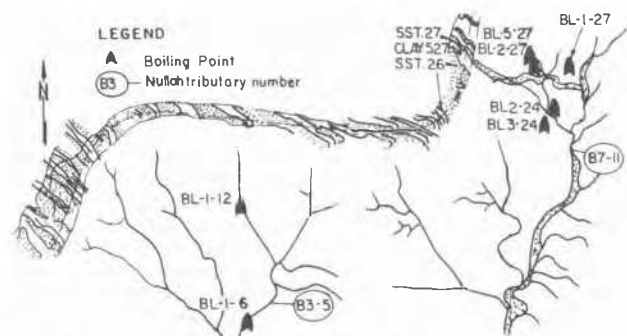
Fig.6 Sukian Dam - Boiling D/S Nullah

There has been an incident of piping (1968) in sandstone 27 (Fig-5 & 6). Sandstone 27 has the lower half virtually of uncemented sand regularly graded unlike other sandstones consisting of fine to medium sand. It appears that the piping was triggered by blockage of seepage leading to high pressures in the cliff face in nala. Removal of overburden of a meter lead to piping which was controlled immediately by putting filters. No piping has subsequently occurred in the nala bed close by at lower levels, and
