Behaviour of the LG 4 main dam

N. S. VERMA, Société d'énergie de la Baie James/Lavalin, Montréal, Canada

SYNOPSIS: The 125 m high main dam at LG 4 is characterized by a zoned earth-rockfill section and a steep 70 m high rock abutment. Stress-deformation behaviour of the dam was studied through finite element analyses and the design of the dam was oriented to take into account the likely occurrence of arching and any eventuality of hydraulic fracturing in the till core. The performance of the dam was monitored during construction, reservoir filling and operation stages through visual inspection and instrument monitoring. This paper presents an analytical review of the observed stresses, deformations, pore pressures and seepage quantities and their implications in terms of the arching and the hydraulic fracturing potentials of the dam core. Comments are made regarding the effectiveness of certain design features in eliminating or minimizing these concerns.

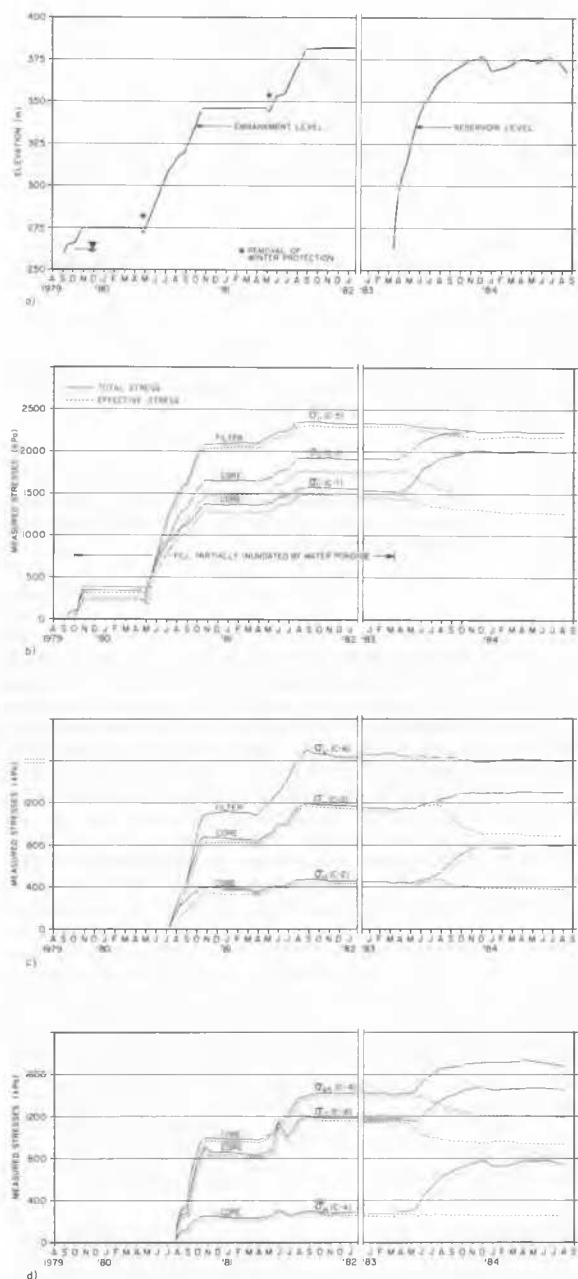
Fig. 6 a) Fill Placement and Reservoir Filling. b) Stresses at Foundation Level in Main River Valley. c) Stresses at Elevation 306 in Main River Valley. d) Stresses at Foundation Level over Steep Abutment.

Figure 6 shows development of total and effective stresses within the core and the downstream filter zones as well as at their contact with the bedrock foundation in the main river valley and over the steep abutment. Also shown on this figure are the curves of fill construction and reservoir filling. Figure 7 shows contours of effective vertical stress distribution at the instrumented section in the main river valley as obtained from the finite element analyses for the end of construction and the end of reservoir filling stages. Also indicated on this figure are the locations of the total pressure cells and the corresponding measured vertical stresses.

The stress orientations during construction in the bottom part of the fill over the steep abutment deviated by about 30 degrees from those in a typical section. Consequently the measured stresses on a plane inclined at 45° were greater than vertical stresses (Figure 6). The stress orientations in the upper part of the fill were not influenced by the abutment inclination and were essentially similar to those in a typical section elsewhere.

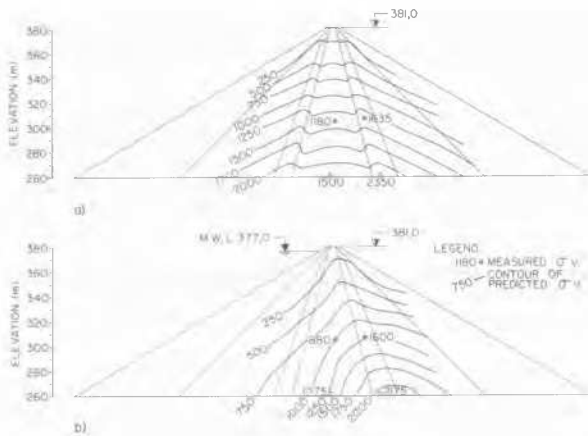
Fig. 7 Predicted and Measured Effective Vertical Stresses at a) End of Construction and b) End of Reservoir Filling.

As shown on Figure 7 for a transverse section in the main river valley, the analyses had predicted almost equal magnitudes of vertical effective stresses in the core and the filter zones for the end of construction condition with slight core to filter stress transfer. This implied negligibly small development of interzo-

ne arching. Similarly no interzone arching was indicated for the end of reservoir filling condition. The measured stresses, however, do show some arching effects. A ratio of the effective vertical stresses in the center of the core to those in the center of the filter zones can provide an empirical indicator of the extent of stress transfer and consequently of arching. This ratio at end of construction was about 0,7 both at foundation level and within the fill (elevation 306) compared to a predicted value of about 1, indicating presence of arching at all levels of the fill. For the end of reservoir filling condition, this ratio of measured vertical stresses was about 0,6 throughout the height of the fill compared to the predicted values of about 0,6 at foundation level and about 0,8 at mid-height of fill. It should be noted that the predicted values of less than unity for end of reservoir filling condition reflect the effect of core submergence on the effective stresses and are not related to arching phenomenon. This shows that whereas the arching is virtually eliminated near the bottom of the fill, it is apparently still maintained in the upper parts.

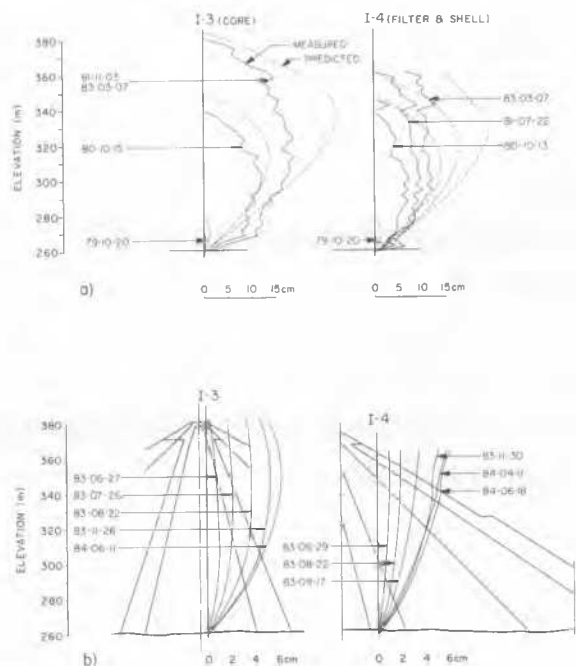
Fig. 8 Embankment Deformations in Main River Valley: a) Settlements and b) Horizontal Displacements during Reservoir Filling.

As can be expected for an embankment with a symmetrical central core, the horizontal displacement during construction were small at all locations except over the steep abutment. Based on readings of the inclinometers (Figure 8) and the surface monuments, transverse displacement for full reservoir condition occurred at or near the dam crest. The magnitude of displacements

measured to date has reached a maximum of about 6 cm in a downstream direction compared to predicted values of about 40 cms.

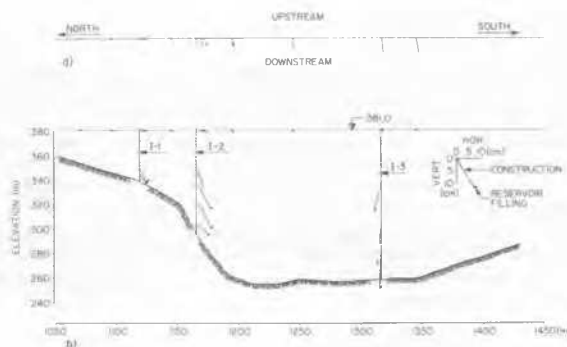
Fig. 9 a) Horizontal Displacements of Dam Crest due to Reservoir Filling. b) Accumulative Movements in Core in Longitudinal Plane.

Over the steeply inclined abutment (Figure 9), the settlement behaviour during construction of the upper part of the core was similar to that of a typical section elsewhere without any appreciable lateral displacement. Below about elevation 350, settlement was accompanied by significant lateral displacements in a downhill direction. The differential settlements and the differential horizontal displacements at any given elevation over the two sides of the abutment hump amounted to a maximum of about 12 cms and 6 cms respectively. The general direction of these displacements was confirmed during reservoir filling by surface monuments and also by a chain of extensometers which measured tensile strain of up to 2×10^{-4} between stations 1085 and 1135 and compressive strains of up to 2×10^{-5} between stations 1135 and 1175. The provision of a relatively wet (i.e. flexible) till is believed to have been beneficial in rendering facility of displacement to the till core at the abutment contact zone where local shear movements producing the desired structural readjustment are inferred to have occurred.

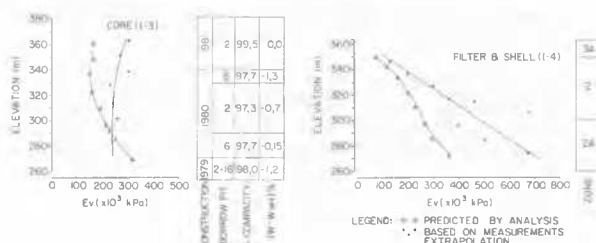
Fig. 10 Secant Moduli Based on Predicted and Measured Settlements in Core and Filter/Shell Zones.

Figure 10 shows mean values of the end of construction secant moduli based on vertical strains accumulated over 12 m fill thickness and the corresponding stresses for the core and the filter/shell zones. The observed moduli are based on strains from inclinometer readings and stresses from extrapolation of pressure cell readings. The predicted moduli are derived from the results of the finite element analyses. Va-

lues of the predicted moduli for the till core varied from about 300 000 kPa near the bottom to about 150 000 kPa in the upper half of the fill. The magnitude of the corresponding measured modulus was about 240 000 kPa for most of the fill height with some increase in the upper part. In the granular filter and shell zones both the predicted and the measured moduli increased with depth, the measured moduli exceeding the predicted values by about 30 to 100%. The higher values of measured moduli are believed to be related to greater than predicted compaction achieved for the well graded granular materials. (Average in-place relative density of 85% compared to a targeted relative density of 70%). The moduli represent the actual stress-deformation behaviour of the fill materials and provide a convenient means of prediction for embankments composed of similar materials and constructed in a similar way.
