Slope failure in surficial weathered tuff induced by the regional drainage system

L. BELLONI, Geotechnical and Engineering Geology Division, ELC-Electroconsult, Milan, Italy

SYNOPSIS The failure of a slope cut in the Upper Canal of the Kalayaan Project (Philippines) was originated by large fluctuations of the water table. Despite the project morphology, modelled in weathered tuff, could not evidenciate any important phreatic level for the design of slope cuts, the underlying volcanic agglomerate resulted, as a regional water bearing formation, the cause of the oscillating water table in the upper formations, thus triggering the instability of the slopes already cut. The strength parameters of the weathered rocks involved in the failures were evaluated from back analysis and they may be of interest to other geologists and engineers, since their determination with standard methods is practically impossible.

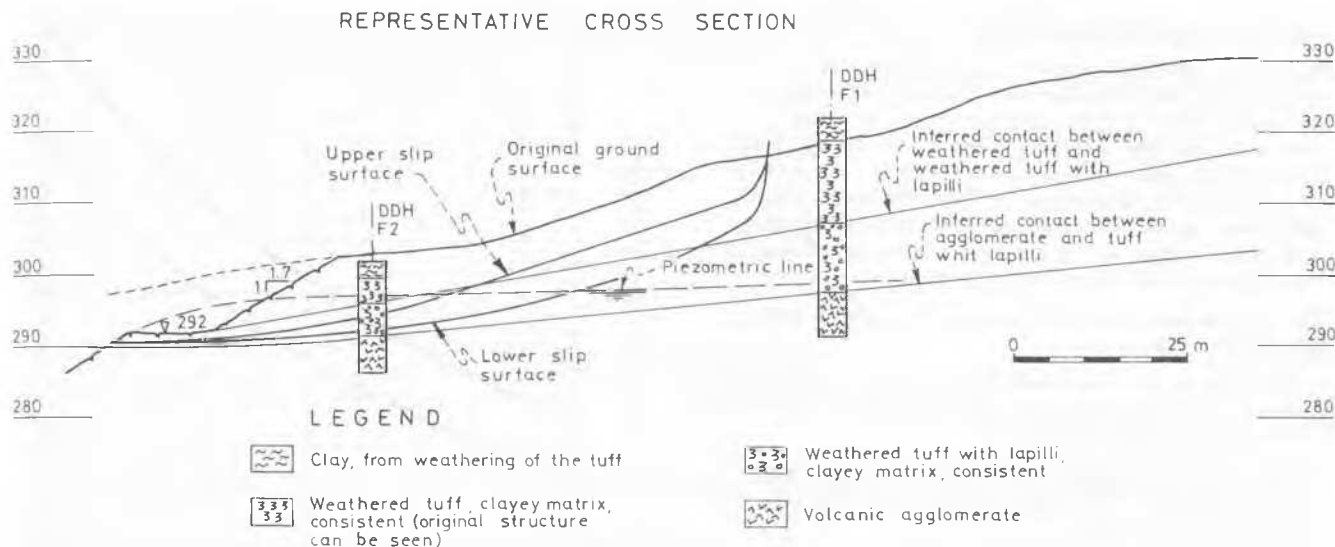
Fig. 1 - Intake - Slope Failure in the Right Bank - Representative Cross Section and Critical Slip Surfaces

On Fig. 1 the inferred correlation among these materials, based on the boreholes and test pits, is shown on the representative cross section of the slide, while Fig. 2 reports the fluctuations of the water table levels during dry and rainy season as measured in the eventually installed piezometers.

- the contact surface tuff-agglomerate gently raise uphill
- the thickness of the tuff with lapilli decreases from uphill to downhill. It is sloping toward the cut.

Water has been observed coming out at the contact more or less along the whole front of the slide. In the piezometers ground water has been measured and based on these data a piezometric line has been traced. In addition it was observed from the recovered samples that the tuff with lapilli has in general a high water content.

- the slide is translational, with a sliding plane surface that is approximately parallel to the ground surface
- movement has taken place along the contact between tuff and agglomerate and through the tuff with lapilli

- the layer of tuff with lapilli and the volcanic agglomerate are water bearing. Water was actually seeping out along the contact exposed in the canal cut. The piezometric line in the soil mass has been tentatively located as in Fig.1

Several slip surfaces have been studied within the boundaries of the actual slide, until the two more critical were located, as shown in Fig. 1.

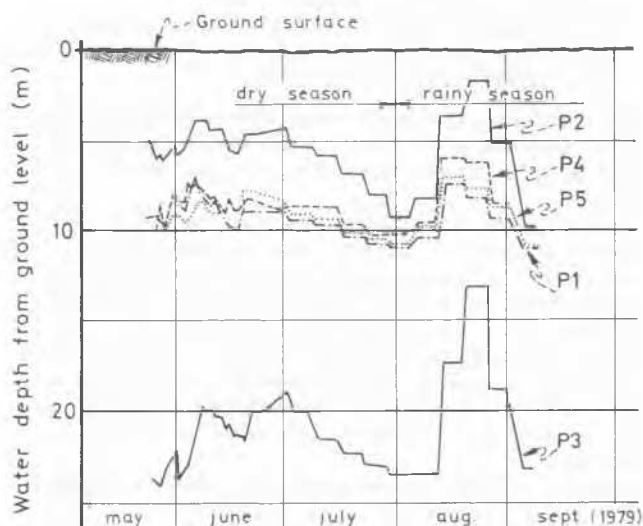
Fig. 2 - Intake - Fluctuations of Water Table Levels as Measured in the Piezometers

- the layer of weathered tuff with lapilli has to be considered pervious with respect to the other present formations.
- A fluctuating water table, recharged by the agglomerate below, builds up pressure at the

Piezometer installed in the upper weathered tuff layers

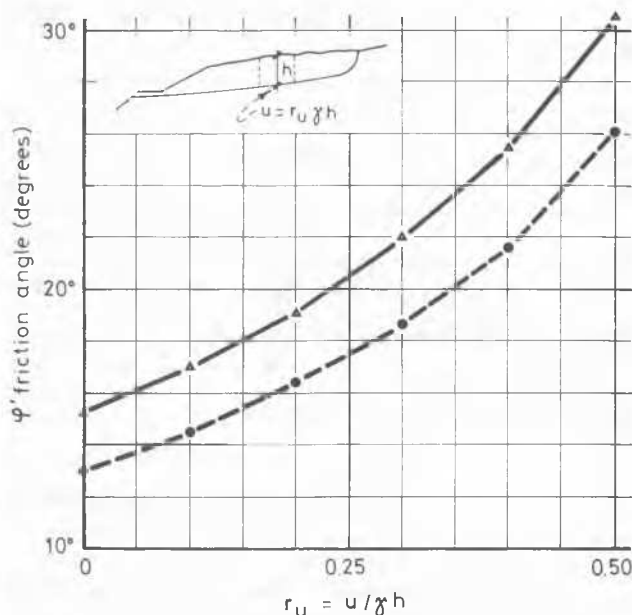
Fig. 3 - Intake - Slope Failure in the Right Bank - Stability Analysis Results

Results of the calculation are shown in Fig.3 for the two critical slip surfaces.

In practice $r_u = 0.2 \div 0.3$ has been considered as the possible range. In the present case, the upper bound for the piezometric surface was suppose to coincide with the contact between tuff and tuff with lapilli, therefore:

- $r_u = 0.15$ for the upper sliding plane
- $r_u = 0.23$ for the lower sliding plane

$$- c' = 0 \quad \varphi' = 20^\circ$$

With respect to the upper surface a more appropriate value of the friction angle would have been $\varphi' = 16^\circ$.
