# Siltstone and claystone foundations at the Bath County hydroelectric pumped storage project

D. E. KLEINER, Head, Geotechnical Department, Harza Engineering Company, Chicago, Illinois, USA

**SYNOPSIS:** At the Bath County Hydroelectric Pumped Storage Project, several changes occurred during construction as a direct result of low bedding shear strength in the siltstone and claystone bedrock. Although all major structures were designed using appropriate bedding shear strength, site excavation produced several surprises that required design changes during construction.

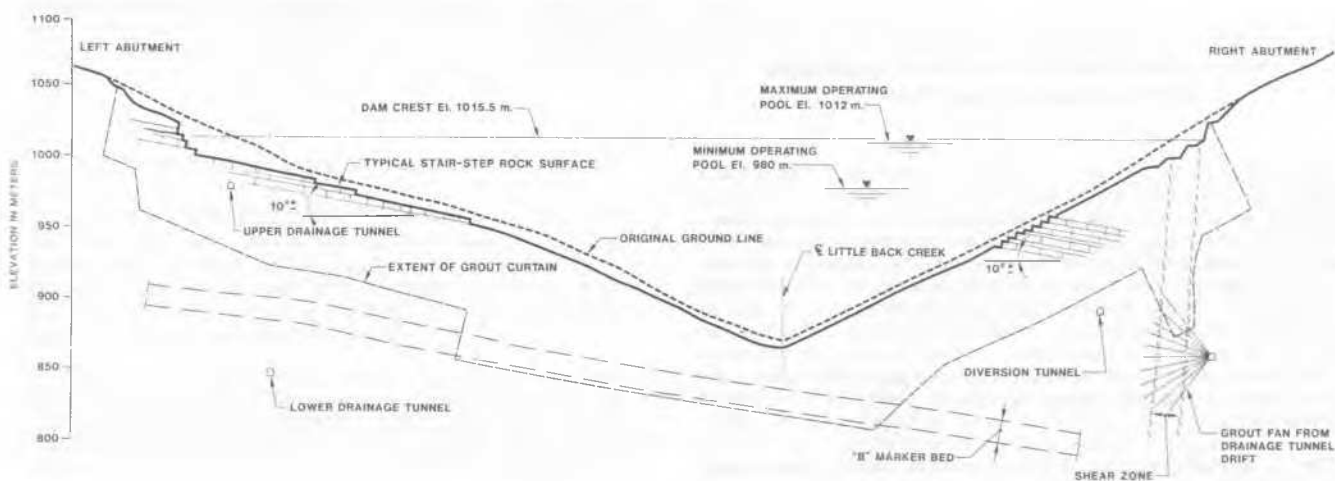
Fig. 3 UPPER DAM CROSS VALLEY PROFILE

Upper Dam Foundation. Since the earliest project investigations, attention had been drawn to the geologic structure of the upper dam foundation and its effect on stability. Interbedded Chemung sandstone and siltstone/shale layers dip at about 10 degrees from the left abutment into Little Back Creek (Fig. 3). Because of a regional joint set that strikes almost parallel to the valley, the rock surface exposed by the core trench is steplike.

Geologic and topographic evidence suggest that rock blocks have slid into the valley as the creek eroded its course. Such evidence includes the presence of broad benches of unweathered rock below steep cliffs of weathered rock and the occurrence of clays on bedding planes at the base of the cliffs. In a number of locations, deeply weathered, near-vertical joints contain-

ing breccia and silt were also found at the base of the cliffs. These features suggest that the fresh rock benches were exposed as the weathered blocks of rock slid along clay seams. The steep cliffs were not evident during site exploration because of a thick mantle of talus and slope wash deposits that accumulated at their base.

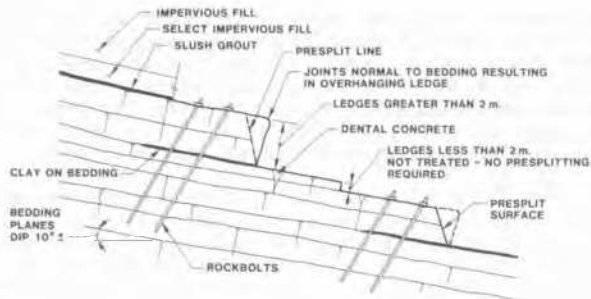
Fig. 4 UPPER DAM LEFT ABUTMENT CORE FOUNDATION TREATMENT

Special treatment details for the core foundation of the upper dam were developed after exposure of the foundation during construction. Excavation of the core trench resulted in a ragged, step-like surface caused by marked bedrock stratification and jointing normal to bedding as shown on Figs. 4 and 5. The varying thickness and competence of the different bedrock units resulted in steps ranging in height from 0.1 to over 4 meters.

On the left abutment, foundation shaping was required to remove unacceptable overhangs. Minor overhangs were tolerated, if less than 0.15 meters, if the overhang was not more than 3-5 meters long and if the bed thickness was less than 2 meters. More competent, thicker sandstone ledges, with more pronounced overhangs were shaped by presplitting. However, the presence of locally occurring clay seams along bedding planes, or weak clay shales at the base of some higher ledges, necessitated stabilization prior to presplitting by rock-bolting to stable rock beneath (Fig. 4).

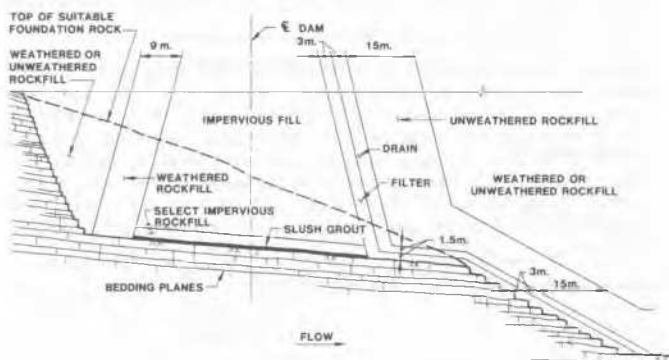
Fig. 6 UPPER DAM LEFT ABUTMENT TREATMENT AT TOPOGRAPHIC REENTRANT

Sharp topographic reentrants on the left abutment created an adversely sloping foundation surface immediately downstream of the core. This condition exposed foundation bedding joints along which fines could conceivably move. A two-stage filter system was placed over foundation surfaces to prevent potential movement of foundation fines into the downstream shell (Fig. 6).

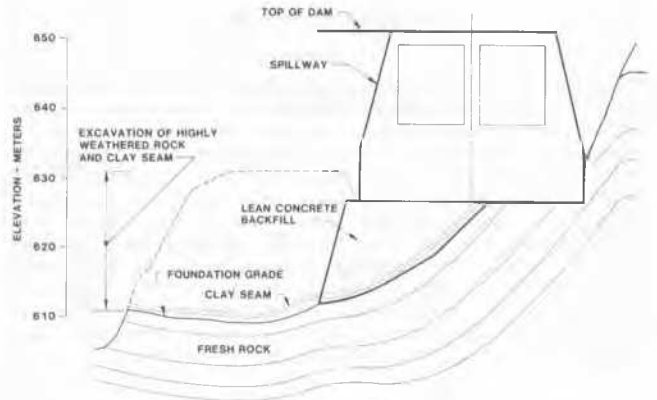
Fig. 7 LOWER DAM SPILLWAY FOUNDATION OVEREXCAVATION

However, upon reaching about 6 meters above the valley floor, a striking difference was apparent in the rock sequence. As shown on Fig. 7, a flat-lying fresh rock ledge was found to be overlain by highly fractured, deeply weathered rock with a clay seam separating the two rock masses. Investigations also indicated that a clay seam extended beneath the spillway ogee. The approximate location and geometry of the clay seam were defined, using the results of geologic mapping, test pits, and drill core logs.

Stability analysis of the rock mass indicated inadequate safety with the construction condition being the most serious. The solution was to excavate the poor quality rock and clay seam, and to backfill with lean concrete.
