Problems concerning clays of very high plasticity in Denmark

B. KNUDSEN, Civil Engineer, Danish Geotechnical Institute, DGI, Århus, Denmark

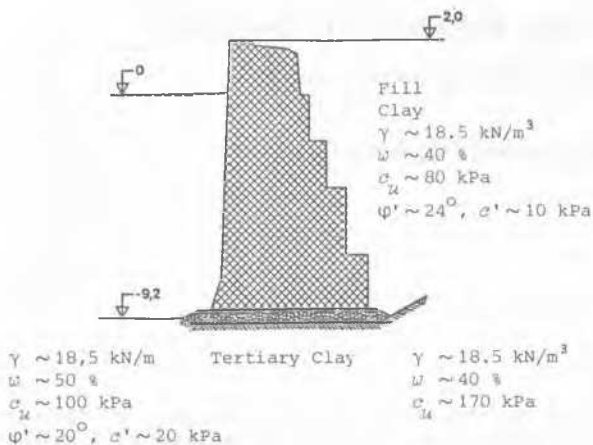
Fig.1 Quay Wall

The structure in Fig. 1 is a quay wall of blocks constructed in 1912 in an area of 4.5 m depth of water. The wall is erected after dredging to 9.2 m below sea level. The backfill consists of clay. During the period 1959-1967 a horizontal movement of 170 mm corresponding to an average movement of 1.5 mm per month was recorded. In 1967 the recorded movement was about 15 mm per month, and it was observed that the movements occurred in connection with low water in the harbour.

The geotechnical investigations showed that the quay wall is founded on fat, tertiary clay. Behind the wall the clay surface was located 5 m below sea level. Fig.1 shows a cross section in the construction with soil profiles and soil strength parameters. By comparing the properties in front of the wall with the properties behind it is observed that the stress relief from the dredging of 4 m clay caused an increase of water content from $w \sim 40\%$ to $w \sim 50\%$ and a reduction in the undrained shear strength from $c_u \sim 170$ kPa to $c_u \sim 110$ kPa within the upper approximately 4 m below sea bottom. By triaxial tests, effective strength parameters of $\phi' \sim 20^\circ$, $c' \sim 20$ kPa were found for the tertiary clay, and $\phi' \sim 24^\circ$, $c' \sim 10$ kPa for the clay fill.

By stability calculations based on the undrained strength parameters a factor of stability of approximately 2 was found, even with the reduced strength in front of the wall. Using the effective parameters in connection with a differential water pressure of 1 m as observed, the stability factor was approximately 1.

The observed movements, therefore, were considered to be the start of a drained failure.

The quay wall was stabilized by anchors to a relieving platform founded on driven piles.

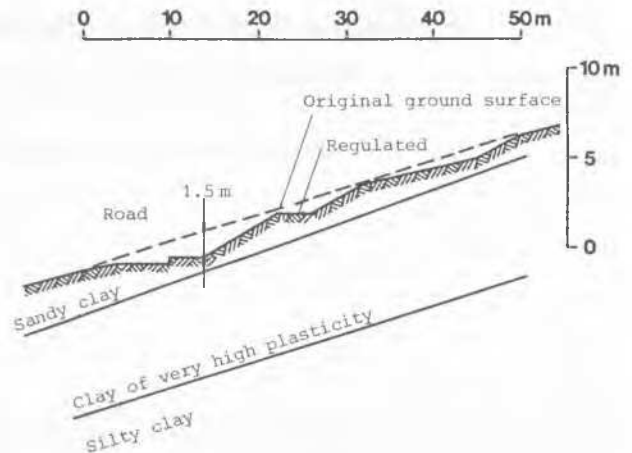
Fig.2 Slope stability

In an area with a slope angle of 8° a road was straightened in 1948 by excavation of approximately 1.5 m. In connection with the regulation of the surrounding ground, the average slope angle was increased to 10° as shown in the cross section on Fig.2. For many years creep movements took place. Measurements to a geodetic point on the road indicated a horizontal movement of 80 cm in 25 years. At that time measurements to points on the slope indicated a creep of 2 cm per year.

Geotechnical investigations showed the soil profile to consist of an upper 2 m zone of sandy clay with $\phi' \sim 22^\circ$, $c' \sim 20 \text{ kPa}$, fat, tertiary clay with $\phi' \sim 17^\circ$, $c' \sim 0 \text{ kPa}$, and from 8 m below the surface silty clay with $\phi' \sim 25^\circ$, $c' > 0 \text{ kPa}$ as determined by triaxial tests.

Stability calculations with the simple assumption of an endless slope with hydraulic gradients and rupture lines parallel to the ground surface gave a factor of stability of approximately 1.

The calculated factor of stability is less than 1 for the regulated slope with $\beta \sim 10^\circ$. A sufficient increase in stability can be obtained by lowering the water table to 3 m below ground level, corresponding to the depth of the active zone. The drainage system was designed as a combination of drains at the ground surface and another system 3 m below, in both cases placed in a herringbone pattern. This method has been used with success to stabilize several slopes.
