# Soil liquefaction problems in recent Japanese earthquakes

Y.YOSHIMI, Professor, Tokyo Institute of Technology, Tokyo, Japan

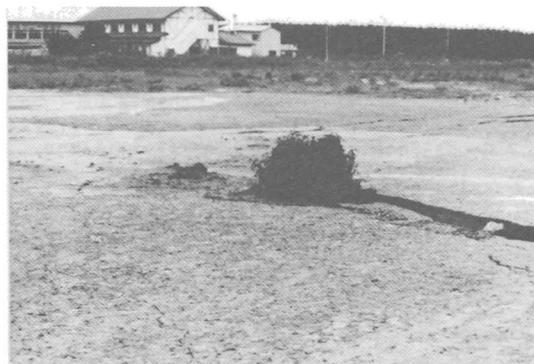
Fig. 6 shows a sand boil caught in action. Many eyewitnesses reported that the soil liquefaction during this earthquake occurred either during the ground shaking period or immediately after-

wards. In contrast, the liquefaction during the Niigata earthquake of 1964 is believed to have occurred at some depth, and its effects did not become visible until some time after the ground shaking had ceased. Another feature of the 1983 earthquake in comparison with the Niigata earthquake is that the damaged areas were predominantly rural. Numerous sand boils occurred in rice paddies, often uprooting the rice seedlings. The rice paddy of Fig. 7 was drained because the buried plastic membrane that had contained the water was broken as a result of the liquefaction of the sand below.

Fig. 6 Sand Boil in Noshiro City, Akita Prefecture (Courtesy of Mr. Matsumori)

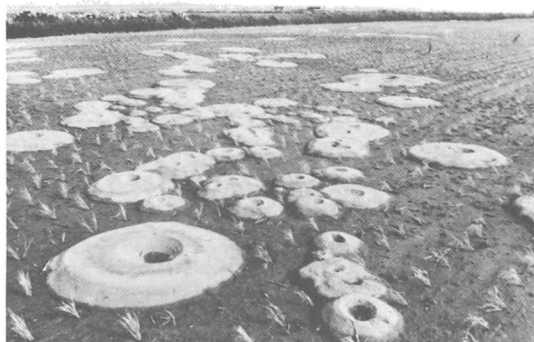
Fig. 7 Sand Boils in Drained Paddy in Wakami Town, Akita Prefecture

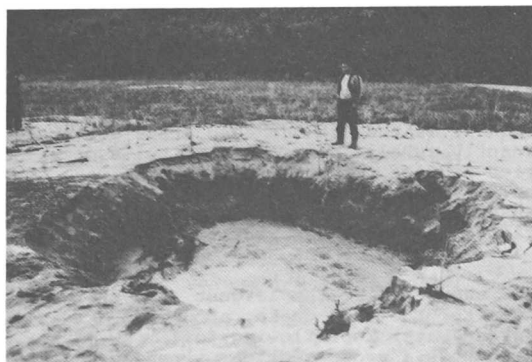
Fig. 8 shows one of the largest sand craters found after the 1983 quake, about 7 m across. The groundwater kept flowing for a few days. Fig. 9 shows a cross-section perpendicular to the coastline. Strong wind from the sea blew the dune sand to form so-called "blowout depressions" that were partly surrounded by parabolic dunes down wind (Kuwabara et al., 1985), as shown in Fig. 10. The blowout depressions became swampy, and then were filled by windblown dune sand in a very loose condition. That is where the giant sand boils were formed. Fig. 11 shows a cross-section of one of the giant sand boils.

Fig. 8 Giant Sand Boil in Shariki Village, Aomori Prefecture (Courtesy of Dr. I. Tohno)

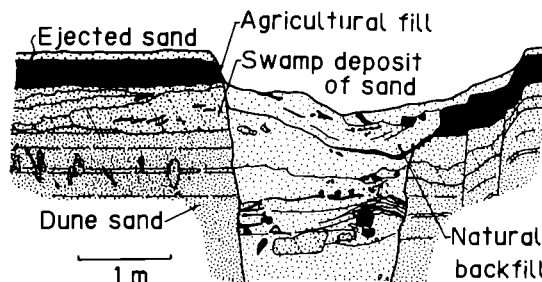
Fig. 11 Cross-Section of Sand Boil of Fig. 8 (Courtesy of Dr. I. Tohno)

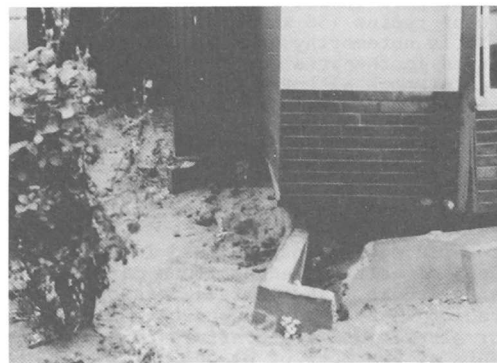
Fig. 12 Foundation of Wooden House Damaged due to Liquefaction

Unlike the Niigata earthquake of 1964 where small houses were seldom damaged, the 1983 earthquake caused extensive damage to light structures such as wooden houses (Fig. 12), or low concrete block walls (Fig. 13), probably because the surface soil liquefied during the ground shaking period.

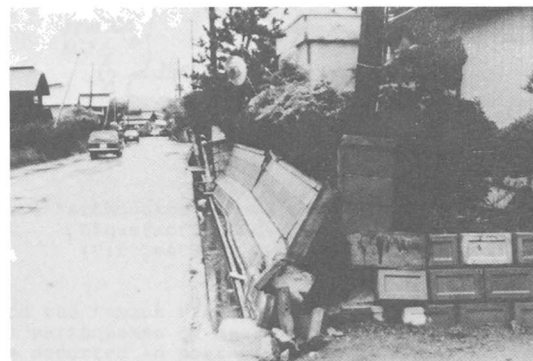
Fig. 13 Concrete Block Wall Damaged due to Liquefaction

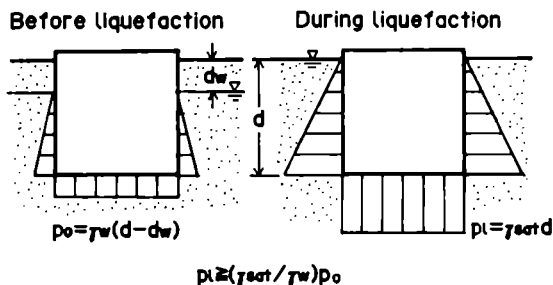
Underground facilities are quite vulnerable to soil liquefaction because the pore water pressure on the bottom increases at least 90 percent or so, while the side wall friction becomes zero. With respect to the example shown in Fig.

14, where  $d_w$  is about equal to  $d/3$ , the uplift pressure,  $p_1$ , becomes about 3 times the initial hydrostatic pressure,  $p_0$ . According to the Public Works Research Institute, about 20 underground liquid storage tanks were damaged due to the uplift pressure. Fig. 15 shows a 60-percent full gasoline tank that rose about 76 cm during the ground shaking. Fig. 16 shows a case in-

Fig. 14 Pore Water Pressure on Underground Object Before and During Liquefaction

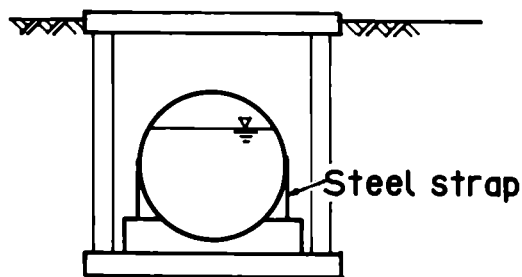
Fig. 17 Typical Cross-Section of Underground Fuel Tank

volving two kerosene tanks buried side by side, one about 1/3 full and the other nearly empty. The empty tank rose about 2 m. Fig. 17 shows a typical cross-section of an underground tank. In most damaged tanks, the steel straps were broken or the anchors were pulled out of the concrete base.

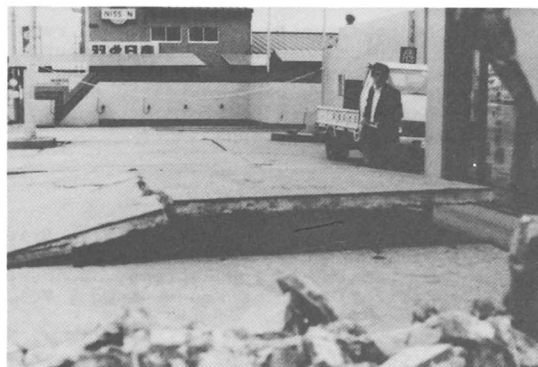
Fig. 15 Damage Caused by Uplift of 60-% Full Gasoline Tank

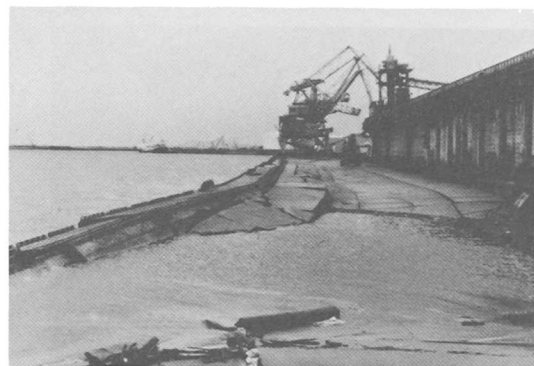
Fig. 18 Damage at Akita Harbor due to Failed Quaywall

Quaywalls are also quite vulnerable to soil liquefaction because the earth pressure increases while the lateral resistance decreases at the same time. Fig. 18 shows a typical damage at Akita Harbor caused by a failed quaywall, and Fig. 19 shows a more detailed description (Nakata and Terauchi, 1984).

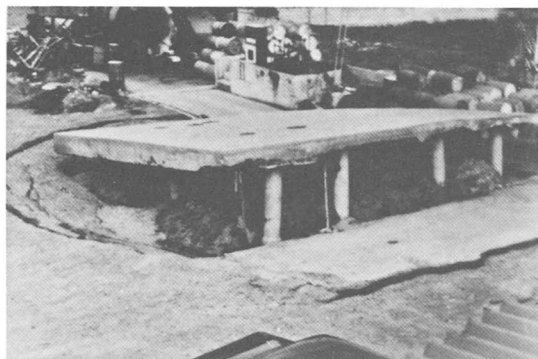
Fig. 16 Damage Caused by Uplift of Empty Kerosene Tank (Courtesy of Dr. E. Taniguchi)

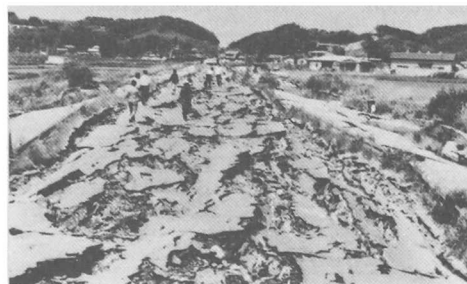
The roads were damaged at numerous places as a result of soil liquefaction (Fig. 20). Approach embankments to bridges were damaged at numerous places (Fig. 21), the damage rate being about 60 percent in the polder area.

Fig. 21 Approach Embankment to Bridge at Hachirogata Polder

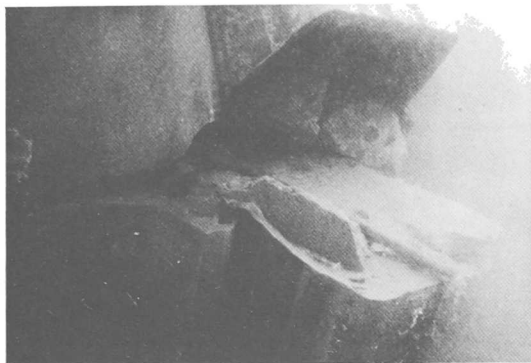
Fig. 19 Damaged Quaywall at Akita Harbor (Nakata and Terauchi, 1984)

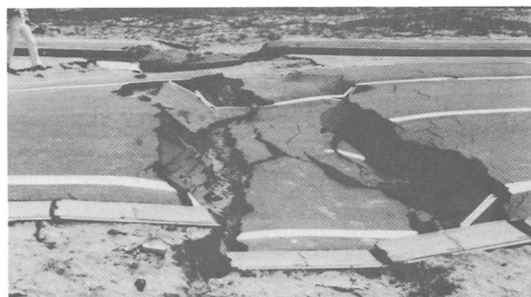
Fig. 20 Pavement Damaged due to Liquefaction
