# Induced Failure of an Instrumented Clay Slope

**R.J. MITCHELL**      Professor of Civil Engineering, Queen's University, Kingston, Canada  
**D.R. WILLIAMS**      Project Engineer, E.B.A. Engineering Consultants Ltd., Edmonton, Canada

**SYNOPSIS**      Piezometers, surface extensometers, lateral deflection meters and distortion gauges were installed in a natural slope composed of a sensitive fissured clay. These instruments were continuously monitored while the local ground water pressures were increased by recharge wells. Slope movements developed as the water levels in the slope were gradually increased and rotational failures occurred at a calculated safety factor very close to unity. The results are presented and analyzed with emphasis on the usefulness of slope distress monitoring instruments.

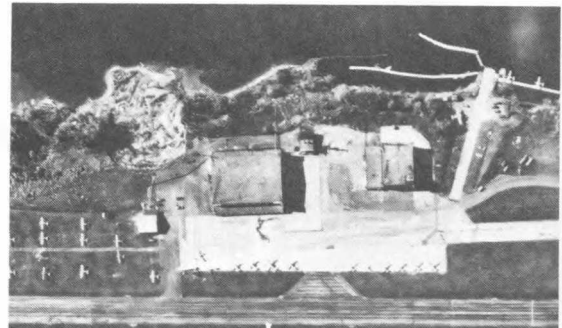
Fig. 1 Air Photo of 1967 Landslide

A natural slope oversteepened by toe erosion was selected for instrumentation. This slope was located on Department of National Defence (DND) Canada property along the Ottawa River in Ottawa and about 500 m downstream from a landslide, pictured on Figure 1, which had occurred in 1967. The interest and co-operation of DND personnel made this an ideal location for a large scale field experiment. Some physical properties of this clay are given in Table 1 and its behaviour in laboratory tests has been detailed by Mitchell (1970).

$r_u$ , for the slope was found to be zero, giving a calculated safety factor of 1.6 for the slope using the Bishop simplified equation in a computer analysis with strength data obtained by Schell (1978) for this site as  $c' = 12$  kPa,  $\phi' = 33^\circ$ . These strength values are identical to those found by Eden and Mitchell (1971) for the 1967 landslide site shown on Figure 1.

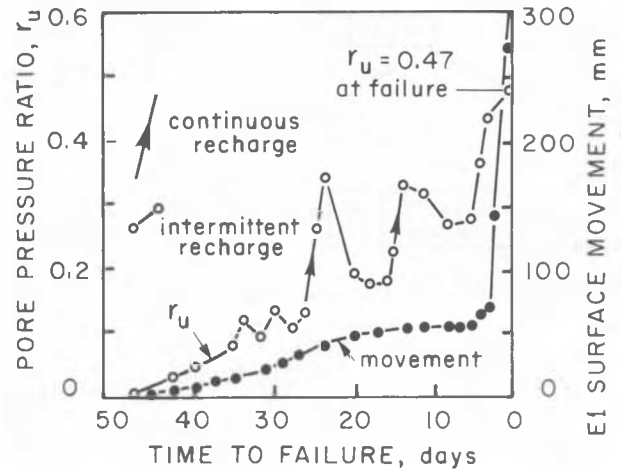
Fig. 7 Slope Movement and  $r_u$

about 0.35 and a tension crack appeared in the ground surface near the location of the junction box (see Figure 5) — the surface of the lower bench had experienced a total lateral movement of about 50 mm but the tension crack was less than 5 mm in width and there was no discernible vertical displacement across this crack. These observations indicate a general distortion of the slope rather than a rotational slip. The above noted results are displayed graphically on Figure 7.

Following this evidence of slope distress, the recharge was reduced and the average  $r_u$  value was maintained at about 0.2 for several days by operating the pump on timer intervals. As shown on Figure 7, the lateral slope movements ceased and the slope did not become active again until the average  $r_u$  value exceeded the previous peak of 0.35.

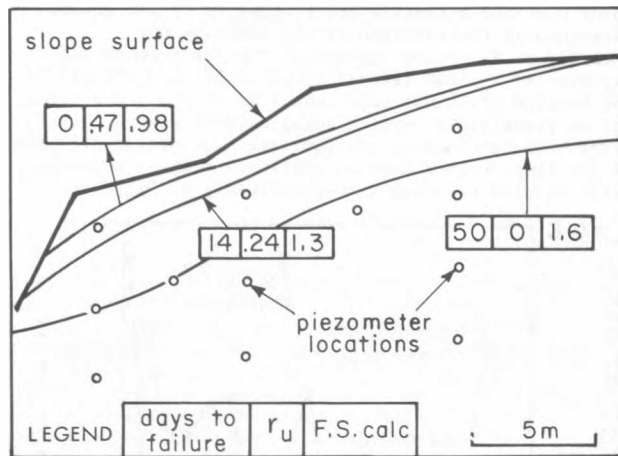
Fig. 8 Phreatic Surface,  $r_u$ , and Factor of Safety

Figure 8 shows the phreatic surface and calculated safety factors at three stages of the field test. For stability analysis,  $r_u$  values were obtained from piezometer readings as  $r_u = u/\gamma h_s$  for each computed slice of height  $h_s$  — the average  $r_u$  values noted on Figure 8 are obtained by averaging all  $r_u$  values for the lower two thirds of the critical circle.

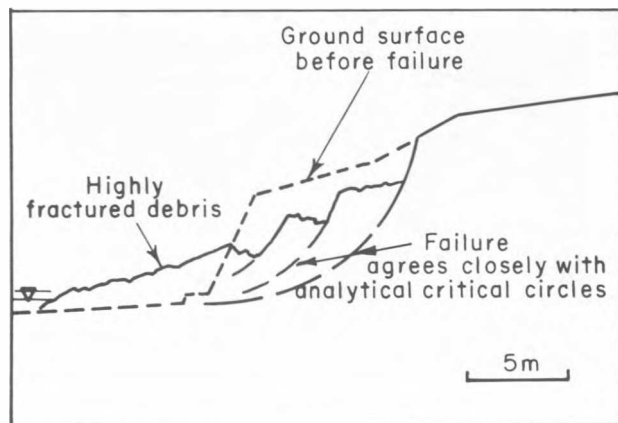
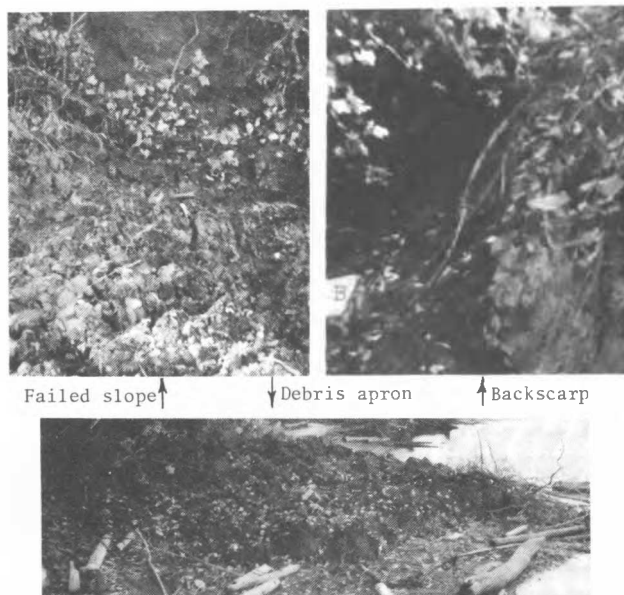
Figures 9 and 10 illustrate the three rotational slips that were observed on the day following the induced landslide. The field failure agrees closely with computed critical circles; for this benched slope, a range of analytical circles have closely similar safety factors. Further details on the analysis are presented by Williams (1979).

Fig. 9 Profile of Observed Landslide

Fig. 10 Failed Material

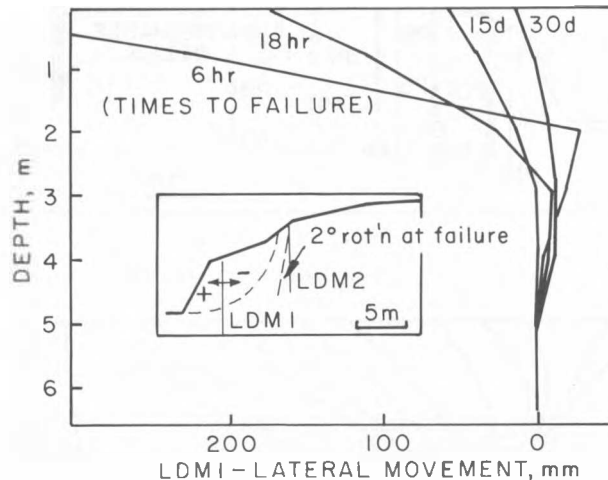
Fig. 11 Lateral Deformations, LDMI

The main purpose of this paper is to evaluate the displacement monitoring instruments with respect to their adaption as slope distress warning systems. Surface movements measured by extensometer E1 were presented on Figure 7. The lateral deformations recorded from LDM1 during various stages of the field tests are plotted on Figure 11. Measurable downslope

movements of the instrument were registered between 30 and 3 days prior to failure as the ground water pressures increased and the safety factor decreased. Major lateral movements developed in the upper 3 metres of soil during the 24 hour period immediately preceding failure. It is believed that this form of movement is caused by volume increase (dilation) within the soil mass as it approaches failure. Dilation at shear stresses above about 80% of the failure shear stress has been observed in drained triaxial tests and shear box tests on this fissured sensitive soil (Eden and Mitchell, 1970; Jarrett, 1972). Extensometer E2 and LDM2 showed very little surface movement up to two days prior to the slope failure. LDM2 was not anchored below the toe elevation; during the final 24 hours preceding the landslide this instrument showed a positive rotation of close to  $2^\circ$  (see inset, Figure 11). The rotation of LDM2 is considered to result from lateral stress reduction as the toe of the slope moved laterally toward the river. Distortion gauges D1 and D2 were positioned close to the analytical locations of critical failure arcs. These instruments cannot detect solid body translation or rotation but measure only local angular distortion (shear strain) within the soil mass. Figure 12 shows a plot of the measured shear strains. Both of these gauges reflected the development of shear strain within the slope about 8 days after the ground water recharge was initiated. This is considered to result from the increased stress ratio imposed on the soil by the reduction in the average effective stress. Following this initial loading reaction, gauge D2 showed a continued angular distortion which confirmed the deformation pattern that developed in LDM2 (i.e. a positive angular rotation). The reaction of gauge D1 is considered to be further evidence of mass dilation in the zone of shear rather than the formation of a rotational sliding surface. About 30 hours prior to failure, however, an increased rate of angular distortion was measured by gauge D2.

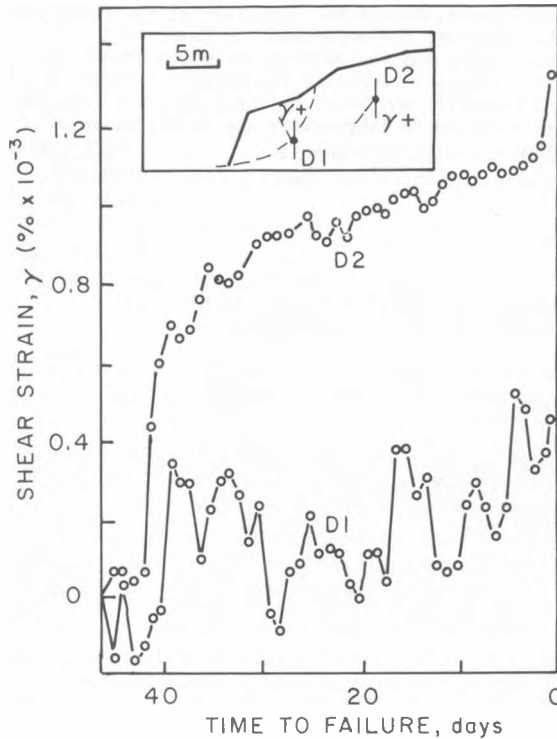
Fig. 12 Distortion Gauge Results

by Williams (1979) who concludes that these accuracies are sufficient to determine an angular rotation of  $\pm 1 \times 10^{-6}$  radians or a shear strain of  $\pm 1 \times 10^{-4} \%$ . Thus while some of the scatter on Figure 12 may be due to measurement inaccuracies, these types of instruments are considered to be capable of providing an early indication of slope distress.
