Failures of a Monozone Earth Dam of Expansive Clay

P.K. NAGARKAR Director, Maharashtra Engineering Research Institute, Nasik-422004, India
 R.P. KULKARNI Research Officer, Maharashtra Engineering Research Institute, Nasik-422004
 M.V. KULKARNI Scientific Officer, Maharashtra Engineering Research Institute, Nasik-422004
 D.G. KULKARNI Sr. Scientific Assistant, Maharashtra Engineering Research Institute, Nasik-422004

SYNOPSIS Failures of Waghad dam constructed of highly plastic clays at construction, steady seepage and drawdown condition have been analysed by Swedish slip circle and Bishop's semirigorous methods. The study indicated that the state of stability and the plane of slip are correctly represented by Bishop's method. Other important conclusions regarding behaviour of monozone dam at different conditions are also presented.

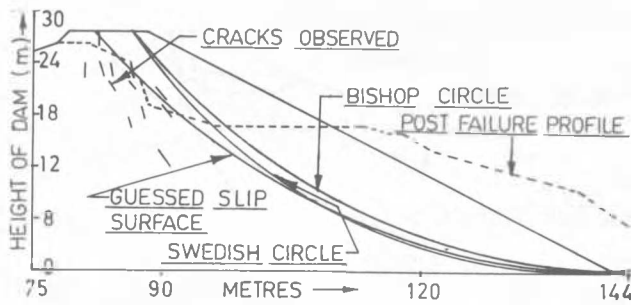
Fig. 1 Stability Analysis of 1884 Slip

The factors of safety for downstream slope by both the methods with the variation of pore pressure factors are so low that the dam section should have failed at a height much

lower than the height at which it failed. The dam actually failed almost at its full height. This indicates that the pore pressure developed in the dam during construction might be smaller than 0.1 and may actually be on the negative side. Figure 1 shows the slip surfaces based on crack pattern observed and obtained by both the methods of stability analysis for $ru = 0.1$. All the three surfaces are almost coinciding. Although reported by Strange (1898) that the quantity of water added into the soil during compaction was rather large still immediately after compaction of the soil negative pore pressures might have been developed. The expansive nature of soil might be responsible for development of rather large negative pore pressures which would not have become positive even after the addition of moderate overburden load (not more than 45 kPa) due to embankment construction. It, therefore, seems that even if there would not have been development of positive pore water pressure, 2:1 slope on the downstream side was inadequate and 3:1 slope as given to upstream side would have been just sufficient to make it stable.

The slope of the dam was not designed at that time (one century before) but was adopted empirically. This is an interesting and unique case where the downstream slope failed during construction not because of high construction pore water pressures but due to the inadequate section with regard to the shear resistance available. From this behaviour of the dam it may also be inferred that the embankment of moderate height constructed of expansive soil may not fail during construction because of development of high construction pore water pressures.

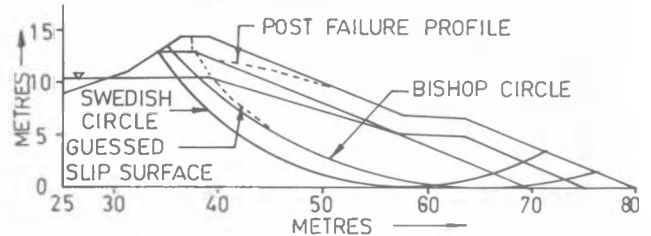
Fig. 2 Stability Analysis of 1907 Slip

The downstream slope at steady seepage condition might have failed because of inadequate section of this height of dam (14.37 m) for available shear resistance. Alternately

the cracks developed upto phreatic line throughout the slope during long drought period get filled up during heavy rainfall with consequent increase in pore pressures so as to make the cracked portion buoyant and lead to failure. To assess the role of first possibility, the stability analysis was carried out at steady seepage condition assuming that cracks are not developed on the slope surface by Swedish slip circle and Bishop's semirigorous methods. The critical factors of safety obtained are 1.04 and 1.18 respectively indicating that downstream slope is stable for this height of dam.

The effect of second possibility was assessed by incorporating a buoyant zone over the downstream slope upto phreatic line in stability analysis. The critical circles obtained by Swedish slip circle and Bishop's semirigorous methods are shown in Figure 2. The critical factors of safety obtained by these two methods are 0.72 and 0.83 respectively.

The results of analysis indicate that for steady seepage condition for the height of dam between chainages 320 to 412 m, the downstream slope is stable but when the steady seepage condition is accompanied by heavy rainfall particularly after scarcity years, the downstream slope becomes unstable. This inference is further confirmed by the fact that adjacent sections of dam of lesser height did not fail in similar circumstances.

The stable profile of the slope after failure is shown in Figure 2. The probable plane of failure is determined by drawing a cycloid by Collin's method (1956) and is shown in the same figure. The plane of failure thus guessed coincides with critical circle obtained by Bishop's semirigorous method and not with that obtained by Swedish slip circle method.

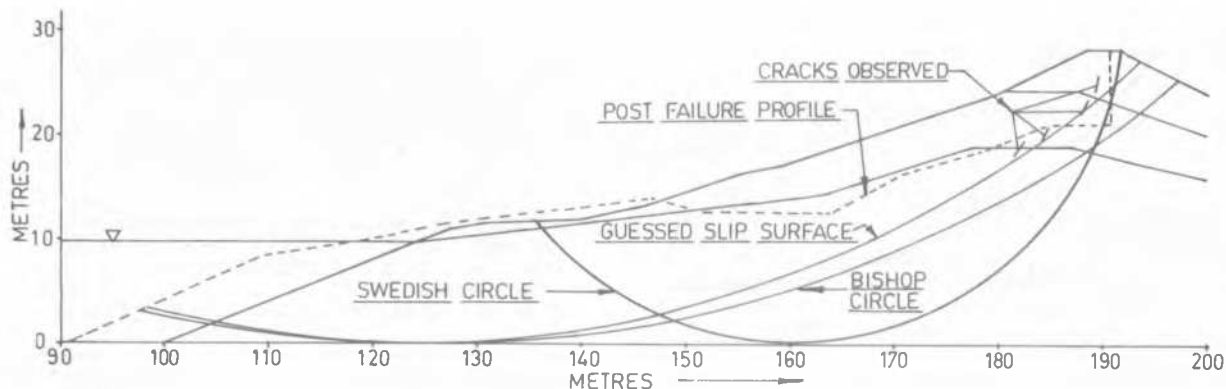
Fig. 3 Stability Analysis of Slip of 1919

The stability analysis of upstream slope was carried out with the cross section existing before the slip. The position of phreatic line at drawdown condition was determined from the observational data of Casagrande type piezometers installed at this location. The pore pressure during drawdown in between the positions of phreatic lines observed at steady seepage and drawdown conditions was taken as zero which is realistic. While below the phreatic line at drawdown condition it was considered equal to the height of phreatic line above the slip planes. The critical factors of safety obtained by Swedish slip circle and Bishop's semirigorous methods are 0.61 and 0.99 respectively (Figure 3). The slip plane determined on the basis of cracks observed is shown in the same figure. From Figure 3 it may be noted that Bishop's semirigorous method not only represents the state of instability correctly but also the plane of failure.

- 4) The state of failure of upstream slope in the year 1919, was accurately represented with reference to factor of safety (0.99) as well as position of slip surface by Bishop's semirigorous method. It may be noted that in this analysis observed pore pressures are considered. Thus there is a scope of improving the present design assumptions as regards position of phreatic line during drawdown. For this purpose more similar cases need be studied.
