Longterm Behaviour of a Dam in a Period of 108 Years

A. WACKERNAGEL Gruner SA, Basel/Switzerland

SYNOPSIS A dam constructed 108 years ago for the water supply of the city of Basle and having ever served its purpose is investigated with respect to safety. The construction materials are lake deposits. At the time of construction the safety of the dam is believed to have been close to unity. As creep has occurred during the life time the present safety factor is estimated to be near 1.14. It may be concluded that in the course of time the safety will increase. Regular checking of the deformation by measurements is, however, advisable.

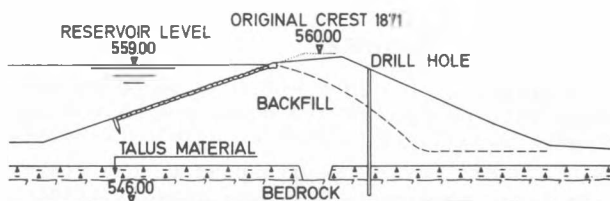
FIG.1 CROSS SECTION OF DAM
1978

The reservoir is formed by an earth dam having a height of 9.0 m. The upstream slope has an inclination of 1:3 and the downstream slope an inclination near 1:2.4. The length of the crest is 75 m. On the left abutment an open channel spillway having a capacity of 8.0 m³/sec is provided. The intake is formed by two steel pipes Ø 500 mm through the base of the dam (Fig. 1).

About the construction of the dam no detailed records are available. The drawings would indicate an impervious core and pervious outer sections. This could, however, not be verified. The cross section is more or less homogeneous. The backfill was started early in the year 1871 by a contractor. It was planned to be completed by the end of June 1871. However, in June 1871, following heavy rains, a flood occurred and

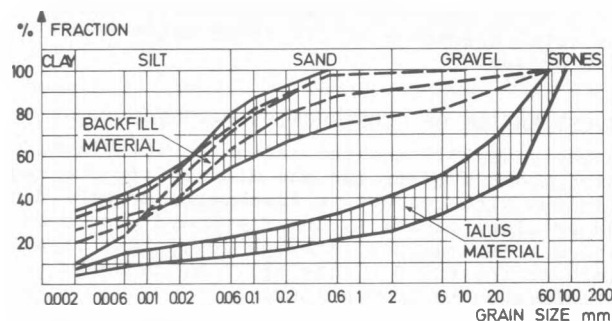
FIG.2 GRAIN SIZE DISTRIBUTION OF MATERIALS

The grain size distribution of the backfill materials and the talus materials are shown in Fig. 2.

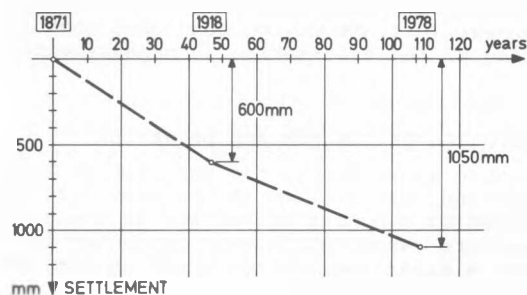
FIG.3 SETTLEMENT OF DAM CREST

During the life of the dam considerable settlements occurred. The magnitude of the settlements can be deduced from available records. Originally, the dam was constructed having a freeboard of 1.0 m. By the year 1918 the crest had settled 600 mm at the maximum section and was then heightened to the original level. By the year 1978 the crest had settled by another 450 mm, thus the average settlement within recent times being 7.5 mm/year. It is, however, a retarded movement.

The total settlement of the dam since construction is amounting to 1050 mm which is 12% of the height of the dam (Fig. 3).

The settlement to be expected from results of oedometer tests are not more than 470 mm. From this it may be concluded that the observed settlements of the dam crest are partly due to creep. From the results of oedometer tests it appears further that the present degree of consolidation of the dam is between 60% and 80%. Therefore, settlements will continue.

The dam has served its purpose ever since construction. As the movements are retarded, the safety of the dam will increase as time goes on. The behaviour will have to be checked by regular surveys.
