# The Teton Dam Failure — A Retrospective Review

H.B. SEED and  
J.M. DUNCAN

Professors of Civil Engineering, University of California, Berkeley, CA, USA

This paper reviews the events leading to the failure of Teton Dam in Idaho on June 5, 1976 and the investigations, conducted over a period of several years, to determine the cause of the failure. Conclusions are presented regarding the probable trigger mechanisms which initiated the failure, the mechanics of failure and the significant lessons concerning earth dam design and construction resulting from the investigations.

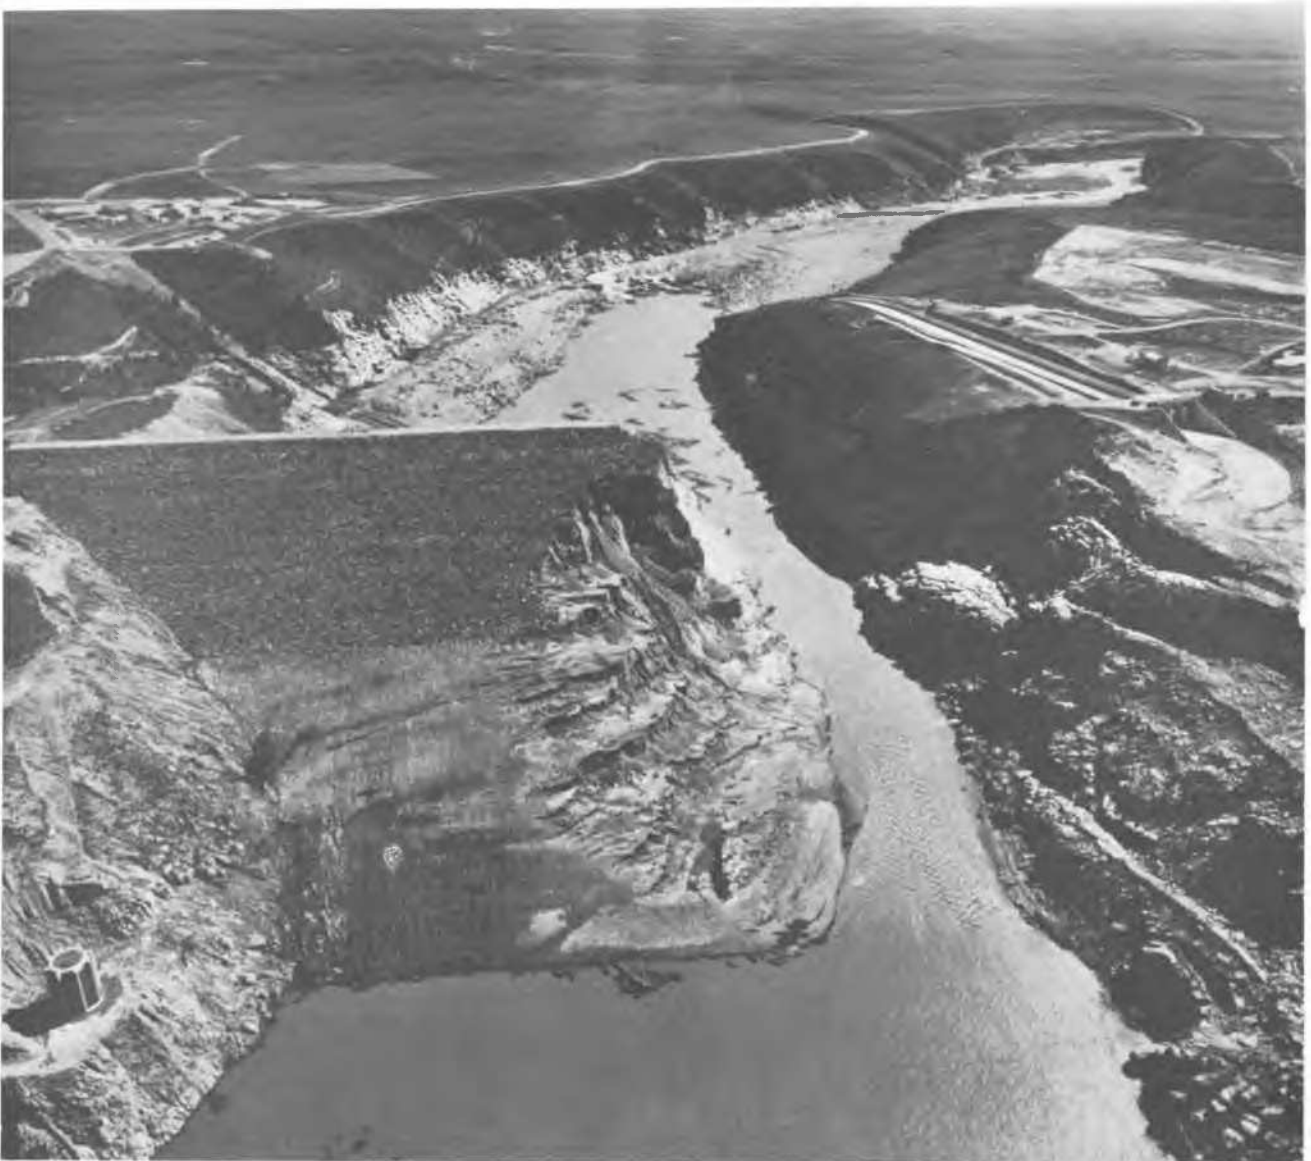
Fig. 4 View of Teton Dam After Failure

On June 5 at about 7:00 am, when the first workers reached the site, water was observed to be flowing from the downstream face of the embankment about 130 ft below the crest (at about El. 5200), the flow of about 2 cu ft per second coming from a point near the junction of the embankment and the abutment at about Station 14+00 on the right abutment. At about the same time a flow of about 25 cu ft per second was observed emerging from the talus near the toe of the embankment.

The water in this latter flow was clearly dirty. In the next three hours the rate of flow from the higher elevation gradually increased to about 15 cu ft per second and at about 10:30 am, one eyewitness reports a loud burst and a coincident movement of the seepage to a point about 15 ft in from the abutment. From this time onwards the seepage increased rapidly accompanied by progressive upward erosion; at 11:20 am the eroded hole in the dam was so large that bulldozers sent to fill the hole sank into the flow, and at about 11:55 am the dam crest was breached and a complete failure occurred. The resulting flooding downstream caused the loss of 14 lives and about 400 million dollars in damage. A view of the embankment after failure is shown in Fig. 4.

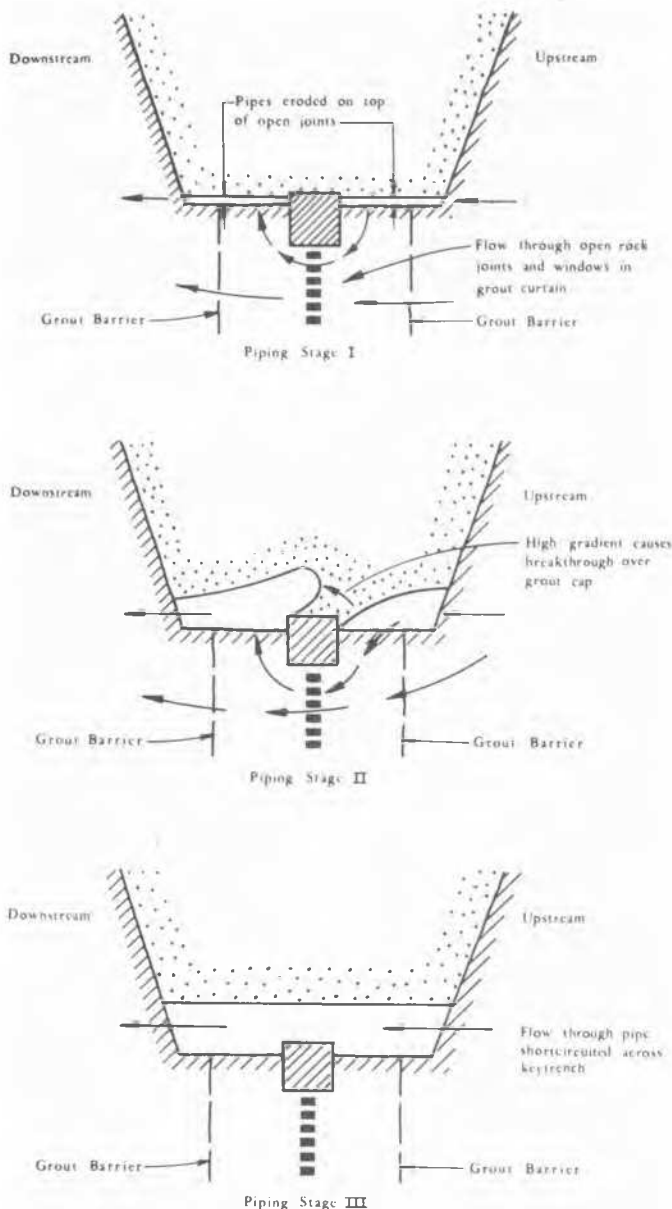
Fig. 6 Conceptual Mechanism of Failure Due to Seepage Under Grout Cap

The first of these was that seepage under the grout cap in unsealed joints in the rock could have led to erosion along the base of the trench and thereby to a piping failure through the key trench fill. The conceptual mechanism for such erosion is illustrated in Fig. 6.

cap. A small pond on the upstream side of this joint showed a flow rate of 28 gpm but the flow was limited by the capacity of the hose used for filling the pond. Such tests revealed a number of joints between Stations 13+00 and 13+90 through which water could pass freely beneath the grout cap. Accordingly this hypothesis of failure was considered plausible.

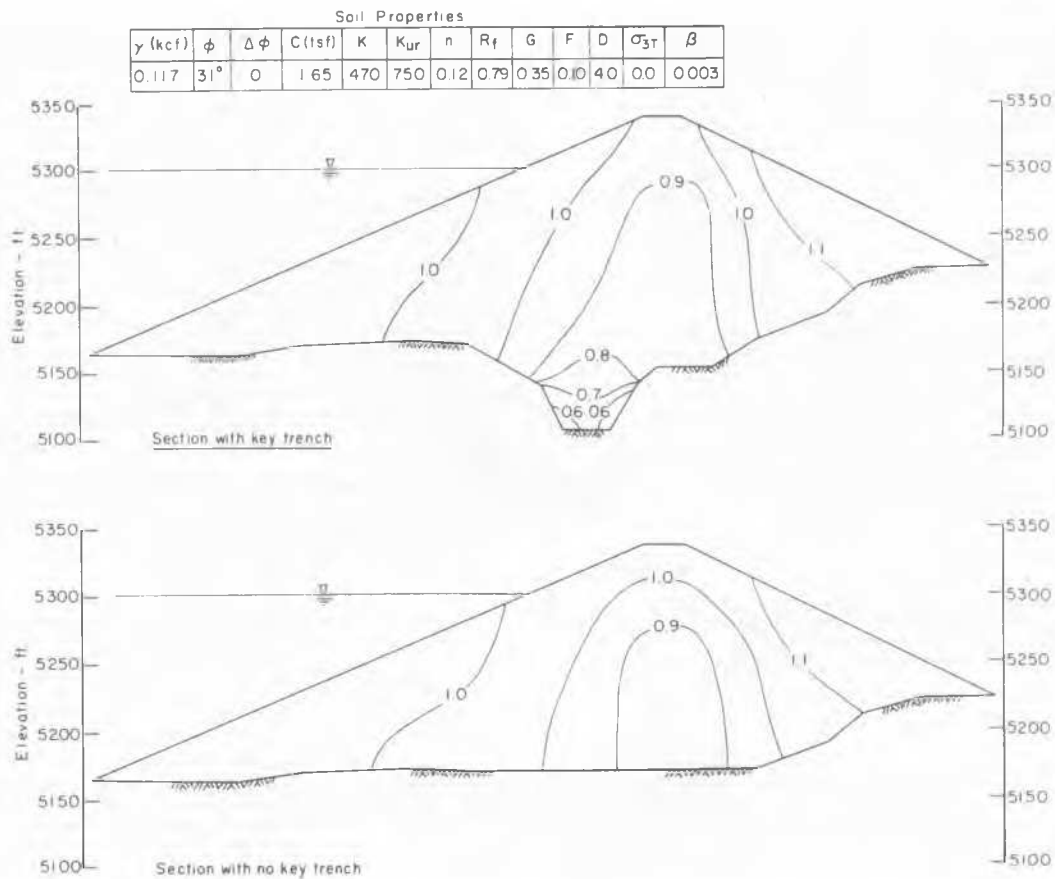
Fig. 7 Computed Values of Vertical Stress Expressed as a Proportion of Overburden Pressure - Station 15+00 - Before Wetting

The possibility of arching over the key trench with a corresponding reduction in stress on the key trench fill is clearly evident from the geometry of the section shown in Fig. 3. A calculated stress distribution in the embankment and in the key trench at Station 15+00 before wetting of the fill is shown in Fig. 7. Vertical

pressures are shown as a proportion of the overburden pressure and the marked reduction in stress in the key trench is clearly apparent.

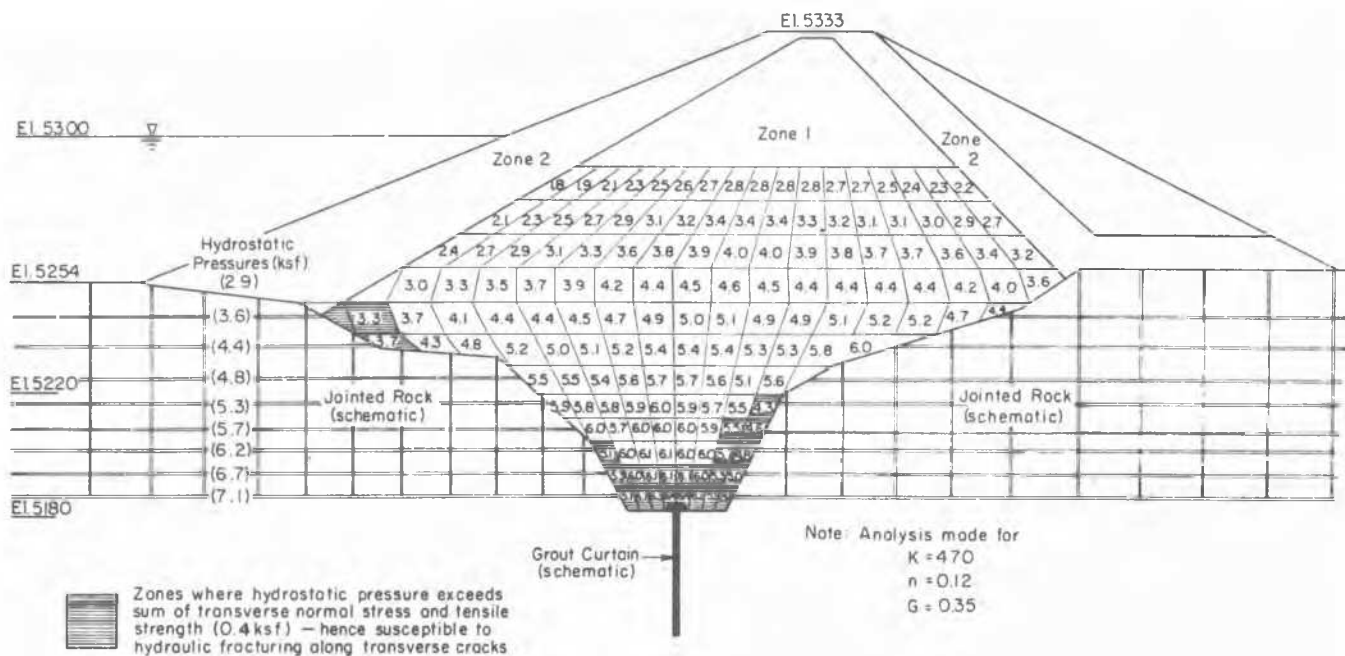
Fig. 8 Computed Values of Normal Stress on Transverse Section in ksf Sta. 13+70 and Comparison with Upstream Hydrostatic Pressures

Finally comparisons were made of the computed values of transverse stress in the key trench fill with the water pressures developed on the upstream side of the fill. It was considered that fracturing might occur if the water pressure exceeded the sum of the transverse normal stress and the tensile strength of the soil. A comparison of these stresses at Station 13+70 is shown in Fig. 8. The soil zones where fracturing could develop on the basis of the foregoing concept are shown shaded in the figure.

From such analyses it was concluded that hydraulic fracturing could possibly have occurred in the range of Stations 13+70 to 15+00 but it was not likely to develop elsewhere on the right abutment. Since this range of stations coincided with position of the seepage and erosion failure of the dam, the possibility that the failure could have been caused by this mechanism was considered plausible.

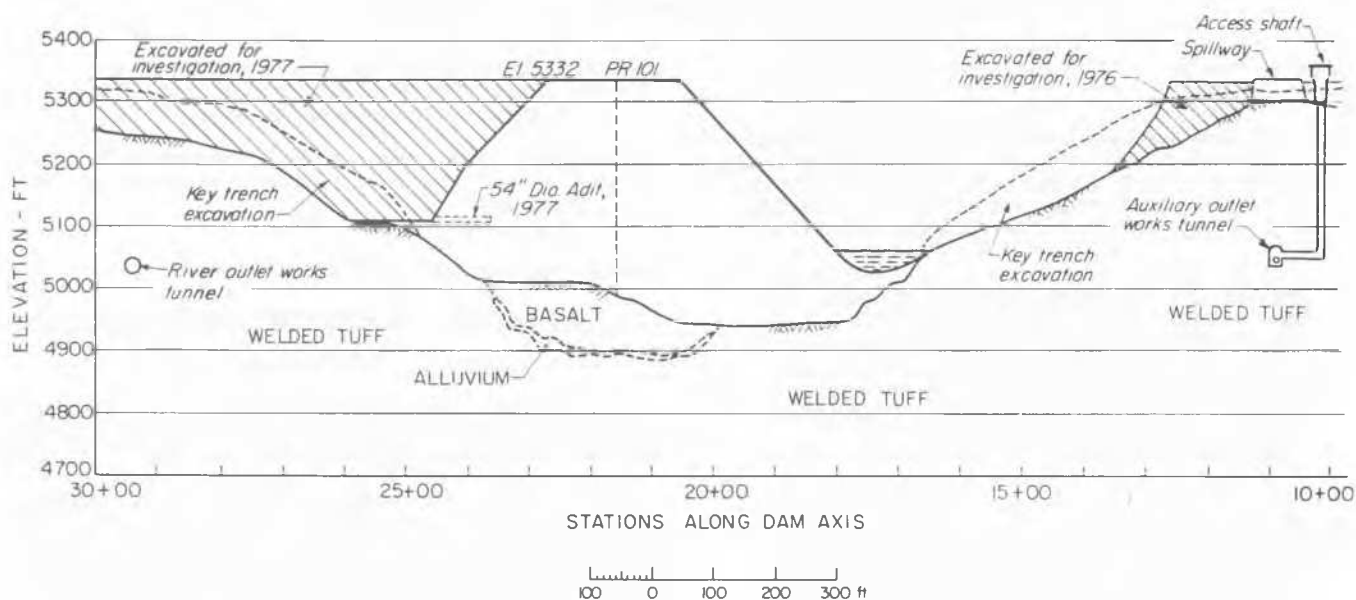
Fig. 9 Excavation of Embankment on Left Abutment in 1977

During the summer of 1977 the embankment fill overlying the left abutment key trench was excavated and careful observations were made of the conditions of the fill. The extent of this excavation is shown in Fig. 9. No findings of major significance were noted until the excavation had almost reached the base of the key trench, when a thin zone of soil of very high water content was encountered. A few hours after it was discovered, water was found to be seeping from the exposed face of this zone. The zone was termed a "wet seam." The investigations of the wet seam and other studies are described in the Final Report of the Interior Review Group, issued in January, 1980.

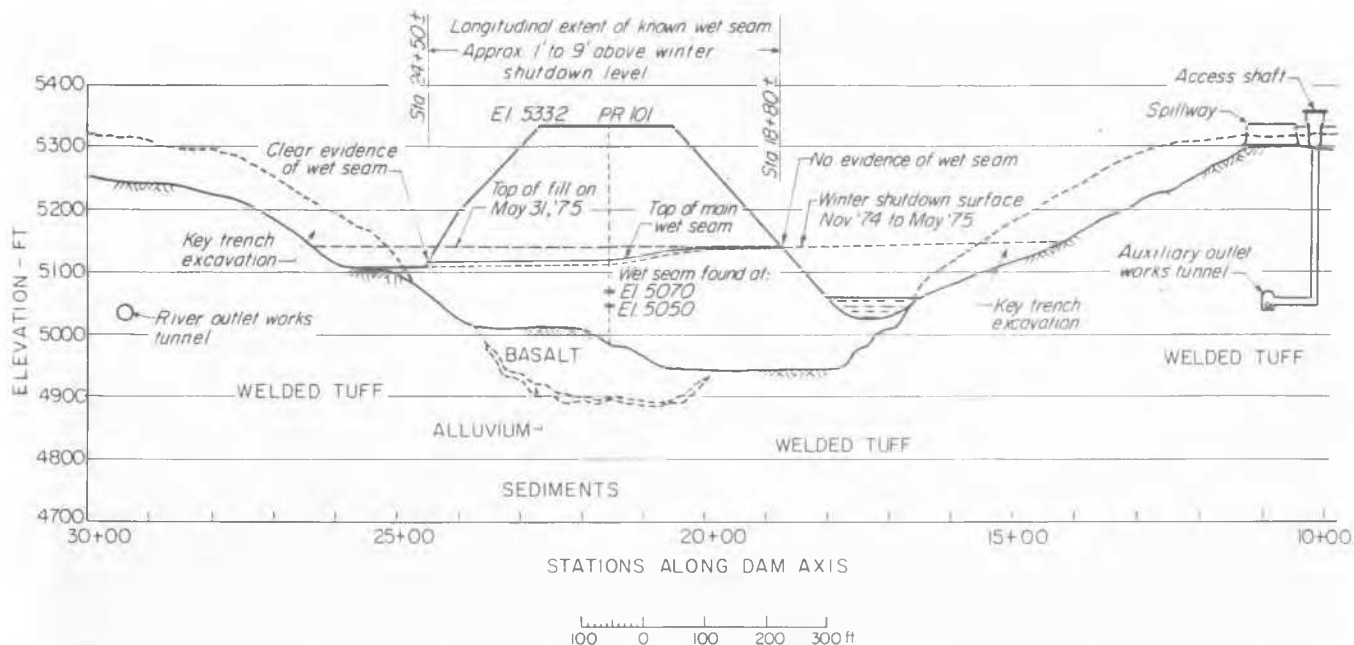
Fig. 10 Zone of Main Wet Seam Between Els. 5112 and 5139

The initial wet seam discovered during the excavation of soil above the left abutment varied in thickness from 3 to 8 inches but as the investigations progressed and the extent was determined by means of borings in the remaining embankment, other wet seams were found. Each seam was usually less than 4 inches thick but in some areas, multiple seams, one above the other, were found. For example, in Boring No. PR-107 near the left abutment, such seams were found at Elevations 5112, 5115, 5117.5 and 5119, covering a depth of about 7 ft, while in Boring PR-108 near the center of the embankment, a single wet seam was found with a depth of about 5 inches. The total depth of the zone of wet seams never exceeded 12 feet at any location and it tended to become thinner as it approached the center portion of the embankment, the outermost borings (towards the center of the dam) showing no conclusive wet seams. The position of the main wet seam is shown in Fig. 10.

1. The location of the main wet seam was essentially parallel to and just above the 1974-75 winter shut-down surface (see Fig. 10). This finding seems to eliminate frost action in the soil placed in 1974 as a possible cause of the wet seam.
2. The soil in the embankment where the main wet seam was found to exist was placed in the period April 29 to May 29, 1975. During this period of construction "there were two extended periods of shut-down due to wet weather (May 6-11 and May 22-26)....Also construction inspectors reported either snow or rain occurring during construction on May 5, 6, 19 and 21."

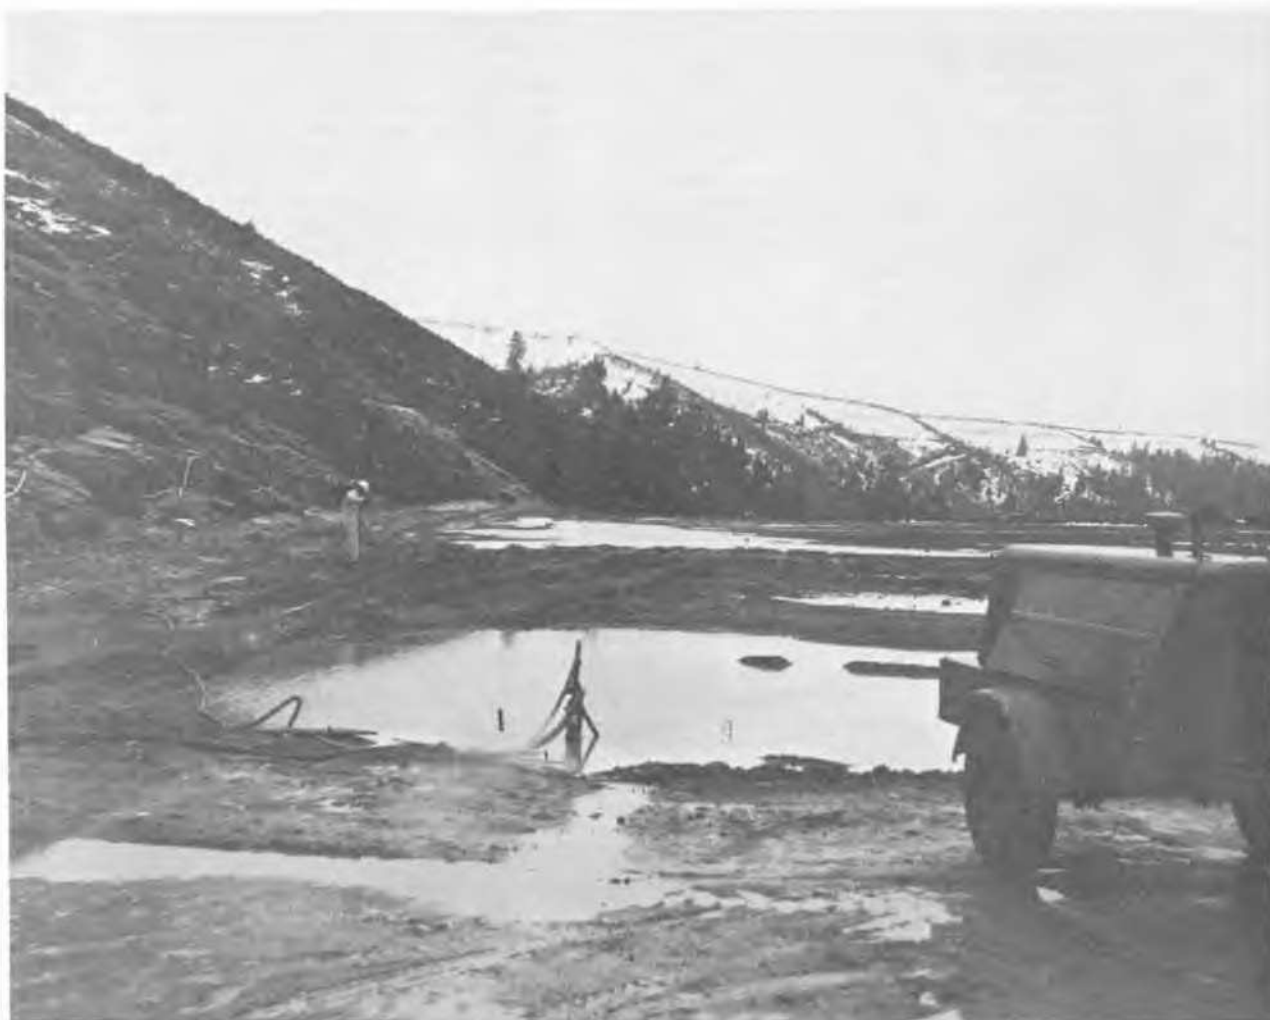
Fig. 11 Photograph of Water Ponded on Fill on Left Side of Embankment on May 7, 1975

3. "The fill surface was wet on several days, particularly May 1, 6, 7, 19 and 21.... Ponding of water on the surface was reported during each shut-down period.... Since the embankment fill was higher near the right abutment than the left abutment during the 1974-75 winter shut-down, there was a water ponding problem on the left side embankment during periods of precipitation. This problem existed until late May, 1975." A photograph of the water ponded on the fill near the left abutment taken on May 7, 1975 is shown in Fig. 11.

"There was a significant volume of rain and snow during May, 1975 and the infiltration capacity of Zone 1 (core) material is greater than ordinarily anticipated. The amount of removal of wet embankment surface material was minimal following the periods of construction shut-down due to wet weather. The time spent to prepare the wet surface for new fill placement was relatively brief."

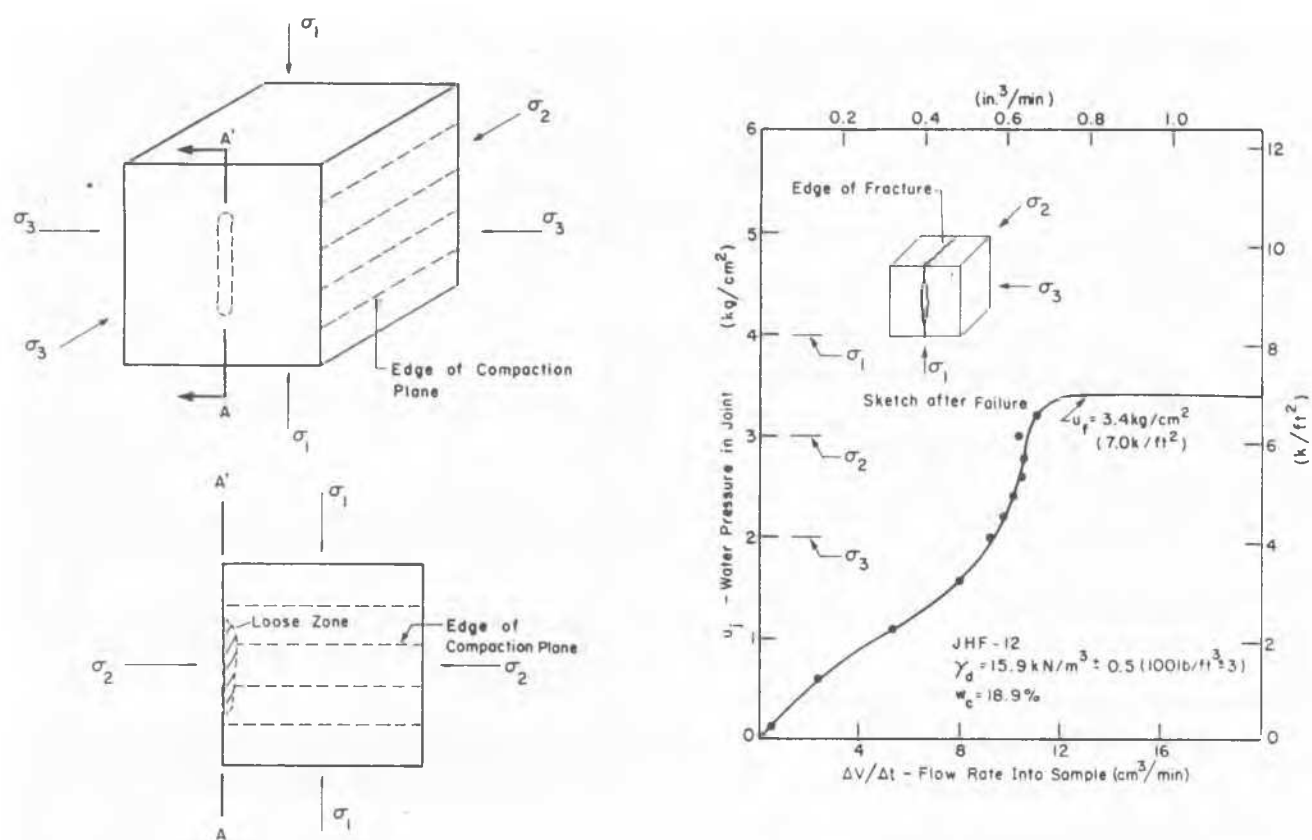
Fig. 17 Test Conditions and Results for Fracture Tests on Soil Compacted Adjacent to Slot

As shown in Fig. 17, attempts to compact the soil adjacent to the open slot or joint led to the formation of a loose zone of soil in this region. When water pressure was introduced into the slot it quickly penetrated the loose zone and acted to wedge the soil apart and cause hydraulic fracturing. As shown on the right side of Fig. 17, fracturing did occur at a water pressure ( $u_f$ ) which exceeded the value of  $\sigma_3$  by  $1.4 \text{ kg/cm}^2$ . This is within the range of values measured in the borehole fracturing tests. The observed fracture coincided with the loose zone adjacent to the simulated rock joint and followed the  $\sigma_3$ -plane across the sample. Similar failures were found in other tests where similar discontinuities were created on the side of a test sample.

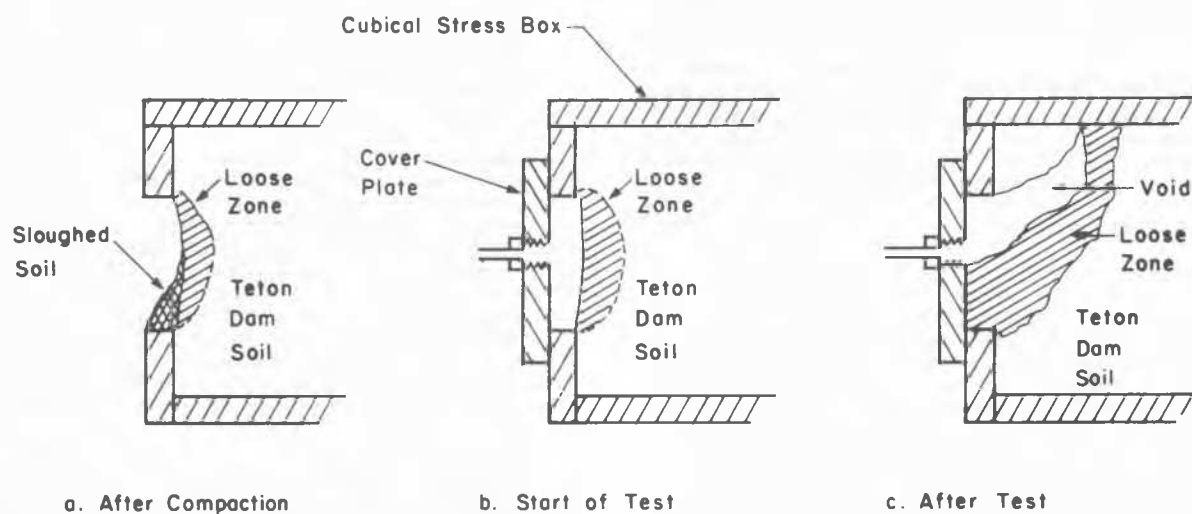
Fig. 18 Sloughing of Soil Around Simulated Rock Joint

In another rock joint test it was found that when water was introduced into the simulated rock joint, the loose soil sloughed into the joint, as shown in Fig. 18. The size of the sloughed zone increased progressively, eventually involving well-compacted as well as poorly-compacted soil, and working its way inward and up to the top of the sample. This observation

seems quite significant, because it indicates that the size of a discontinuity resulting from a rock joint can be many times the dimensions of the joint if the soil sloughs as shown in Fig. 18. Clearly not all soils will be vulnerable to sloughing in this way, but some samples of the aeolian silt which formed the core of Teton Dam have this characteristic.

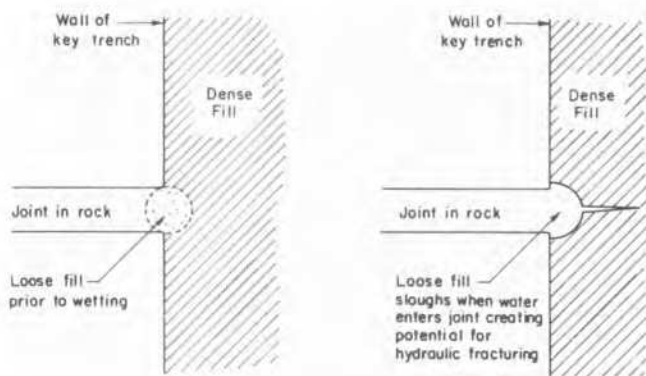
Fig. 19 Conceptual Mechanism of Hydraulic Fracturing in Key Trench Fill

These observations suggest the mechanism of hydraulic fracturing of the Teton Dam key trench fill which is illustrated in Fig. 19. It was

concluded that a zone of loose soil formed during compaction of the fill against the wall of a trench containing a vertical joint. When the water level rose in the joint, the saturated soil fell out leaving a cavity in the fill adjacent to the joint. The gradually increasing water pressure acting on the walls of this cavity was then able to cause hydraulic fracturing across the key trench.

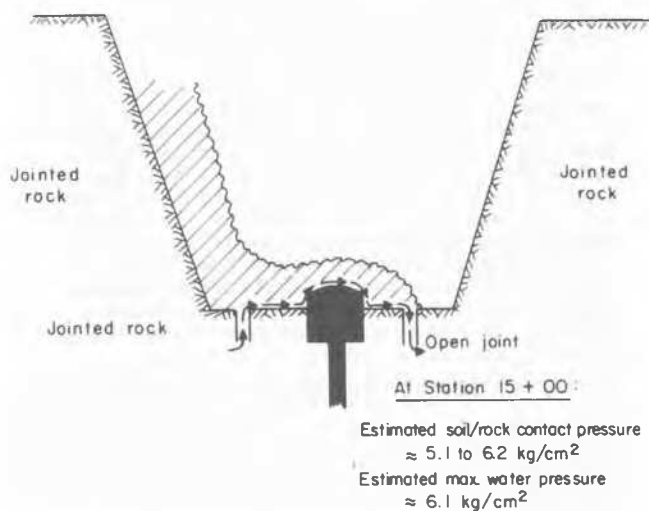
Fig. 22 Piping Due to Seepage and Sloughing Over Base of Key Trench

- (3) Seepage through the soil near the base of the key trench, facilitated by sloughing of wetted fill into open joints, thereby progressively increasing the hydraulic gradient as illustrated in Fig. 22.

All of the failure mechanisms postulated above could have been prevented if adequate protection of the Zone 1 fill against internal erosion had been provided in the original design. Such protection would have involved appropriate treatment of the rock to ensure that all joints in contact with the core material were sealed, together with the provision of a suitable filter system for the highly erodible fill. By these means erosion could have been prevented and failure could not have occurred. Thus while the new investigations indicate additional modes of failure to those proposed in 1976 and 1977 they do not change the basic conclusion of the report of the Independent Panel that:

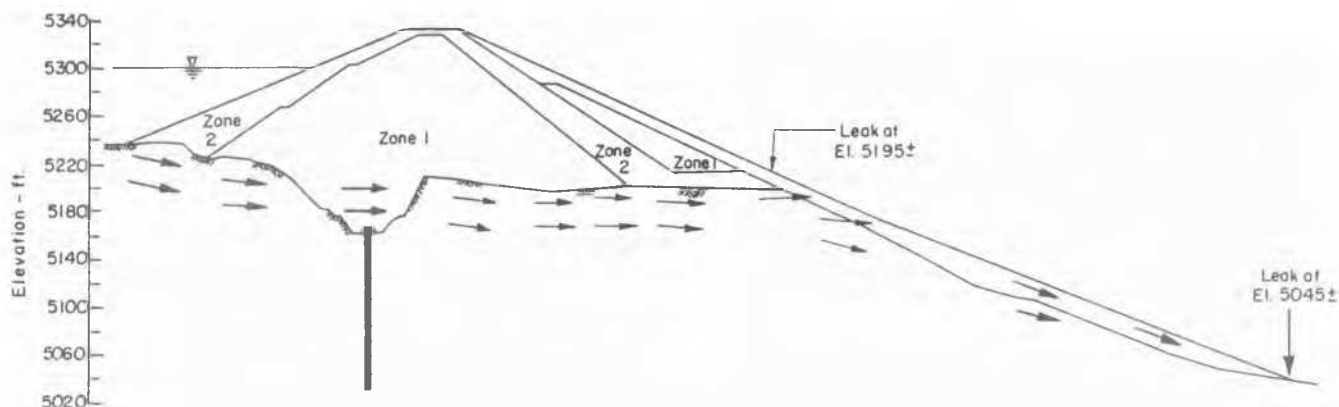
Fig. 23 Probable Path of Water in Early Stages of Leakage

"In this way the initial seepage probably eroded a small channel along the base of the dam, both upstream and downstream with the seepage flowing under the Zone 2 material, down the talus on the upper part of the right abutment and finally emerging as the leak at the toe of the dam on the morning of the failure.

"As the flow continued, further erosion along the base of the dam and a resulting concentration of flow in this area, led to a rapid increase in the size of the eroded channel. At this stage water probably began to emerge at the contact of the embankment with the underlying rock at about El. 5190 to 5200.

"Progressive erosion led to continued increase in the size of the channel along the base of the dam, and perhaps some erosion of the soil above Zone 2 until finally the water pressure was sufficiently great to break suddenly and violently through the Zone 2 fill and erupt on the face of the dam.
