Failure of Waste Fill Buried within a Soft Clay

F.E.BARATA Prof., Eng. School, Federal Univ. of Rio de Janeiro, Soils and Foundation Consulting Engineer, Brazil

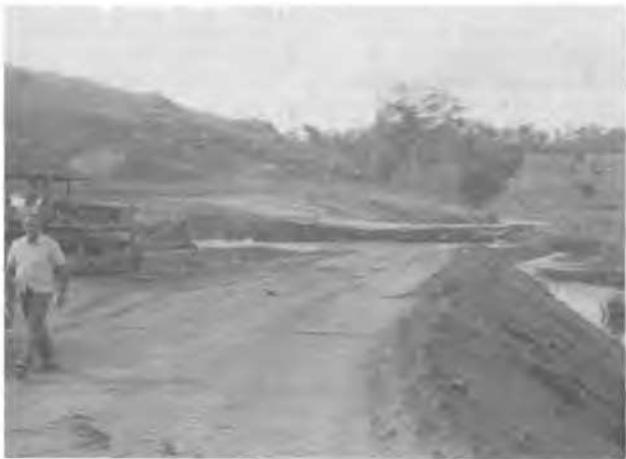
Fig. 2

The Author visited the place to see the beginning of the construction of the new rail-road fill. While taking a walk over the waste-fill, accompanied by other engineers, the failure occurred. Many cracks appeared suddenly and advanced rapidly in numbers and openings. The extreme side of the waste fill had opened in a few seconds, giving way to a large stream of retained water (See Fig. 2).

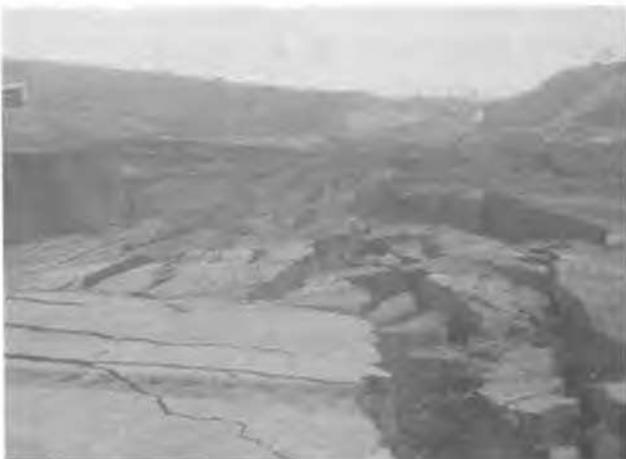
Fig. 3

New cracks continued arising and opening up, rather like an earthquake (See Fig. 3), across a long portion of the waste fill, which displaced vertically and laterally. As a result, some vehicles became isolated (See Fig. 4) during some minutes, but were removed

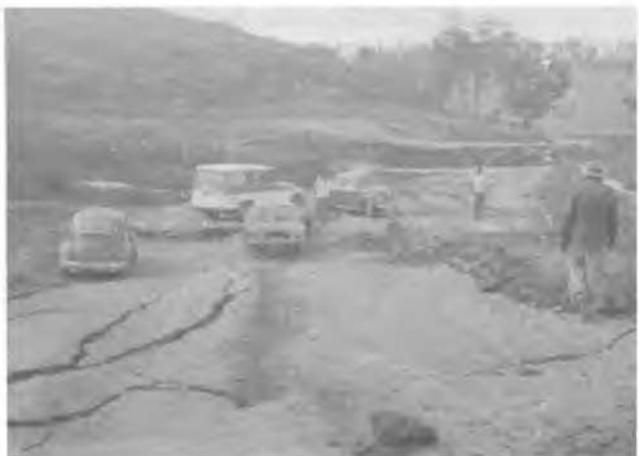
Fig. 4

in good time along a way prepared quickly by a bulldozer.

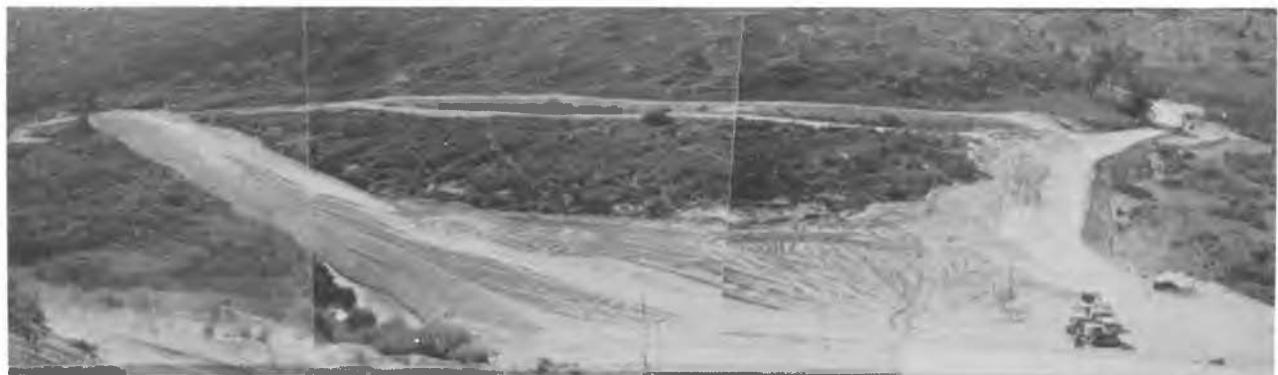
Fig. 5

Besides the photographs taken on the waste-fill during the failure, the Author took the opportunity of photographing panoramic views one before (See Fig. 5) and the other after the failure (See Fig. 6). Such views were taken from a hill located 40 meters above the swamp area.

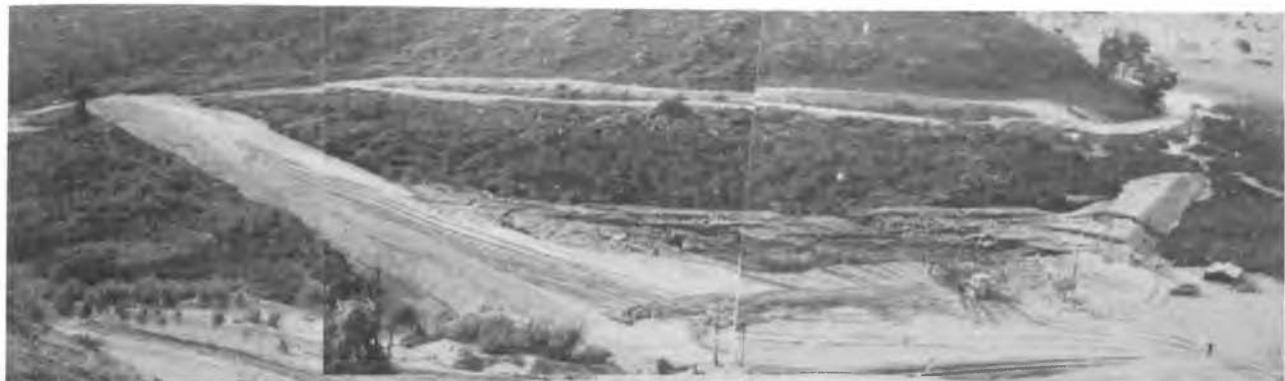
Fig. 6

It is worth noting that at the moment of the failure, the Author observed that the whole extent of L' was the first part to displace and sink, even though all the 50 meters ($L' + L''$) had undergone movements and cracking since the beginning. The sinking of the extent L'' occurred later. It is interesting to note also the deflection undergone by the remaining part of the waste fill (See Fig. 6).

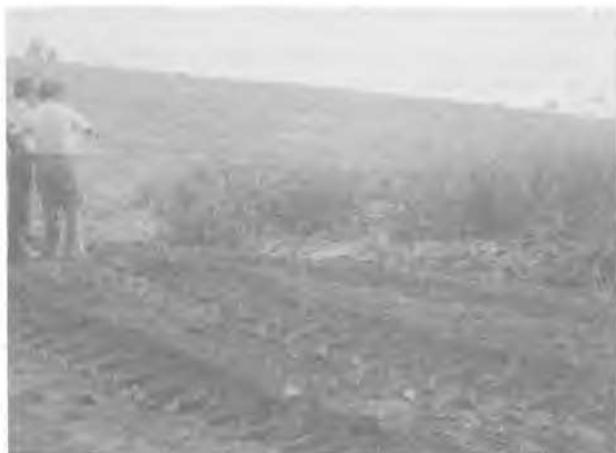
Fig. 7

The Author searched to investigate the main and probable causes of the failure and its mechanics. An stability analysis demonstrated that the failure was due to an increase of earth-pressure arising from a mud surcharge risen adjacent to the fill (See Fig. 7). The sketch in Fig. 8 shows the most probable sequence of events and movements during the failure. The phenomenon may be classified as a Composite Rupture, started by a translational slide which was followed by spreading and a final and complete immersion of the fill

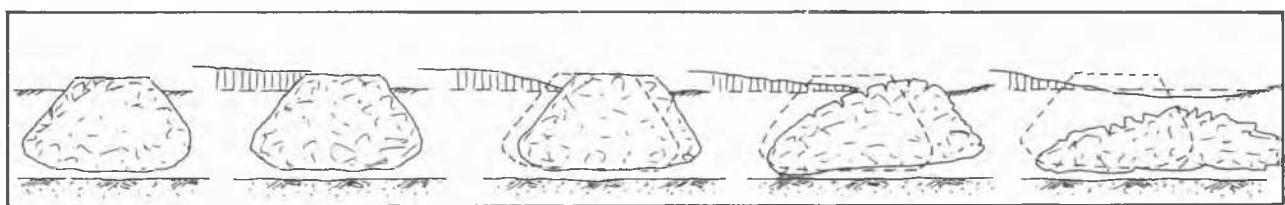
Fig. 8

A typical transversal section of a buried fill is presented in Fig. 8. In the analysis however, that section was simplified to a

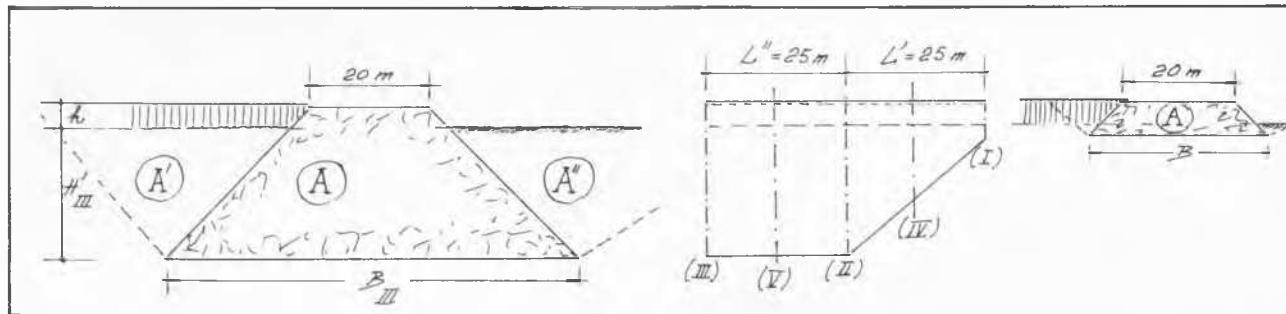
Fig. 9 shows the longitudinal and transversal sections of the failed waste fill.

(See Fig. 9 with areas Λ , Λ' and Λ'')
