A Liquefaction Case History, Chiapas, Mexico

R.J.FLORES-BERRONES Research Professor,
A.W.DAWSON Research Professor at the National Autónoma University of México, Mexico

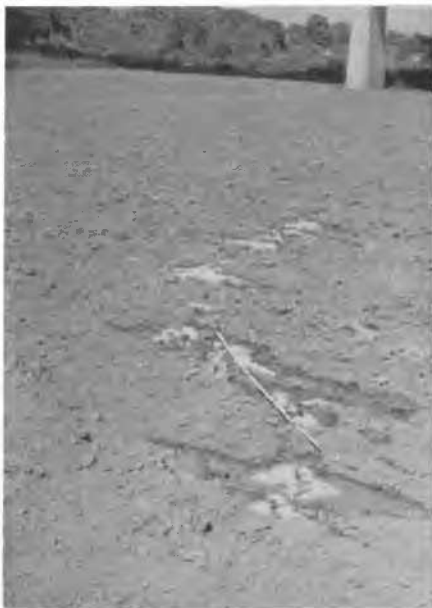
The main evidence of liquefaction consisted of long cracks in the ground from which sand and water flowed out in a liquid condition (figs 2 and 3). The cracks were only found in the nearly horizontal fields of recent alluvium adjacent to the river and ran parallel to the river and/or contact with compact terrace deposits which stratigraphically underlie the alluvium. No transverse cracks and only a few sand volcanoes or boils were observed. The longitudinal cracks which expelled sand and water in a liquid condition varied from only a few meters to more than fifty meters in length; these cracks were observed by the authors in numerous areas of the recent alluvium along the Santo Domingo River, and farmers in the zone reported similar descriptions in many other analogous areas. Locating the cracks was very difficult in fields which were not recently plowed because of the thick vegetative cover in the area. The cracks were typically only a few centimeters wide and large lateral displacements of the fields did not occur; this was probably due partly to the flat topography of the recent alluvium and partly to the short duration of shaking. The earthquakes occurred during the dry season when the river itself was only 50 cm deep and the ground water table in the adjacent fields varied between 1 and 2 meters in depth.

Fig 2. A crack from which sand and water flowed out

The principal manifestations of the liquefaction consisted of long cracks parallel to the river with expulsions of sand and water in a liquid state. The volume of expelled material was relatively small, and only spread some 50 cm on either side of the crack to a depth of several centimeters.

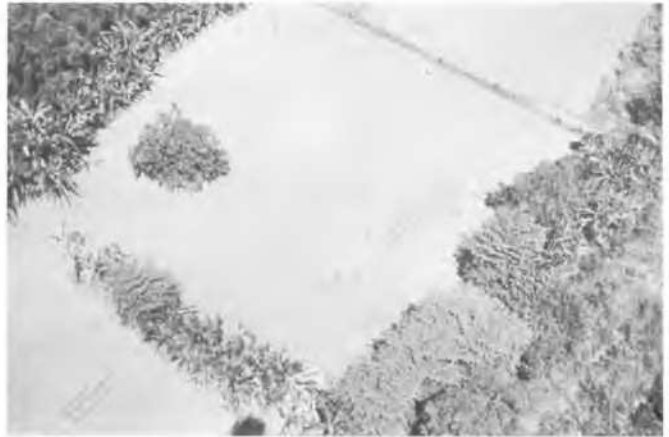
Fig 3. Aerial view of some cracks with liquefied sand

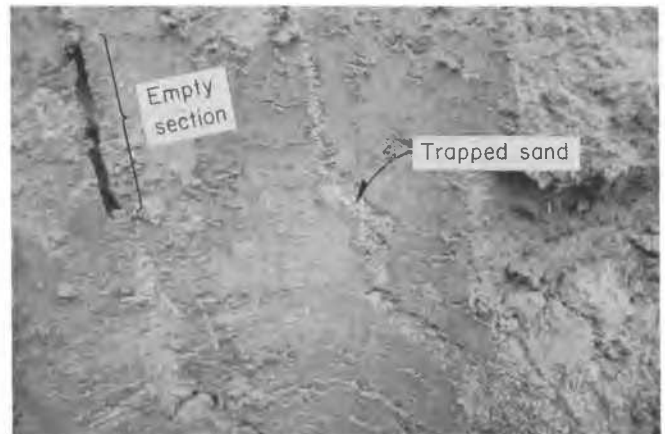
An open pit was excavated around a crack with expelled sand in the field adjacent to the Santo Domingo Bridge in order to get a better view of the phenomenon (fig 4). The ground water table was found at a depth of 1.3 m. Fig 4 shows a pair of cracks in the cohesive surface layer which filled and trapped the liquefied sand when the pore pressure dropped and the crack closed somewhat. The crack was generally narrower near the ground surface than at the ground water table where it was often empty. It typically was composed of only one branch up to 4 cm wide. The grain size curves of the liquefied sand found at the crack at the test pit and from other areas are shown in fig 5. The sand which liquefied appears to be mostly a uniform medium to fine granular material with little or no fines. The individual grains are generally subangular to sub-rounded in shape.

Fig 4. A front view of the cracks at the open pit

All of the cracks observed in the recent alluvium were parallel to the river and/or contact with underlying firm terrace deposits. No transverse cracks were observed and although lateral displacements of the fields were generally small, some of the fields appeared to have moved as a massive unit. It is believed that this kind of liquefaction manifestation is typical when the topography of the recent alluviums is relatively flat and a surface layer of cohesive material exists. In such cases it would be useful to dig shallow trenches and carefully try to lo-

cate such cracks as an auxiliary means of evaluating the liquefaction potential at future construction sites.

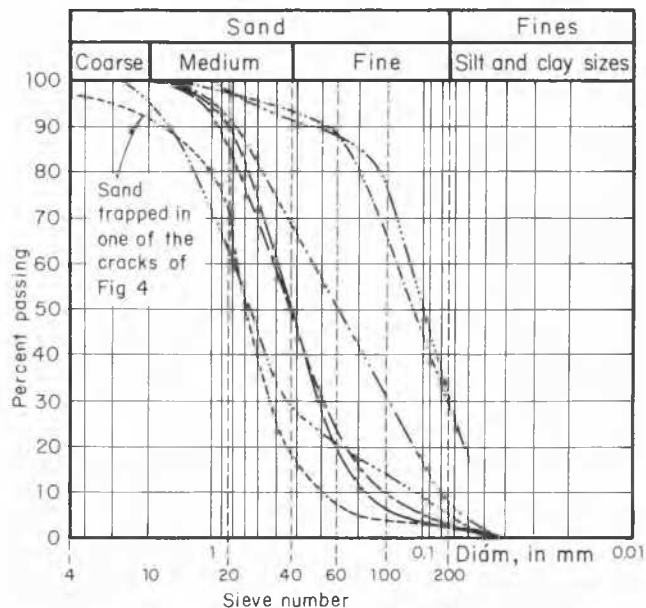
Fig 5. Grain size curves of the liquefied sand

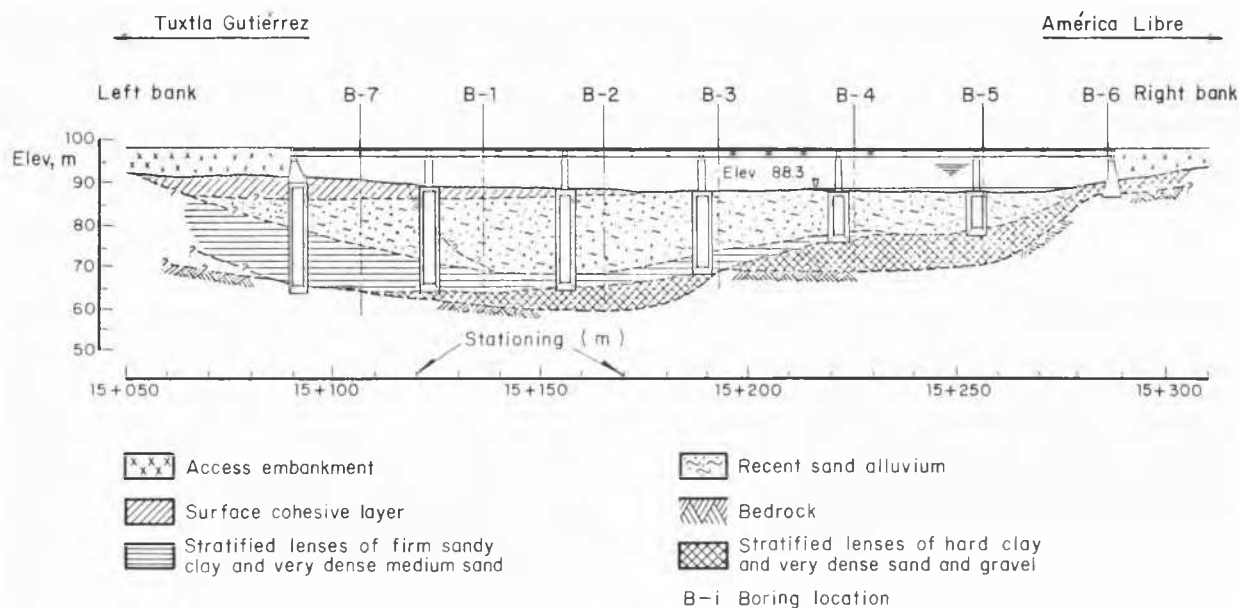
The soil profile along the axis of the bridge is shown in fig 6. The results of the test boring standard penetration resistance for that project (ref 3) were redrawn using the Gibbs and Holtz (ref 2) correlation for average conditions. It was found that Boring N°7

was located in dense formational terrace deposits of medium to coarse sand with few fines. This material was observed not to liquefy or show any other sign of distress. Borings made in the recent alluvium show considerable scatter in the penetration resistance but generally indicate correlated relative densities above 55% and may be classified as being medium dense. The penetration resistance of borings located in the river indicate significantly lower relative densities in the zone of frequent erosion and re-deposition. Although these data were obtained in 1962, they appear to be reasonably consistent and tend to indicate that the sands which liquefied were generally located within a medium to dense alluvial deposit

Fig 6. Santo Domingo bridge soil profile

Borings and standard penetration tests made in 1962, for the Santo Domingo Bridge, indicate that the recent alluvium is probably in a medium to dense state, and that it typically consists of uniform medium sand with few fines passing the N°200 sieve.
