**DEEP FOUNDATIONS FOR A BRIDGE IN BRAZIL**  
**FONDACTIONS PROFONDES POUR UN PONT BRÉSILIEN**  
**ГЛУБОКИЕ ФУНДАМЕНТЫ МОСТА В БРАЗИЛИИ**

**SIGMUNDO GOLOMBEK, Director Consultrix S/C Ltda, S. Paulo (Brazil)**

**SYNOPSIS** - The paper deals with the design and execution of the foundations of a highway and railway bridge on the Brazilian National Road BR-101. Caissons 1,5 m. diameter with lengths up to 70 m. through sands and soft clays to weathered rock were used. Some peculiarities are mentioned as well as problems in execution and changes in design made necessary by special conditions of subsoil and equipment shortage.

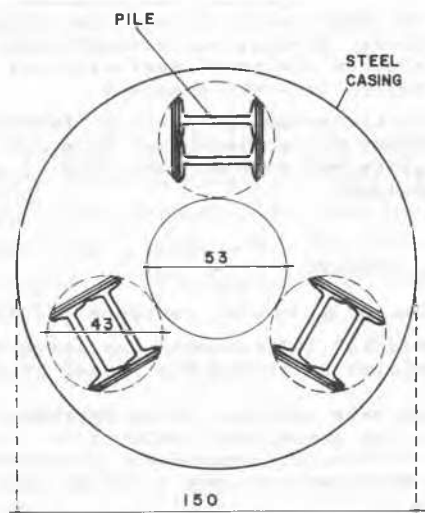
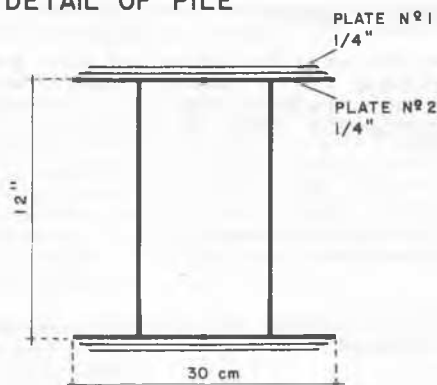
FIG. 3

- a.3 - Finally when the deformations were too deep to be eliminated through compressed air and the mandrel was unable to solve the problem, the design was changed and steel piles driven through the casing to refusal in rock.

Special templates were arranged to guide the piles at different depths to guarantee verticality of the piles. Because Brazilian steel mills don't produce heavy profiles, the piles had to be specially made.

Three piles were driven in each caisson. Each pile was composed of two I profiles 12" x 5 1/4" with 66 kg/m. each, with additional reinforcement consisting of steel plates welded to the profiles in order to obtain a total weight of 186 kg/m.

Figure 3 shows a cross section of such a pile and the disposition of the pile in the caisson.

Top of piles was at elevation -25 m. in order to guarantee buckling resistance in case of erosion and a minimum penetration of 3 m. in the casing.

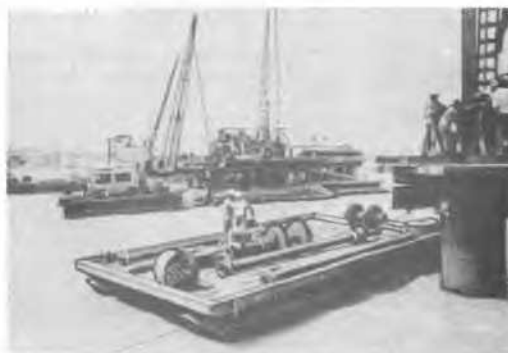
FIGURE 4

Figure 4 shows the equipment in use. At the right hand caisson a steel pile is being put in position

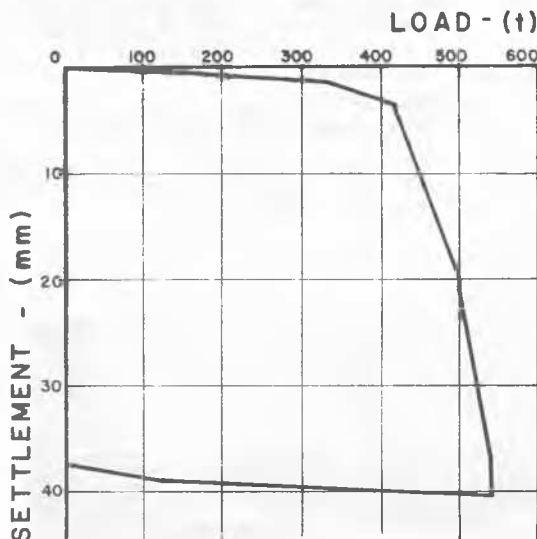
FIG. 5

In the first caisson to be finished with 61,55 m. long, during concrete pouring when concrete reached elevation -39,5 m. a reduction in the necessary effort to retrieve the tremie was verified.

Pouring was continued and, when finished the tremie retrieval, 16,7 meter of the total length were missing, showing that a reasonable quantity of bentonite was mixed in the concrete, probably causing a complete interruption of the concrete column.

Even knowing that this caisson was not to be used a load test was performed (fig. 5).

DESIGNED WORKING LOAD	438 t.
MAXIMUM SETTLEMENT	40,36 mm.
RESIDUAL SETTLEMENT	37,32 mm.

Up to approximately 420 ton. total settlement was 3,5 mm but from that load on settlement increased rapidly to 40 mm with 535 ton.

In this load test reaction was provided by traction of two steel casings 1,5 m. in diameter and 27,0 m. long driven 4,5 m. center to center from the tested caisson.

These two casings were afterwards used for two caissons to replace the faulty one.
