LONG-TERM FAILURE OF A BANK ON A SOLIFLUCTION SHEET
RUPTURE A LONG TERME D'UN REMBLAI SUR UNE COUCHE DE SOLIFLUCTION
ДЛИТЕЛЬНОЕ РАЗРУШЕНИЕ БЕРЕГА НА СЛОЕ, СКЛОННОМ К СОЛИФЛЮКЦИИ

R.J. CHANDLER, Lecturer, Imperial College, London

SYNOPSIS. A railway embankment in Northamptonshire, England, showed considerable instability some 70-80 years after construction. The bank, on an 8 1/2° slope, was founded on a solifluction (fossil periglacial mudslide) sheet, dating back at least 10,000 years to the last glacial period. The shear surface at the base of the solifluction sheet proved to be the seat of the instability of the bank. The limited movements probably developed after the establishment of long-term pore water pressures, controlled by a perched water table in the ballast beneath the railway track. Stability analyses suggest that the bank was only unstable under the increment of undrained loading provided by passing trains, a conclusion consistent with the small movements of the bank. If the bank had not been previously stabilized by grouting, the progressive displacements would have led to complete failure.

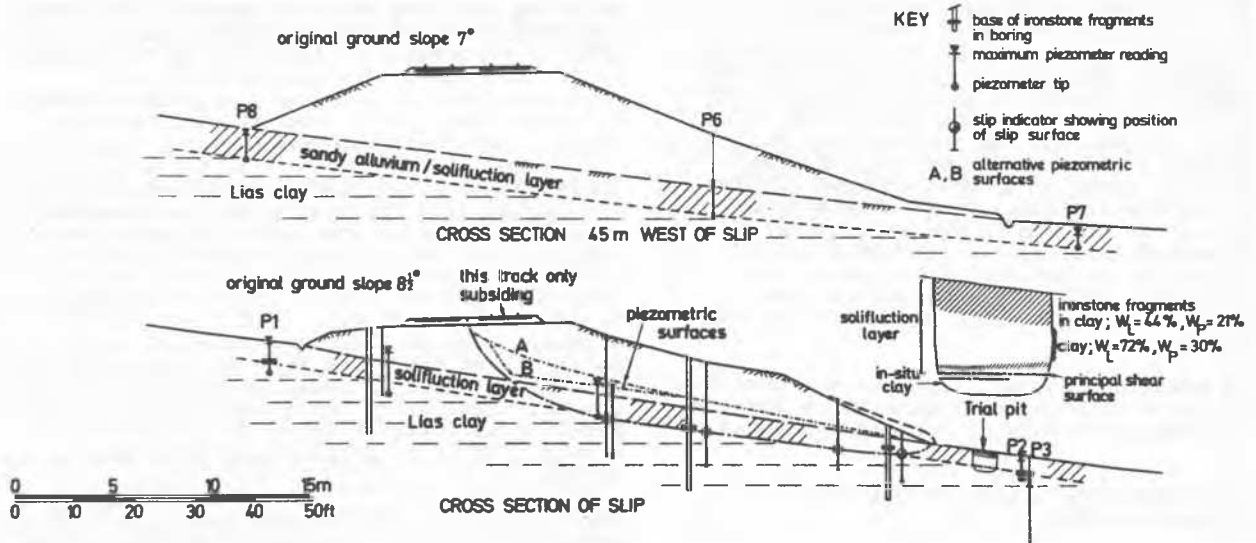
FIG.2 EMBANKMENT FOUNDATION FAILURE, GRETTON, NORTHAMPTONSHIRE

In 1961, following slow subsidence, perhaps over many years, of the track on the down-slope side, an investigation was initiated by British Rail, who sunk borings and also installed alkathene tube slip indicators through the embankment into the *in situ* Lias clay beneath. Fig.2 is a cross-section of the bank at this point showing the borings and slip indicators.

The deflection of the slip indicators, detected by the jamming of a rod passed down the tube, showed the embankment to be moving on a shear surface parallel to and about 1.2m beneath the original ground surface. Some heave had occurred at the toe of the embankment. The slip indicator on the upslope side of the bank showed no movement confirming that the instability was limited to the downslope half of the bank.

This trial pit, dug in ground undisturbed by the embankment movements (see Fig.2) showed that the solifluction layer consisted of reworked Lias clay with bands of ironstone-rich clay above a polished shear surface. Water seeped into the trial pit along these layers. These ironstone fragments are derived from the 'cap-rock' at the crest of the escarpment, about 100m upslope from the embankment. The depth to which ironstone fragments were noted, both in the original borings and in those carried out more recently for piezometer installation, also provides evidence for the thickness of the solifluction layer, which as seen in Fig.2, agrees well with the depth of the slip surface beneath the embankment. There can be no doubt that the bank instability is due to the reactivation of movement on the shear surface beneath the solifluction layer.

after the piezometric level relative to the base of the tube had been established, the bottom of the tube was blocked with cement grout and the tube cut at the point of contraflexure just above the slip surface. The piezometric levels relative to these depths are shown in Fig.2, and clearly indicate a downward component of flow, as do piezometers P2 and P3 at the toe of the bank. All the piezometric levels shown, both at Gretton and at the site at Seaton described subsequently, are the maxima recorded in the period December 1970 to April 1972; in almost every case these maxima occurred in February - March 1972.

As a result of the 1961 investigations the embankment was stabilized by grouting, using the methods described by Toms and Bartlett (1962).

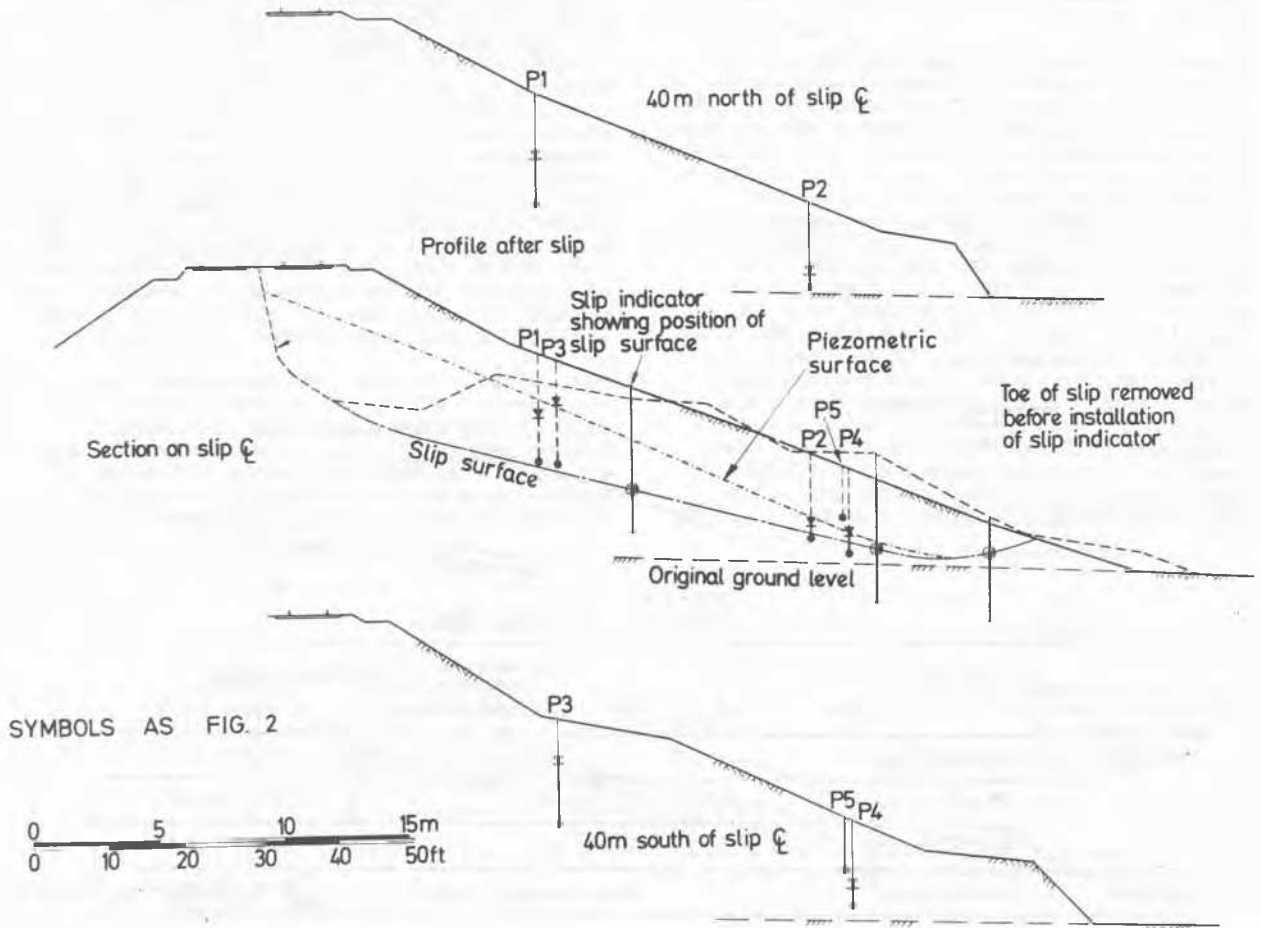
FIG.3 SLIP IN RAILWAY EMBANKMENT, SEATON, RUTLAND

at the toe of the bank to be slightly displaced at the point where failure eventually occurred. The final rapid movement to the 'after-slip' profile shown in Fig.3 took place in a period of less than an hour, and at least twelve hours after the last train passed.

The position of the slip surface was located after the failure, with alkathene tube slip indicators. No further investigation was undertaken until 1971 when piezometers P1 to P5 were installed at the depth of the observed slip surface, but either side of the site of the landslide.

Over the 1971-72 winter these piezometers indicated high water pressures towards the crest of the bank with considerably lower pressures near the foot of the slope. Such a water pressure distribution is almost certainly the result of the downward flow of water ponded in the ballast beneath the rail way track. As the crest of the embankment

Seaton embankment. The piezometric surface used in the stability analysis of this slip was that determined from the piezometers located at the depth of the slip surface adjacent to the site of the slip. These piezometers and the corresponding maximum piezometric levels are projected onto the cross-section of the slip in Fig.3. The stability analysis, in common with all those considered in this paper, was carried out using the method of Morgenstern and Price (1965). The result of this analysis suggests that at failure the average strength along the slip surface was 14.8kN/sq.m (310 lb/sq.ft), which corresponds to effective stress parameters $c' = 0$, $\phi' = 21^\circ$. A study of a number of long term failures of Upper Lias Clay cutting slopes shows that for the undisturbed clay the lowest average effective stress parameters operative at failure are $c' = 0$, $\phi' = 23^\circ$. It is probable that the fill material had similar effective stress parameters at failure, since higher than usual pore pressures were no doubt the final trigger mechanism causing failure. There is no evidence that the 1971-2 pore pressures used in the analysis were other than usual for the winter period, and were probably lower than those operative in the slip area in January 1961. An average rise of the piezometric surface of 0.4m above the 1971-72 values would lead to failure with $c' = 0$, $\phi' = 23^\circ$.

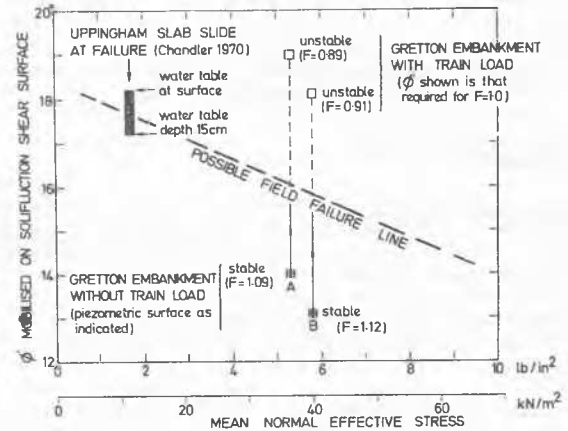
FIG. 4 SUMMARY OF STABILITY ANALYSES, GRETTON EMBANKMENT
Use electric typewriter if possible.

Also shown in Fig. 4 are the results of the stability analyses carried out for the Gretton embankment. When these are compared with the suggested field failure curve it is seen that with only the self-

Utilisez de préférence une machine à écrire électrique.
weight of the fill providing the disturbing force the bank was probably stable, the mobilized ϕ' was between 13° and 14° , and $F = 1.1$; with the passing of a train the bank became unstable, with a factor of safety perhaps as low as 0.9.
