SETTLEMENT DUE TO DEEP FOUNDATION CONSTRUCTION
TASSEMENT DU A LA CONSTRUCTION DES FONDATIONS PROFONDES
ОСАДКА В РЕЗУЛЬТАТЕ УСТРОЙСТВА ГЛУБОКИХ ОПОР

SWAN BENG TAN, Executive Engineer, Public Works Department (Singapore)

CITY HALL BUILDING

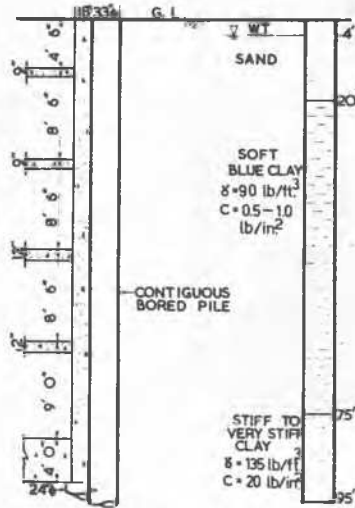
Figure 3 Soil Conditions and Cross Section of Colombo Court Excavation

The Colombo Court Shopping Complex approximately 282 feet by 156 feet, Fig. 3, has a 4'6" lower ground floor and four underground basements each of approximate height of 8'6". *private development

The fourth basement is on a 4 feet thick floor slab which rests on piles. The total depth of excavation required during construction was 45 feet. To construct the basements contiguous bored piles each of diameter 33", were first placed round the periphery of the proposed site. These piles were embedded about 20 feet into the stiff clay. Next the excavation for the substructure was made to the first basement level. The floor slab which was to act as a permanent strut was cast. The

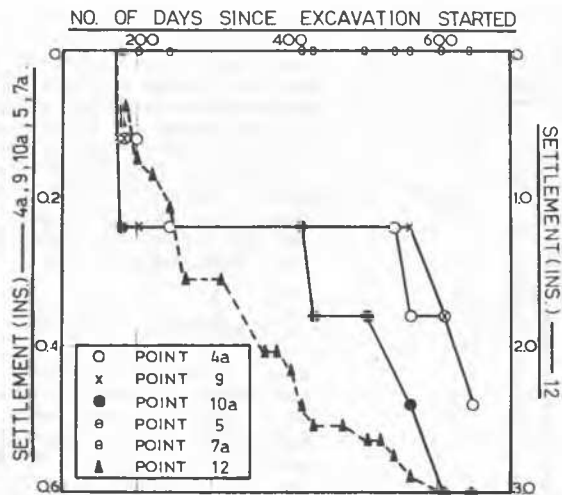
Figure 4 Settlement - time curves

About a month (November 1969) after excavation had begun at the Colombo Court site, a series of cracks and gaps were observed at the City Hall Building, in particular, Block E (cracks) and Block D (gaps). As a result a number of tell-tale glass were fixed to the walls and measurements taken of the width and length of cracks and gaps. Subsequently, in April 1970, when the cracks became more pronounced and numerous, settlement readings at various points were also taken. The positions of some of the gap and settlement points are shown in Fig. 2. The plot of the amount of settlement against time since the excavation commenced for points 4a, 12, 5, 10a, 7a and 9 is presented in Fig. 4. It is observed that the settlements of the building are high at points (12, 10a, 9) nearest to the excavation and low (4a) further away. They are practically zero at points 5 and 7a. The amount and rate of settlement increased as the excavation deepened and tailed off as the construction of the final fourth basement approached completion. The rate of settlement was greater than that expected from consolidation settlement which had been very conservatively estimated as less than 0.1 inch per year. The above observations suggest that the consolidation settlement is unlikely to be a major contributor to the observed settlement but

rather the excavation work. This could be seen by examining the factors (PECK 1943, 1969) associated with deep excavation, which if not properly taken account of, would result in excessive settlement. The first of such factors to which scant attention had been accorded in the construction of the basements of the Colombo Court Shopping Complex, is the critical depth of excavation. This critical depth is the depth before which the first strut must be inserted in order to minimize any excessive adjacent ground settlement (PECK 1943). A conservative estimate of the critical depth for the construction in question showed that the first strut should be inserted before the excavation reached a depth of 10.5 feet. Referring to the dates shown in Table 1, it is seen that the first strut (permanent floor slab) was at a depth of about 13 feet below ground level and not at 4 feet 6 inch as indicated in Fig. 3. Hence the critical depth had been exceeded and excessive adjacent ground surface subsidence would result as had been observed. The second factor is the time lag between excavation and strut insertion, the shorter the delay, the lesser would be the adjacent ground settlement. For the Colombo Court excavation it was noticed that, Table 1, the date of completion of the first basement excavation was 4th March, 1970 and that of the floor slab which would act as a permanent strut was 13th March, 1970 - a time lag of 9 days. This delay was made worse by the additional time necessary for the floor slab concrete to cure and mature before it could become effective as a strut. Similarly there was a considerable time delay for the second basement (more than one month), third basement (more than one month) and fourth basement (more than two months). Further it was noted that before the floor slab became completely effective as a strut, excavation for

the next basement level had begun. This is shown by the date of commencement of the second basement (2nd March, 1970) and the date of completion of the first basement floor slab (13th March, 1970). Likewise the same applies to the third basement (date excavation commenced 21st May, 1970, date second basement floor slab completed 29th June, 1970) and fourth basement (date excavation commenced 10th August, 1970, date third basement floor slab completed 5th September, 1970). It is also noted that the bottom fourth basement is in the soft marine clay. This means the tendency for the base to rise during excavation is greater than otherwise. These factors, as discussed above all contribute to the observed excessive adjacent loss of ground. These excessive settlements are clearly shown by the settlements measured at points 4a and 9, which were five times the maximum depth of excavation away. (Note that the maximum quoted by PECK (1969) for three or more basements is only four times). It is also noted that the settlement at point 12 (3 ins.) is less than that (6.5 ins.) which could be estimated from PECK'S (1969) graph. This is because all the settlement readings were taken some six months after settlements had begun and hence the observed settlements would be less than that which had actually occurred.

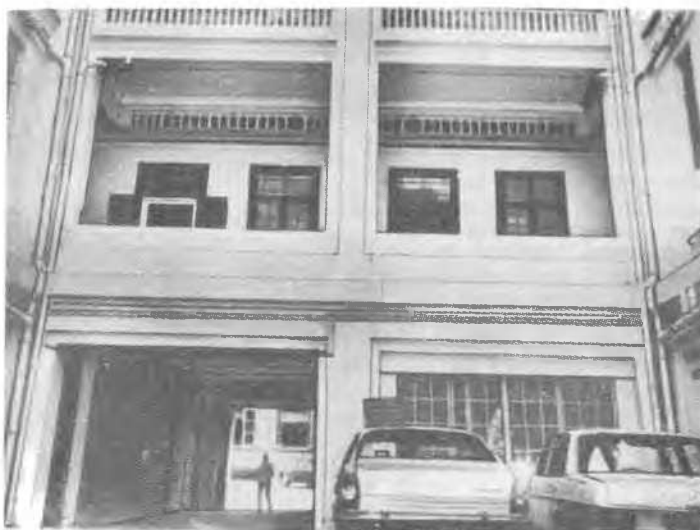
Figure 5 Crack patterns on beams

In Fig. 5 the crack patterns on the first floor beams (Block E) facing the open space are presented. The photograph shows clearly that the columns at the extreme right had settled more than that at the middle left. This middle left column had in turn subsided more than that at the extreme left. These differential settlements had given rise to excessive tensile stresses at the bottom of the concrete beam (nearest to extreme right column) and at the top (nearest to the middle column) and hence the cracks pattern resulted.

The same observation applies to the span between the middle and the extreme left column and also to the beams of the two upper floors though not shown. It is interesting to note that the crack propagations were consistent with the differential settlements observed, Fig. 4, where point 12 settled more than points 4a.

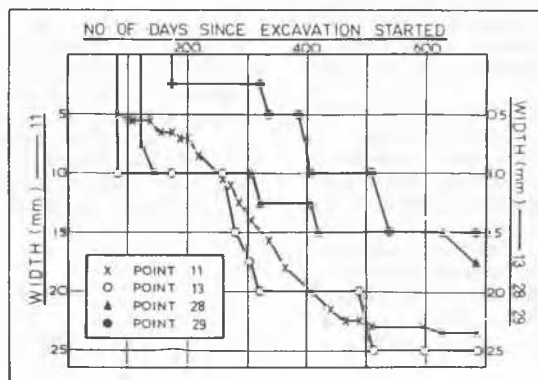
Figure 6 Crack and gap widths against time curves

The plot of crack width against time for points 28 (first floor) and 29 (second floor) of Block E is given in Fig. 6. The same figure also shows the third floor gap width for point II (between Block D and C and point 13 (between Block D and A) against time. The crack and gap widths increased with time i.e. with deepening of excavation, and became st-

eady and constant when the basement work was almost completed. This behaviour agrees with that observed for settlements, Fig. 4, indicating again that the excavation work is mainly responsible for the cracks and gaps. It is interesting to note that the gap width for point 11 is consistently greater than that for point 13. This suggests that Block C settles more than Block D, which of course is so since Block C is nearer to the excavation. This inference is again in agreement with the settlements observed.
