# DAMAGE TO STRUCTURES ON PRECONSOLIDATED CLAY

A. KOMORNIK, D.Sc., Senior Lecturer

J.G. ZEITLEN, M.Sc., Professor of Soil Engineering  
Israel Institute of Technology, Haifa, Israel

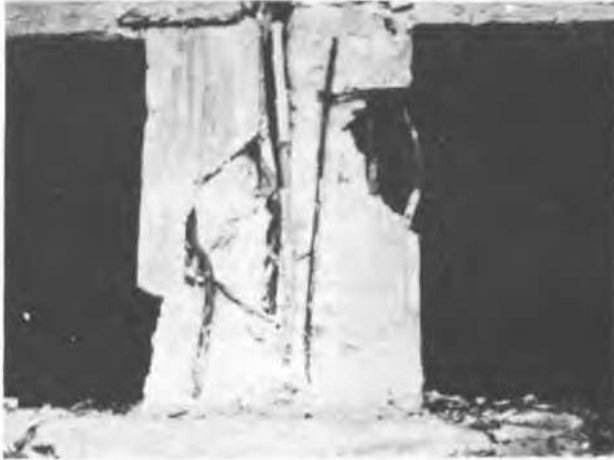
Fig. 1 Column Destruction at Expansion Joint (Site A)

In the area at least 17 structures showed various degrees of structural damage. Differential settlements and tilting of the various sections occurred, causing some of the columns near the joints to rupture (Fig. 1). In another building in this project, differential settlement of several inches occurred between adjacent columns and the building itself was distorted throughout its full height. A typical soil profile of this area is shown in Fig. 2,

Corrective measures for the main portion of the buildings to date have mainly included replacing the broken columns. Performance since has been satisfactory.

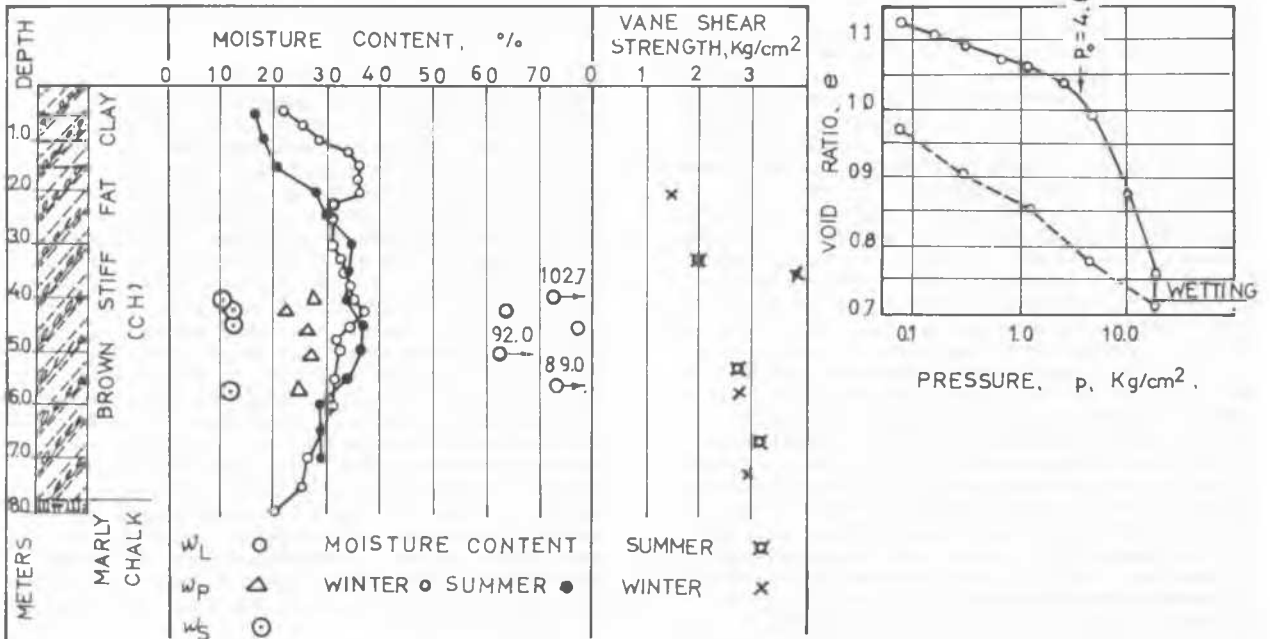
Fig. 2 Typical Soil Profile and Characteristics (Site A)

and can be described as follows: the upper layer (8 meters thick) is a desiccated highly plastic stiff clay, mainly montmorillonite, overlying a bedrock of chalk and marly chalk layers. Water table is usually found at an elevation of about +1.0 m while the area is at above +12 m elevation. The clay has a liquid limit varying between 109 to 64 and plasticity index of 75 to 42. The shrinkage limit varies between 10 to 13. Moisture studies in this area indicated the major seasonal variations to occur in the upper 2.5 m of soil with moistures varying from 16 to 36 per cent. At greater depths variations were relatively small and the moisture content is about 5% higher than the plastic limit, which varies between 28 to 22 percent. The vane shear strength of the clay tested both in winter and in summer varies from 2 kg/cm<sup>2</sup> to 4 kg/cm<sup>2</sup>, with most of the results more than 3 kg/cm<sup>2</sup> for depths below three meters.

A consolidation test is shown in Fig. 2 for a sample tested at its natural moisture content and wetted only at 20 kg/cm<sup>2</sup> pressure. It should be noted that the addition of water at a high pressure caused an immediate increase of settlement ("slump" phenomena). This type of phenomena had been also found in similar clays tested under lower pressures but at loads higher than the preconsolidation pressure.

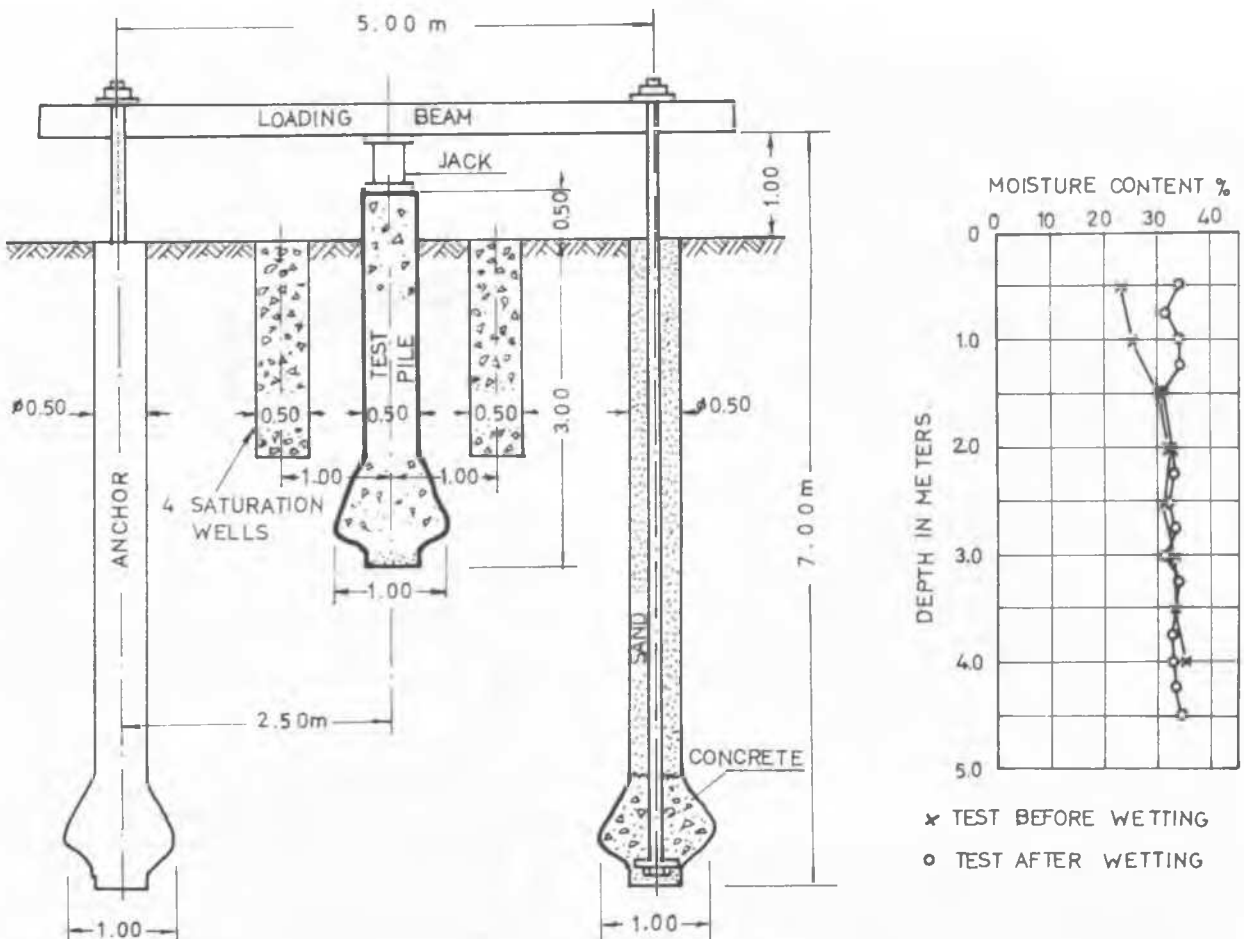
Fig. 3 Loading Test Arrangement and Moisture Profiles

During investigations at a site, A', adjacent to A, the influence of wetting was studied in the course of a loading test on a typical bored pile, 3 meters deep, with an underreamed bell diameter of 1 meter. The soil around the pile was wetted by saturation wells extending to 2 meters depth (Fig. 3). The total settlement increased from 5 mm to 23 mm during six days under a constant load of 25 tons (Fig. 4). Determination of the moisture content profile, before and after saturation, showed no change in the value of about 32 percent at the depths of the pile tip. The increased settlement was probably due partly to decreased resistance of the upper clay around the stem, as well as to decreased shear resistance of the pile end. The wetting action of the wells may have caused decreased suction in the pores of the lower bearing clay, not accompanied by a noticeable water content increase.

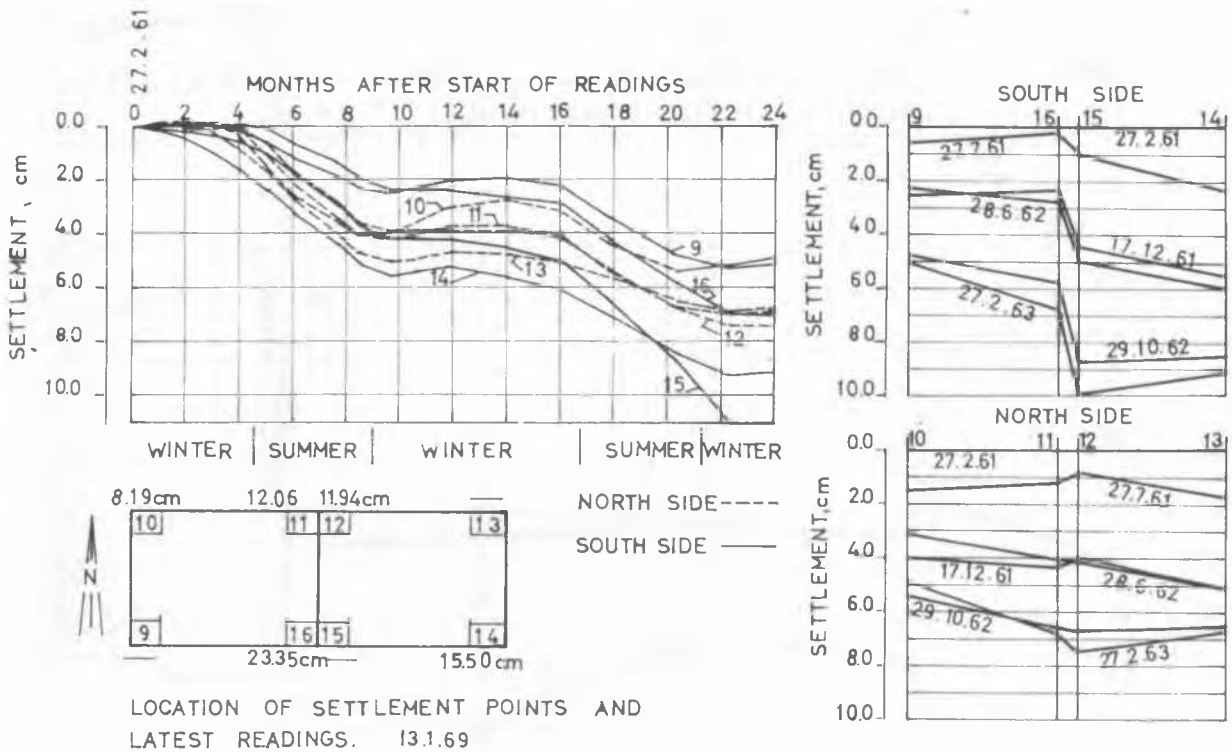
Fig. 5 Level Measurements of Typical Structure (Site A)

Settlement measurements of these structures were taken after the damage to the structures became obvious, from 1961 to 1963. Results of these level measurements are given in Fig. 5 for two structures. The curves for the settlement of each point with time show a clear tendency for the piles to settle in summer (during the dry

spell) and to level up and even to swell a little bit during the winter period (rainy season). This phenomena repeated itself in the other structures when detailed levelling was performed. This can be explained by the fact that during the summer, cracks form in the clay, relieving the lateral support on the stems of the piles and allowing full transfer of load to the pile bulb. In winter, due to the swelling of the soil, the clay "grips" the side of the pile and tends to raise it. The total settlement increased with every season and varied between 3 cm to 10 cm during the period of measurements. Differential movement of the various blocks at different times show up clearly in the plots on the right side of Fig. 5. It should be noted that in several structures one or two columns tended to settle more than the rest of the structure, as was evidenced by minor cracking in the walls.

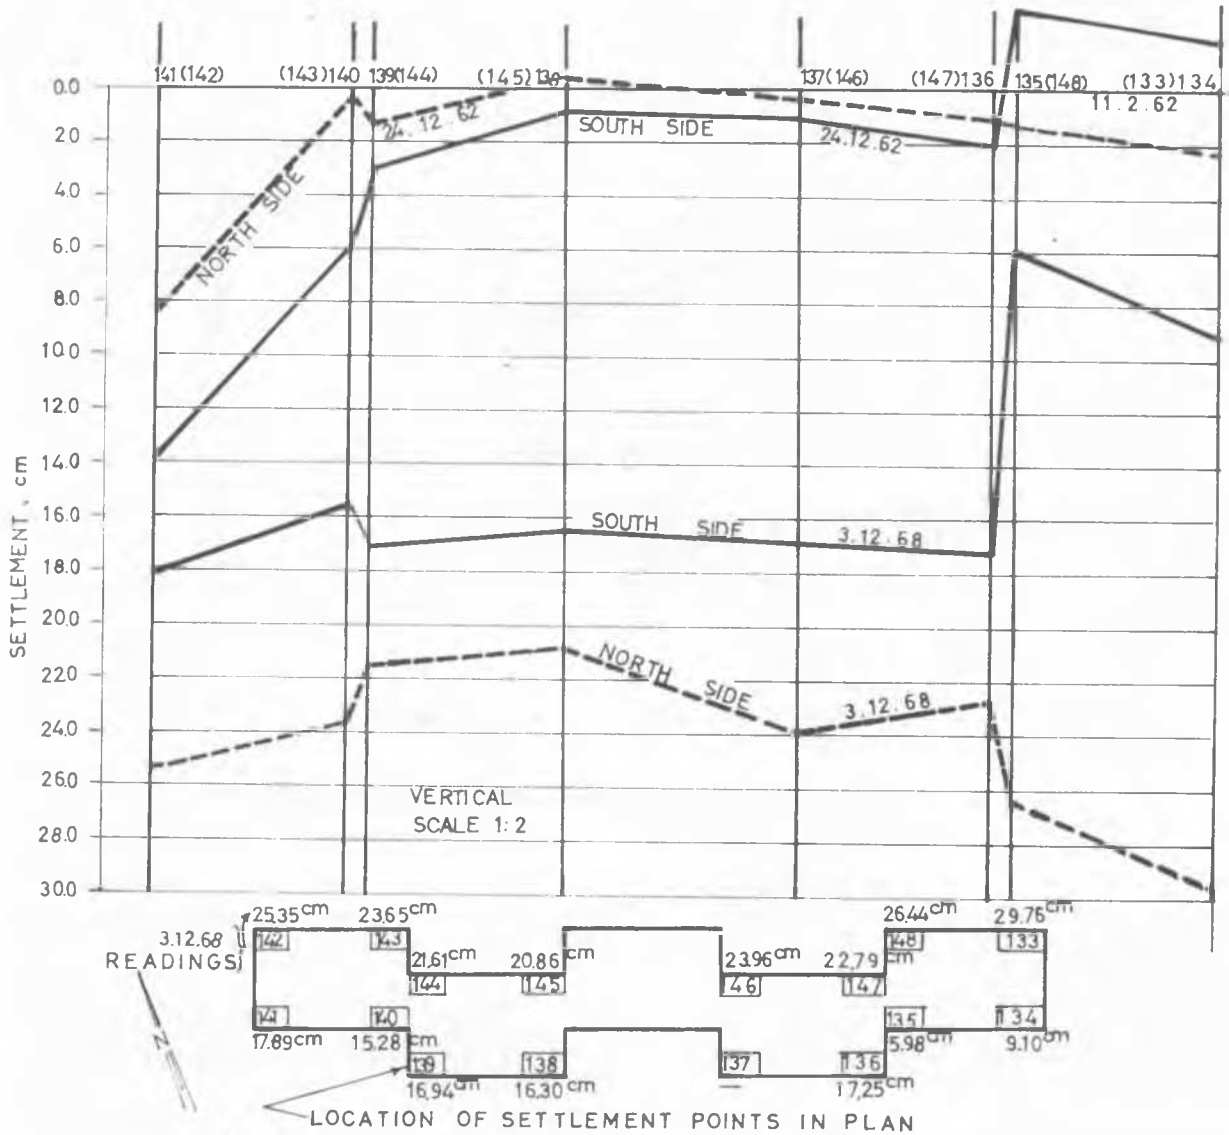
Fig. 6 Vertical Movements of Building (Site B)

In one of these buildings, the underreaming was not properly executed, thus causing overstressing of the clay layer and giving rise to large settlements (between at least 10 cm to 30 cm) and tilting of the sections. Minor damage occurred to the superstructure.

Other structures in this area have settled much less (several centimeters) but serious cracking of columns has occurred. The columns were 30 x 30 cm in size and 2.5 meters in height (between the top of the foundation beam and the first floor).

Level measurements were initiated after large differential settlements were observed. Results are shown in Fig. 6.

Consolidation and swelling tests were performed on undisturbed samples taken at the foundation depth of 3.0 meters. A specimen from this depth evidenced a swelling pressure of 4.9 kg/cm<sup>2</sup>. The building having excessive settlement is about to be underpinned on new bored straight piles founded on top of the rock layer at a depth of 7 meters. The damaged columns have been already encased in a cover of additional reinforced concrete.

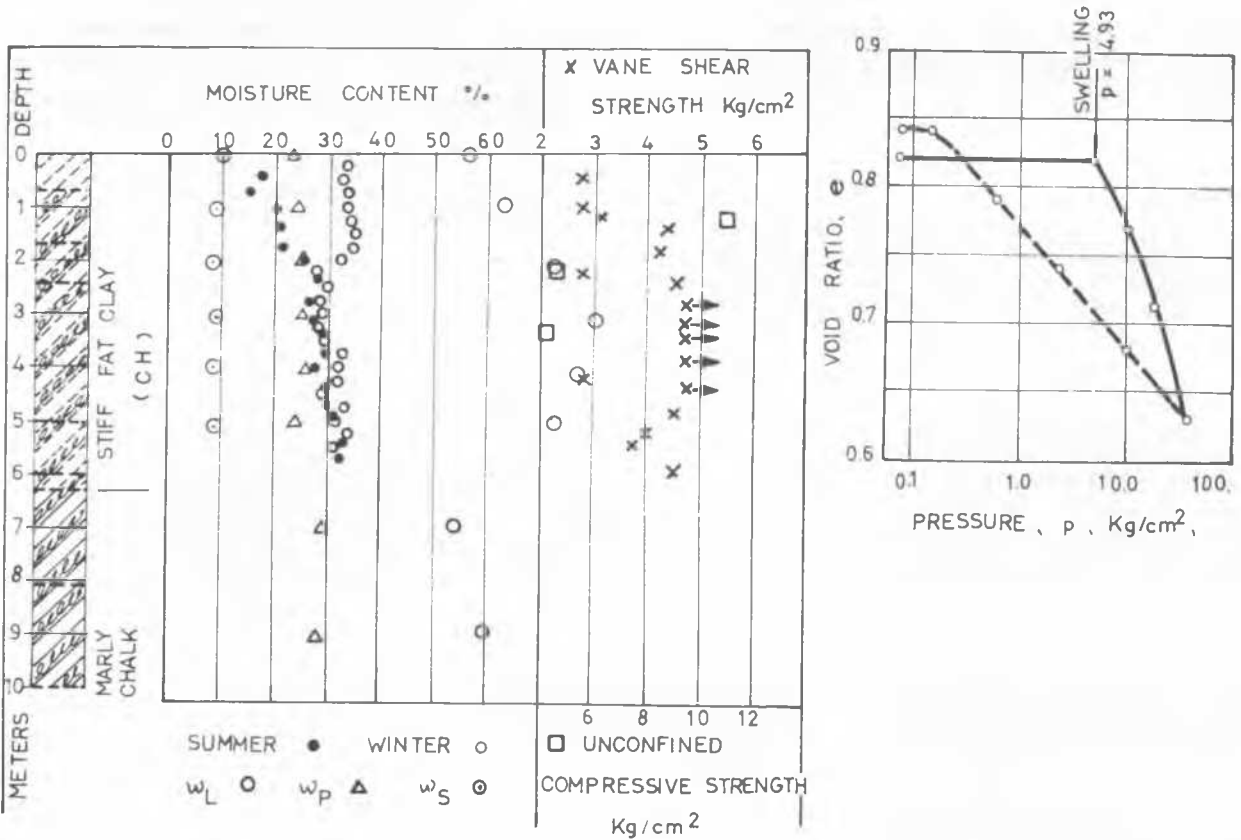
Fig. 7 Typical Soil Profile and Characteristics (Site B)

Fig. 7 shows the soil profile at this site, with moisture content, shear strength and Atterberg limit variations with depth and seasons.

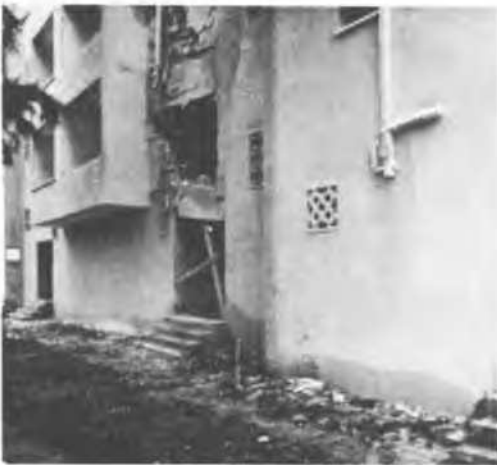
Fig. 8 Building at Site C, Showing Settlement of 30 cm in Right Hand Portion of Building

During the final work on the building almost the whole of one section suddenly settled about 30 cm, following a long rainy period (Fig. 8). Investigations to date indicate that the foundations themselves did not settle appreciably, but that the settlement was due to collapse of 20 x 40 cm short columns under the section.

One corner was on an improperly executed pile, which did not have under-reaming as designed, in an area where a septic tank had soaked the ground. It is believed that the

weakness of the corner, compounded by the rain and softening of adjacent foundations, kept transferring load onto other columns until one failed, starting a "domino" action. Failure did not occur at the end of the section near the center of the building, because of a shelter construction able to take the loadings. The other section of the building was undamaged, since it was designed with grade beams resting on the pile caps.
